Municipality of Strathroy-Caradoc Parks and Recreational Area Condition Assessments Executive Summary Report - November 2024

Re: RFP-2024-132 – Parks & Recreational Area Condition Assessments

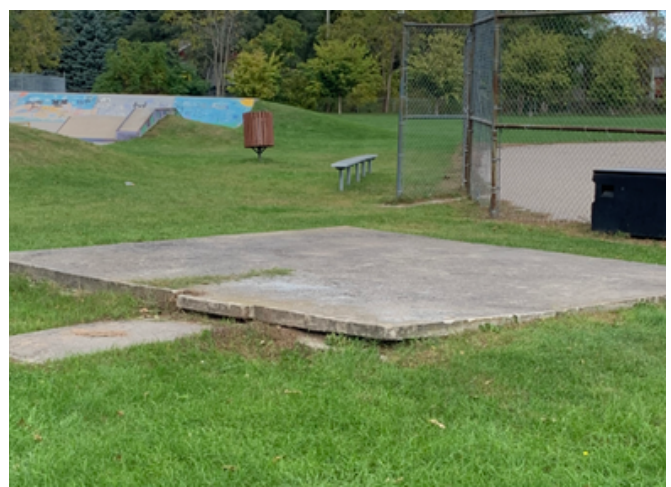
The Mt. Brydges Legion Park, covering 3.44 acres, offers a range of recreational facilities including a baseball field, a skate park, and courts for tennis and pickleball. The skate park, while generally in good condition, shows some signs of wear with chipping at the expansion joints that could potentially pose trip hazards for skaters.

The baseball field has a surface of chips and dust and is without lighting. The fencing is in average to good condition but shows some surface rust, and one post is rotten and requires replacement. The players' benches are in good condition, but a standalone bench along the first base side is in poor shape and should be removed. The outfield's sports turf is in average condition due to weed growth and uneven areas, which affect its overall health. The transition between the infield and outfield is uneven, and it is recommended that the transition height be reduced to improve the playing surface. The bleachers are also in average condition, with some damaged boards needing replacement. It is suggested that side railings be added, the steel frame repainted, and a concrete pad installed under the bleachers to prevent weed growth. A concrete pad behind the backstop has been identified as a trip hazard and should be removed.

In summary, while the park is in good overall condition, there are several areas where improvements can be made. Addressing the trip hazards in both the skate park and baseball field, along with repairing or replacing the damaged infrastructure such as fence posts, benches, and bleachers, would enhance the park's safety and usability. Additionally, improving the baseball field's playing surface and turf health would further elevate the quality of the facility.

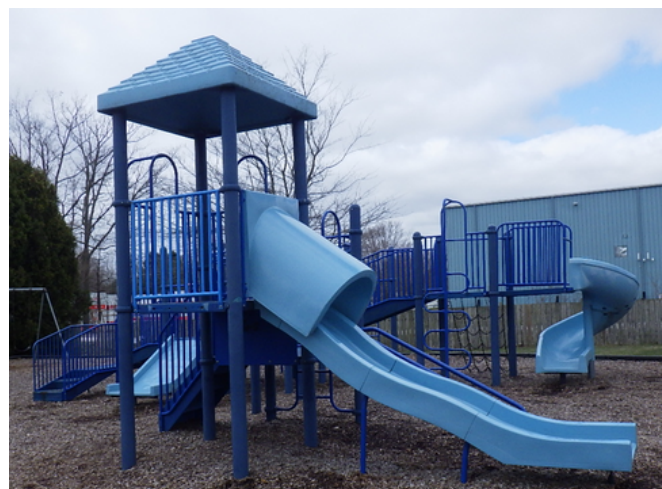
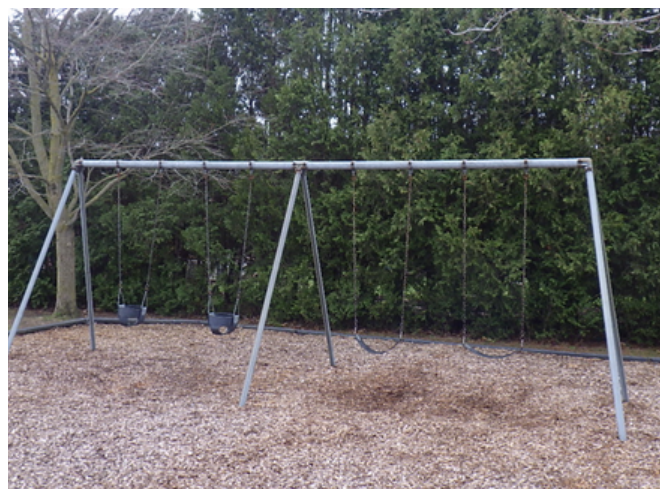
Applewood Park, located in Mt. Brydges, covers 0.49 acres and includes a playground surrounded by a well-maintained natural environment. The park is enclosed by perimeter fencing, all of which is in good condition, providing a secure boundary for visitors while maintaining the park's accessibility. The fencing does not currently require repairs or upgrades, reflecting regular upkeep and maintenance.

The park's landscaping features a mix of young and mature trees, with no identified hazard trees or branches at the time of assessment. The mature trees are in good health, and their structural integrity does not present immediate safety concerns. To facilitate grass cutting and general park maintenance, the report recommends trimming low-hanging limbs and continuing regular inspections during each cutting cycle or after significant windstorms. These inspections ensure any broken branches caught in the mature trees are identified and removed promptly, minimizing potential risks.

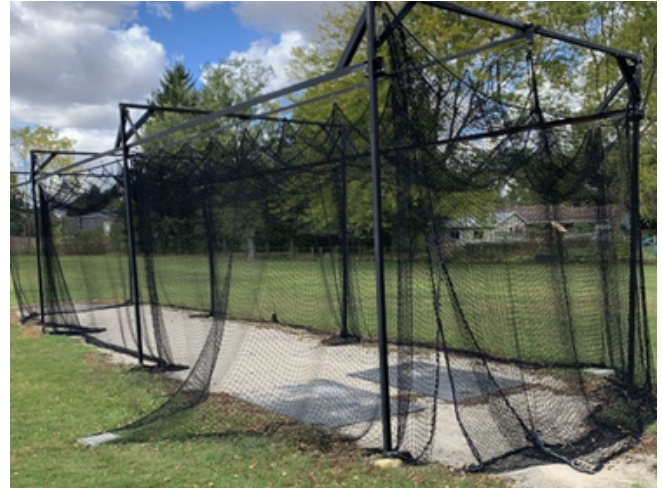
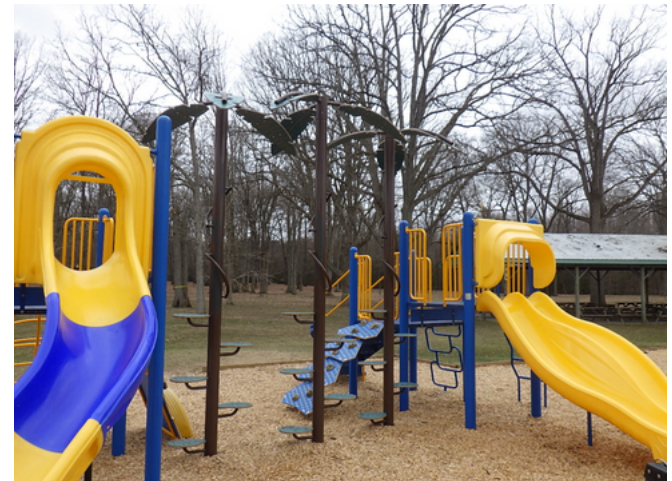
The baseball field is noted to be in excellent condition. The red clay infield provides a well-maintained playing surface, while the fencing, backstop, and outfield sports turf are also in excellent shape. The outfield is level with minimal uneven areas, contributing to safe play conditions. The players' dugout benches are in excellent condition, but the spectator bleachers are rated as average, with some wood rot visible on the seating planks. To enhance safety and usability, the report recommends the installation of side railings on the bleachers. The baseball field lighting has recently been upgraded to LED, providing efficient and high-quality illumination. The transition lip between the infield and outfield is in excellent condition, and ongoing field maintenance is advised to maintain the field's current status. The batting cage is in excellent condition, although it is unclear whether it is municipally owned or managed by the local Ball Association.

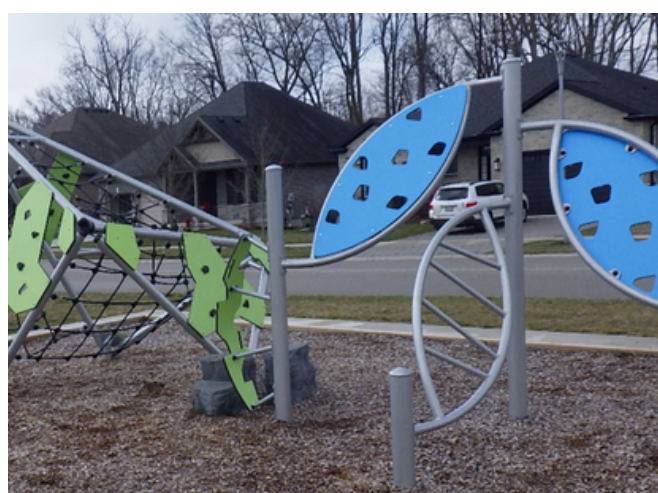
Bennett Crescent Park, covering 0.45 acres, features a playground and a pavilion. The park's perimeter fencing, which exists on only one side, is in excellent condition and requires no immediate repairs. Park furnishings, including benches and picnic tables, are also well-maintained and in excellent condition, offering high-quality seating and gathering areas for visitors.

As a newer park, Bennett Crescent Park has no mature trees, and no hazardous trees or branches have been identified. Regular maintenance of low limbs is recommended to facilitate grass cutting and park upkeep. Given the youth of the trees, it is advised to monitor them during drought periods for early signs of stress. The addition of water bags may be considered to support the trees' healthy development during dry conditions.

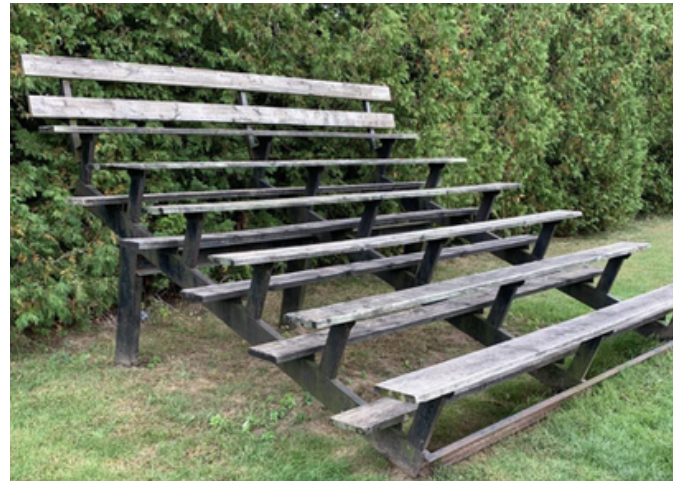
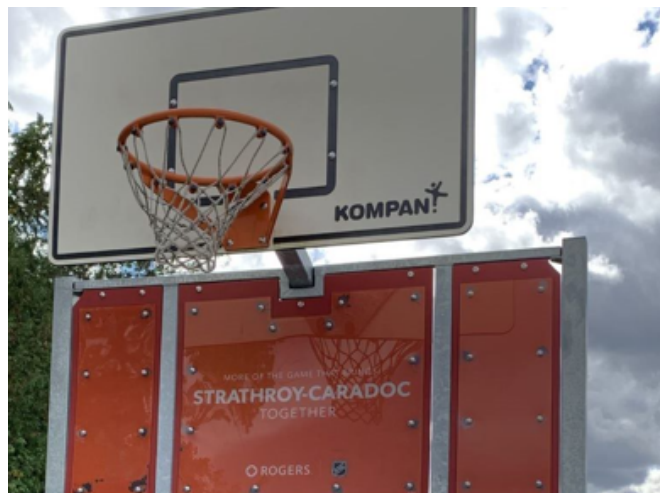
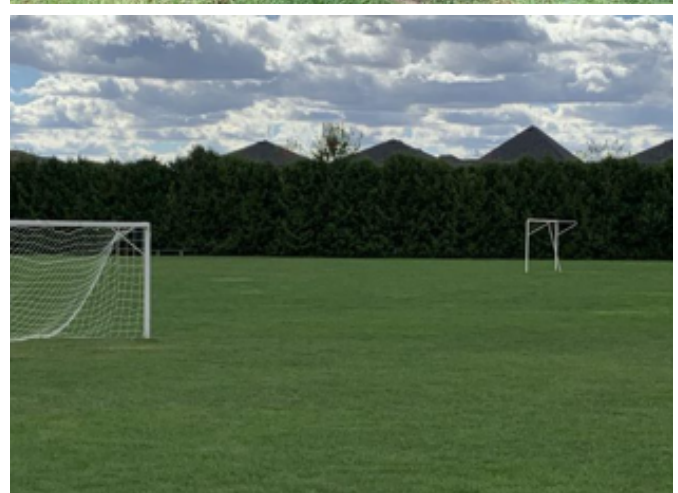
Caradoc Community Park spans 9.31 acres and includes three soccer fields and a single basketball net. The soccer fields are in excellent overall condition, with natural grass turf that has grown well and remains mostly weed-free. Minor restorative work is needed around the goal mouths, but the goal frames themselves are in excellent condition. Player benches are in good condition, though some boards are beginning to show signs of wear, indicating a need for monitoring and potential future repairs.

The spectator bleachers are rated as average, with some boards showing signs of wear and decay. The addition of side railings is recommended to enhance spectator safety. The basketball net is in excellent condition, although it is unclear if it is a municipally owned asset or was donated by a third party.

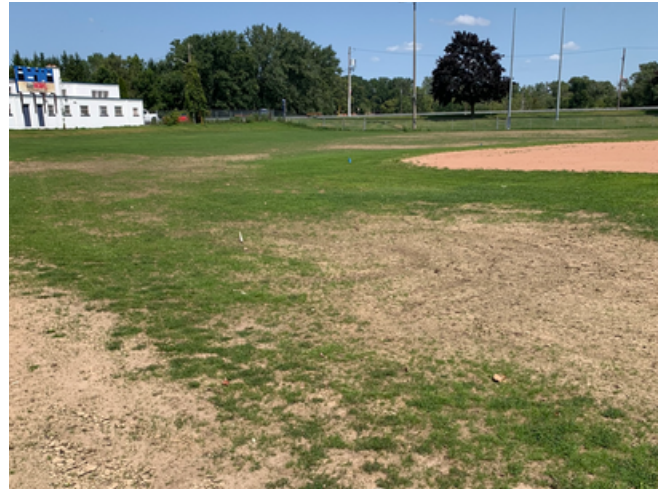
Located at 154 Caradoc Street North in Strathroy, consists of a 26.87 acre multi-faceted park. The park includes open green spaces and mature trees along with playground equipment, splash pad, pavilion and baseball field. The park also features walking paths and connects various sections of the park, enhancing accessibility.

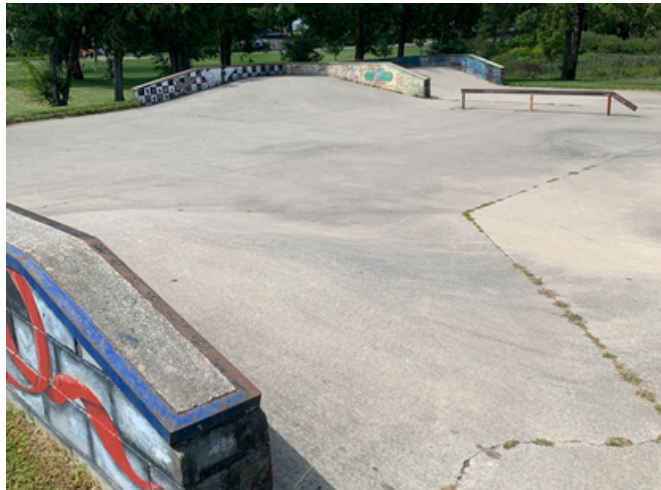
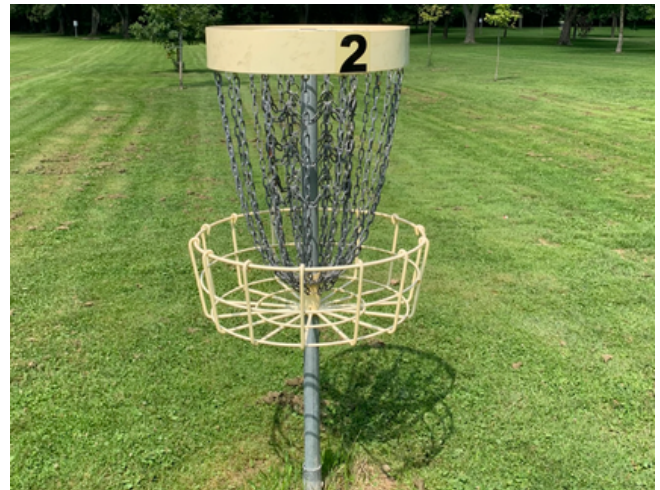
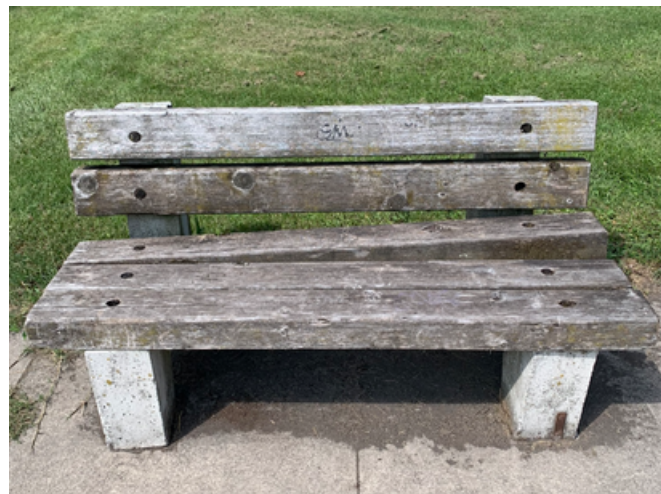
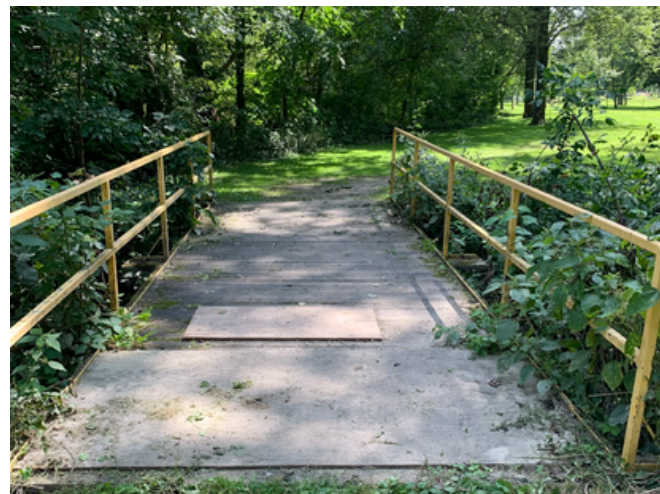
The bridge located in the park is in fair condition. Plywood has been installed in a few sections that now pose a trip hazard. Consideration should be given to replace the planks and to have the bridge inspected by a structural engineer. The cast in place concrete skatepark is in good condition with limited signs of cracking. The concrete should be monitored annually for signs of deterioration. Benches are noted to be in poor condition and should be replaced.

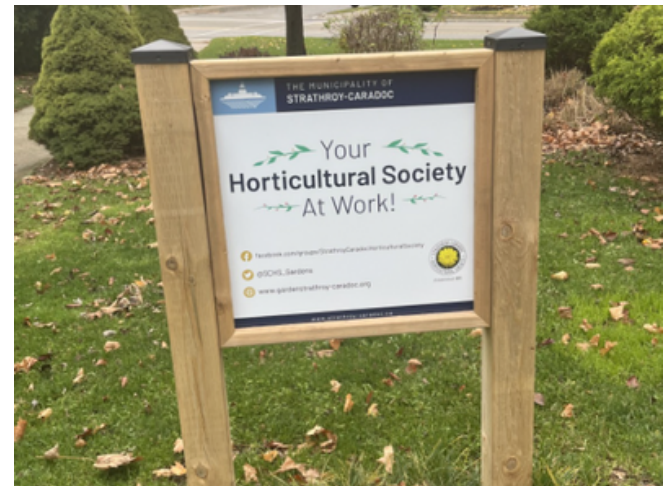
The flower beds are in excellent condition, maintained regularly by the local Horticultural Society. These beds enhance the aesthetic appeal of the park and contribute to its vibrant, welcoming atmosphere. The central fountain is in good condition but will require paint restoration in the coming years to preserve its appearance and structural integrity.

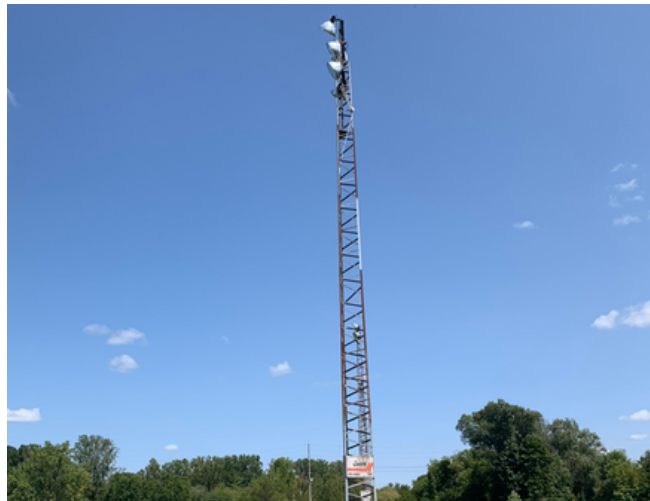
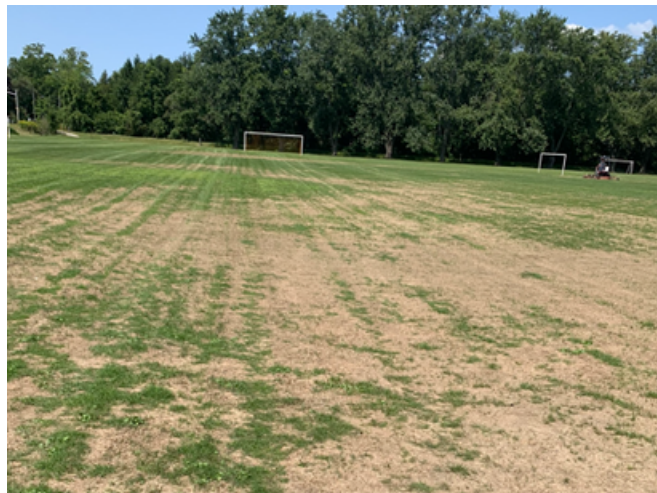
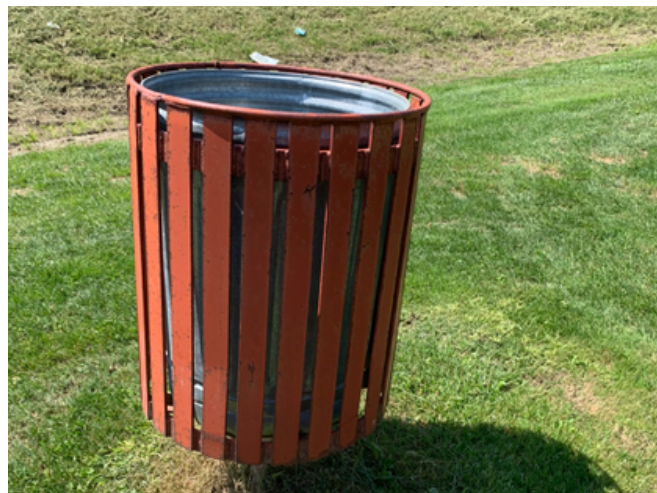
The current field conditions have been assessed as being poor due to the unprecedented rains that affected Southwestern Ontario on July 16th, 2024. Fall and spring maintenance programs are required and should include, dethatching, top dressing and re seeding of the areas affected. The bleachers overlooking the large field are noted in fair condition and consideration should be given to replace these units in the next few years. There are several benches along the trail with a number of benches requiring attention along with the players benches. Consideration should be given to upgrade to newer seating. It was noted that a number of nets are movable. These units should be properly anchored as per 'Bill 99 2023'.

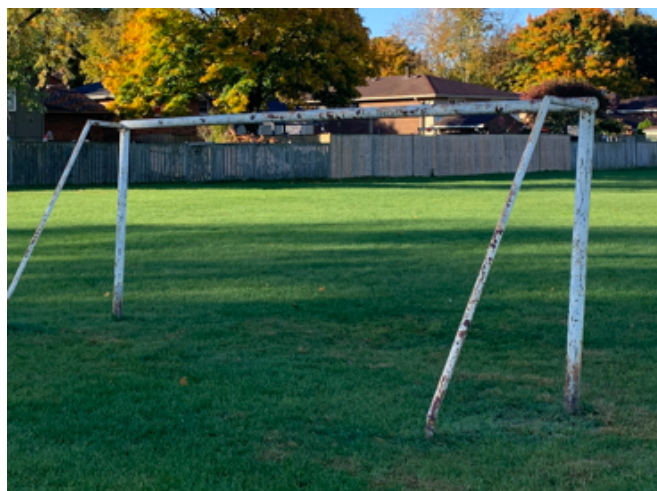
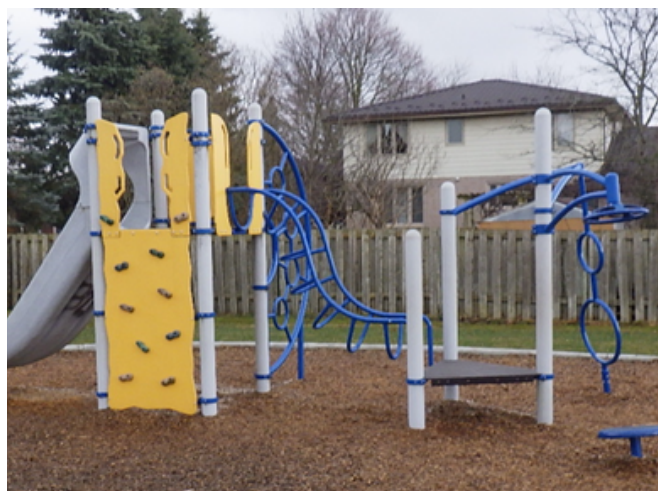
Perimeter fencing is not municipally owned, as all boundary fences belong to adjacent residential properties. Park furnishings are in mixed condition; the metal benches are in excellent shape, enhanced with fitness-related signage, which adds value to visitors. However, the wooden picnic table is showing signs of decay, and the report recommends replacing deteriorating boards to maintain safety and functionality.

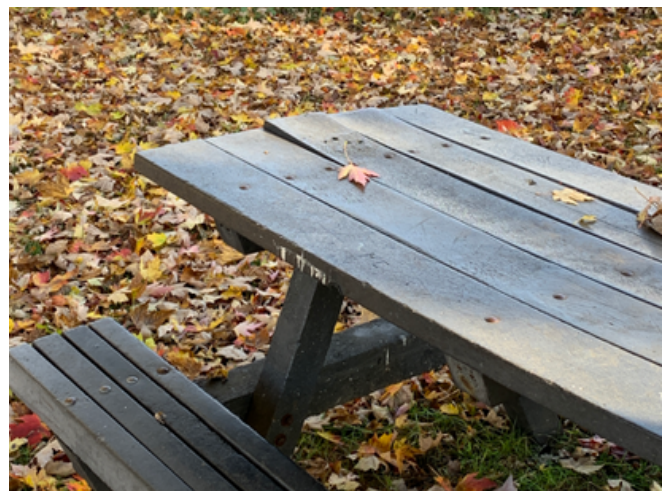
The pavilion is in poor condition, showing signs of age and wear. Due to its deteriorated state, it may require significant repairs or replacement to restore functionality and safety. The park's only wooden picnic table is in very poor condition, with noticeable warping. Removal of the table is recommended to eliminate potential safety risks for park visitors. Tree assessments indicate that the park has a mix of young trees and shrubs, along with one mature tree that appears to be in good health with no visible hazards. While there are no immediate safety concerns regarding the trees, routine monitoring is advised to maintain their health and prevent future risks. This parcel could be considered for future development as a community park, which may enhance its recreational value and provide a more comprehensive range of amenities for residents.

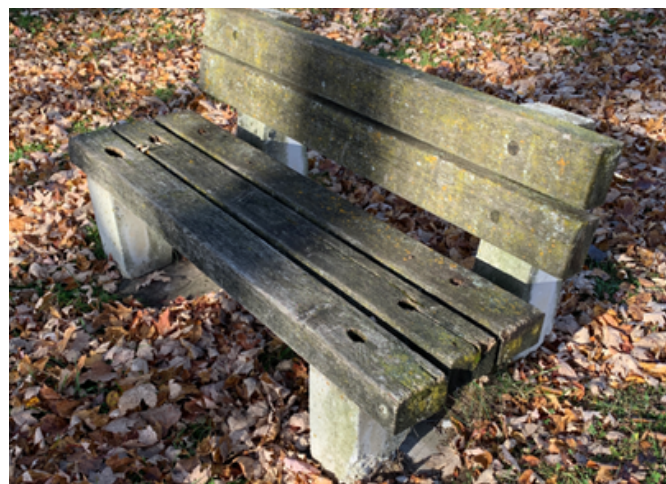
The park furnishings include a single park bench in very poor condition, which poses a safety hazard due to its deteriorated state; removal is recommended. The picnic tables are in average condition, constructed of wood and showing signs of decay. Continued monitoring of these tables is advised, with potential replacement of decayed boards to maintain safety.
