GEOTECHNICAL INVESTIGATION

**PROPOSED RESIDENTIAL DEVELOPMENT
101 HULL RD, STRATHROY, ONTARIO**

LDS PROJECT NO. GE-00286

JUNE 7, 2023

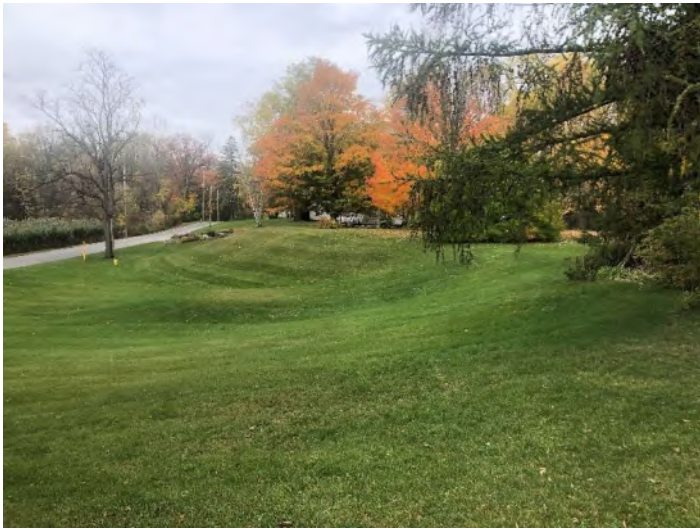
Photograph 2:

Looking west along Hull Road. Note the grade change from the lot to the current road alignment.

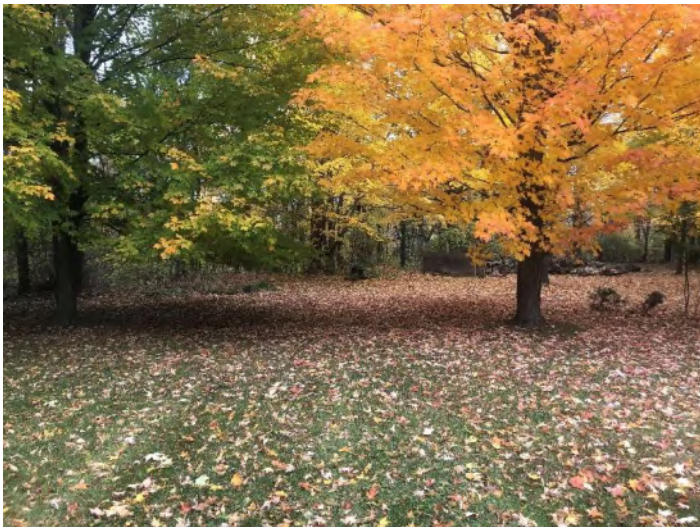
Photograph 3:

Looking across the rear yard area, towards the existing slope crest along the north side of the property.

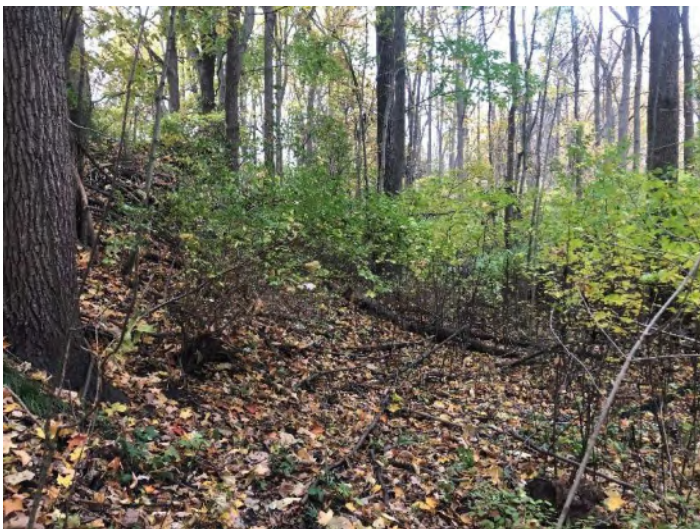
Photograph 4:

Typical view of valley slope along the north side of the property.

A site review was carried out on October 25, 2019. At the time of the site reconnaissance visit, the slope was observed to be well vegetated with a mixture of young and mature trees. No water seepage or signs of significant overland erosion were observed. Select photos were taken at the site to document slope conditions, and are appended for reference.

During the site reconnaissance, sufficient site details were collected to assess the slope condition using the Ministry of Natural Resources and Forestry (MNRF) Slope Stability Rating Chart. The Rating Chart summarizes site observations and empirically scores various elements which contribute to slope stability, to assess the potential for slope instabilities at the site. A copy of the chart is appended for reference. The Slope Instability Rating is 16, indicating a low potential for instability.
