# 14067 – Closed Caradoc Landfill Site Visit May 15, 2025

**Notes:** Ryan DeVries (BMROSS) met with Paul Zuberbuhler (Strathroy-Caradoc) and Mark Ortiz (Strathroy-Caradoc) on site at 9am. It was sunny and approx. 20°C. The site was mostly dry (i.e. no ponded water), but the air was humid.

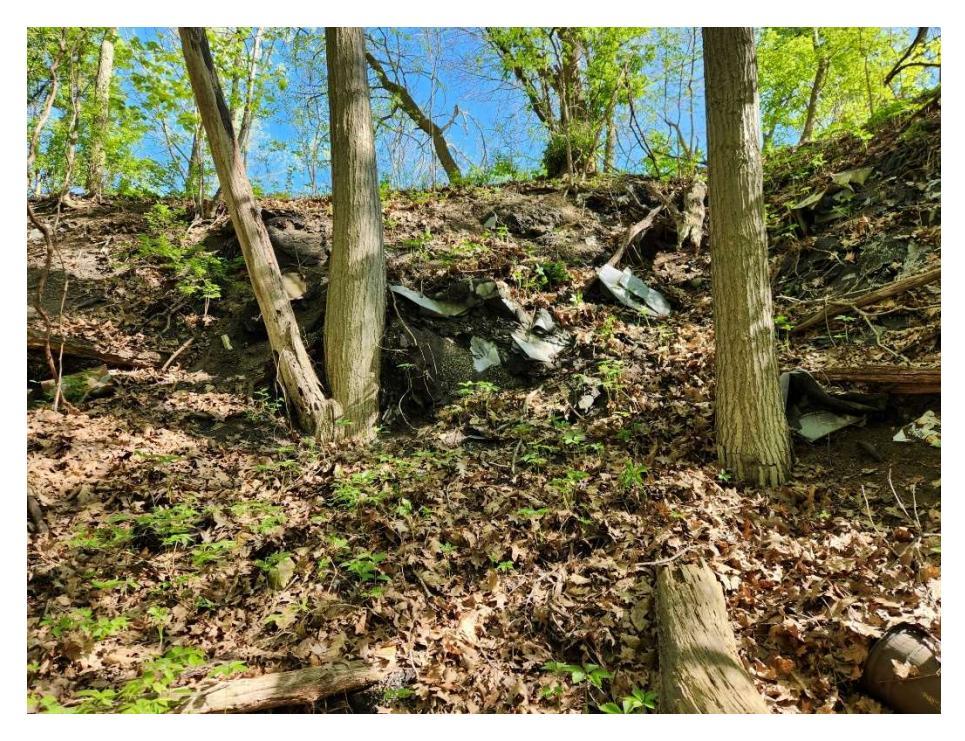
#### Photo 1

Picture taken from the stream looking back towards the landfill mound. Waste (predominately shingles) evident here in the embankment. Note this is not part of the "landfill mound" as previously identified on the Annual Status Report figures.

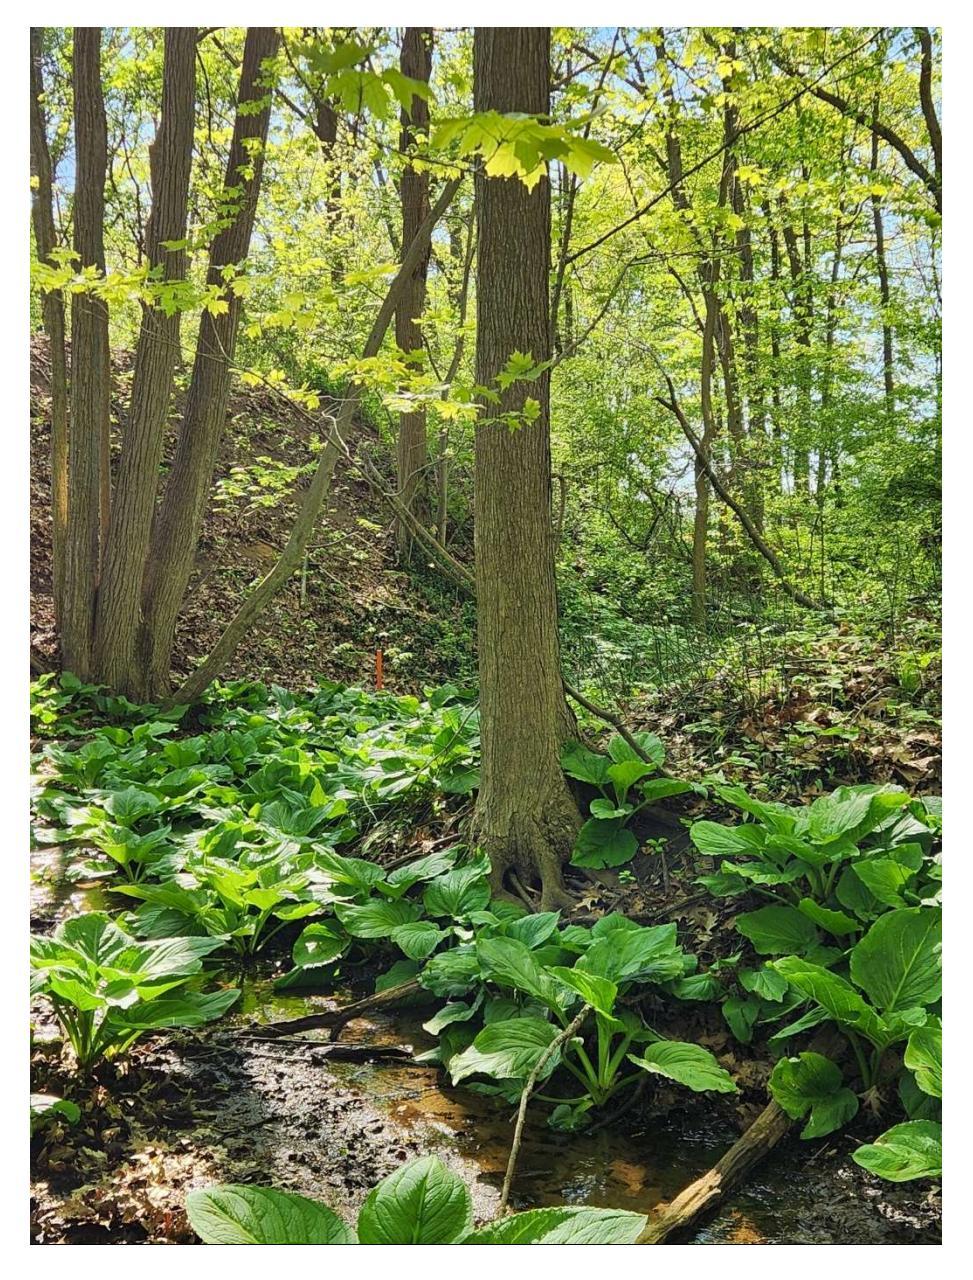
Picture taken of the stream looking east at where the south watercourse leaves the east side boundary. Stake installed at this location as a future potential surface water sample location to replace the "Stream West Side Rear" sample location.

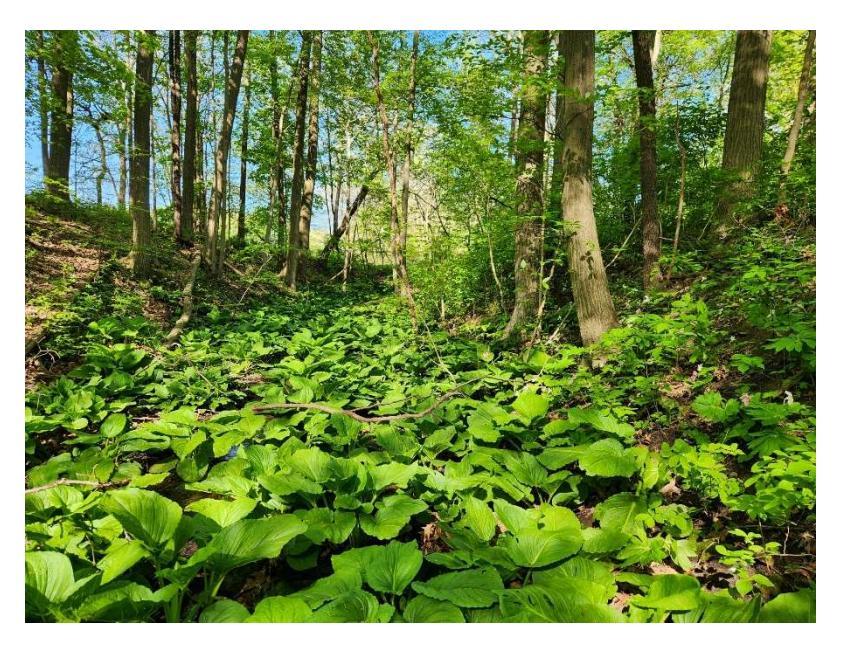
Picture taken facing west looking down the watercourse. This is typically what the vegetation looks like along both the south and north watercourses. Stream is hardly noticeable amongst all of the skunk cabbage.

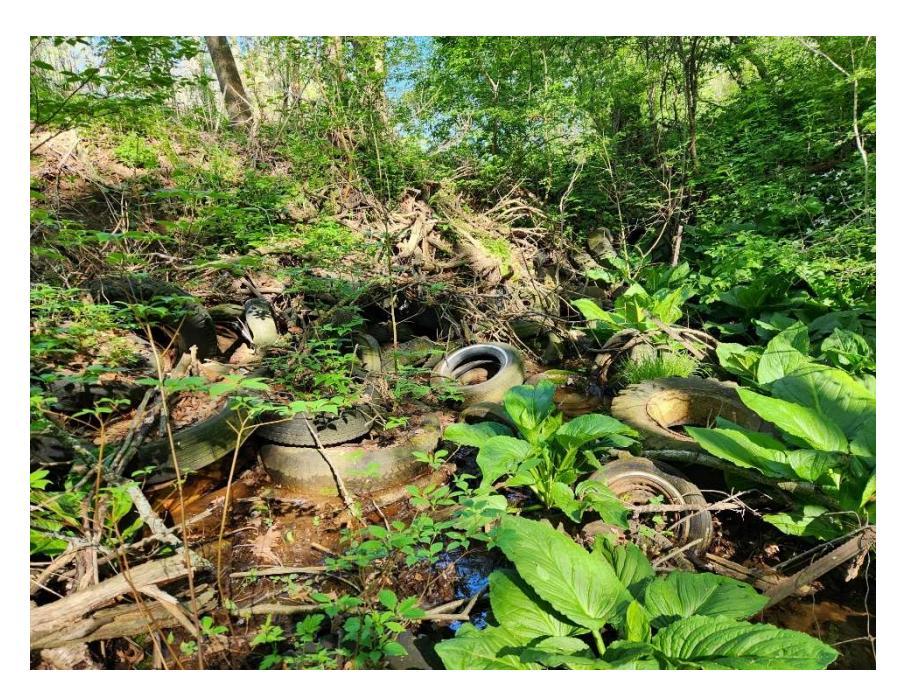
#### Photo 4

Picture taken facing west at the location where the south watercourse crosses into the south boundary of the site. There are several suspected culverts (the ends are likely over 80% clogged) which drain the stream from a higher elevated upstream point (dam) to the lower downstream location. There is also a collection of tires at this location which appear to be on the adjacent private property.

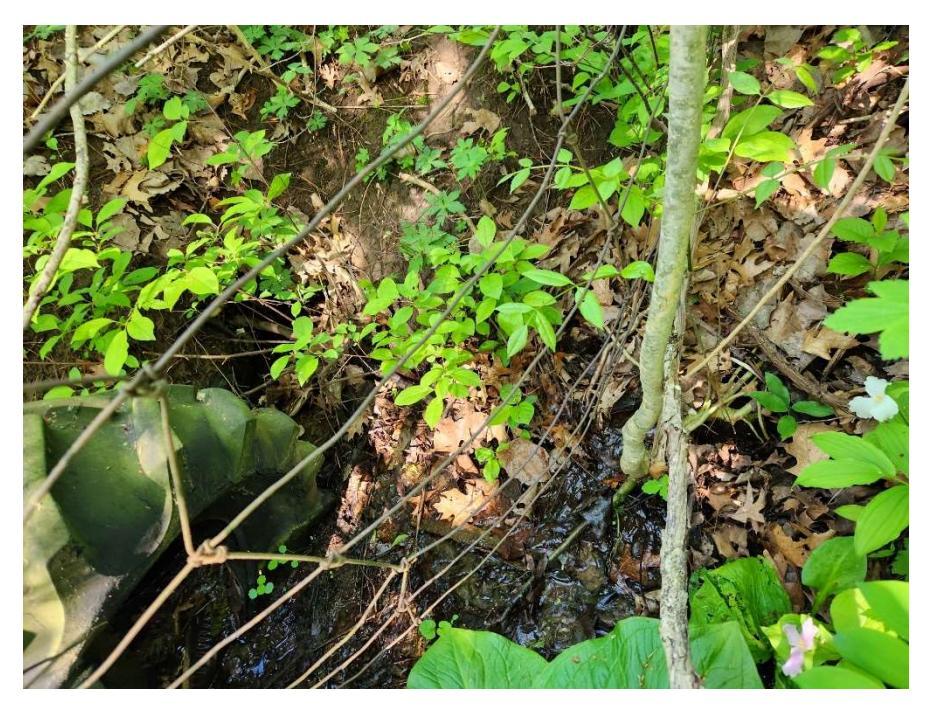
Picture taken of suspected dual culverts noted in above (Photo 4) description (downstream side).

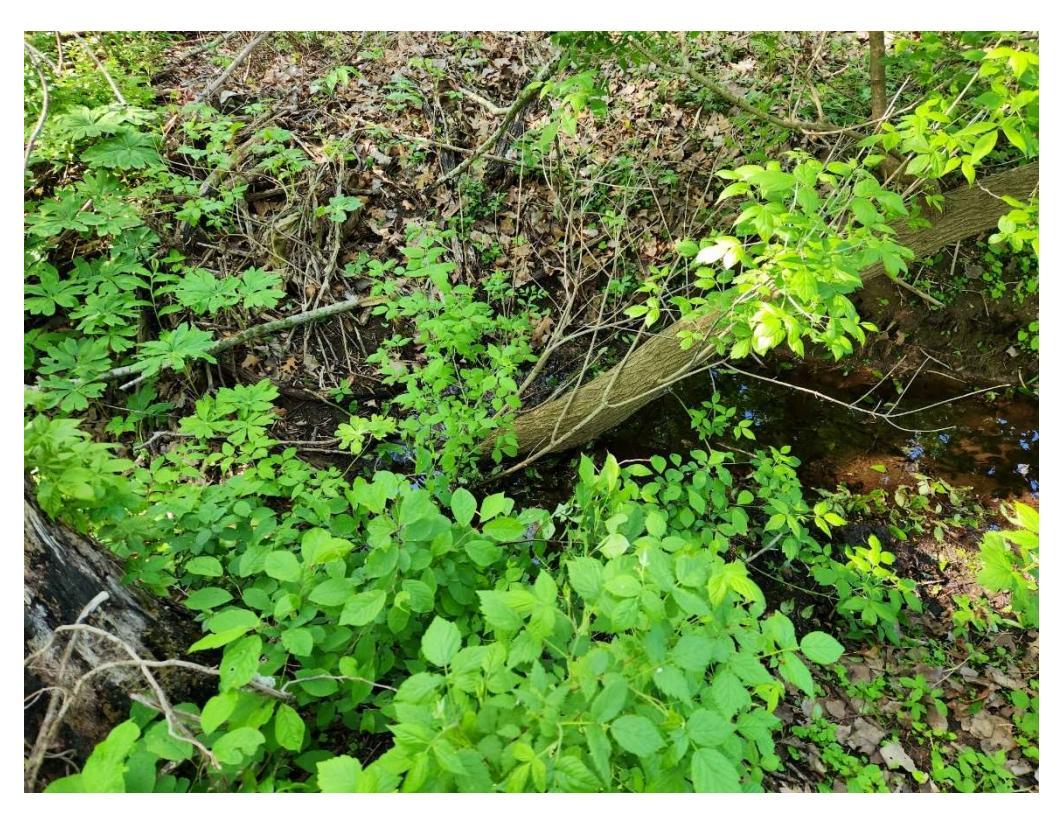
### Photo 6

Picture taken of upstream suspected end of culverts, where stream appears to be draining "into the ground" since the culverts are not actually visible and only suspected to be there.

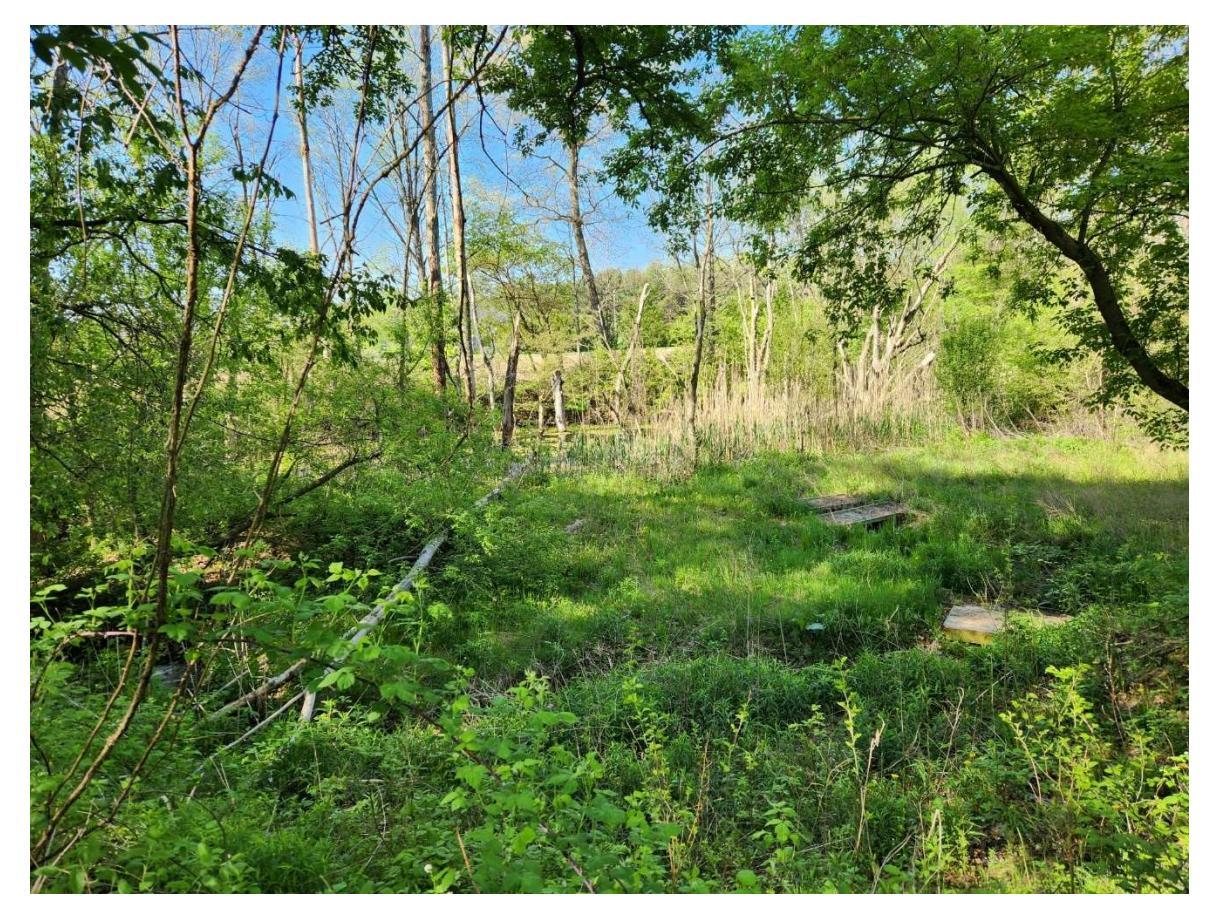
Upstream of Photo 6,on the adjacent property is a pond. It appears that the stream flows into the pond on one side and out of the pond on the other side.

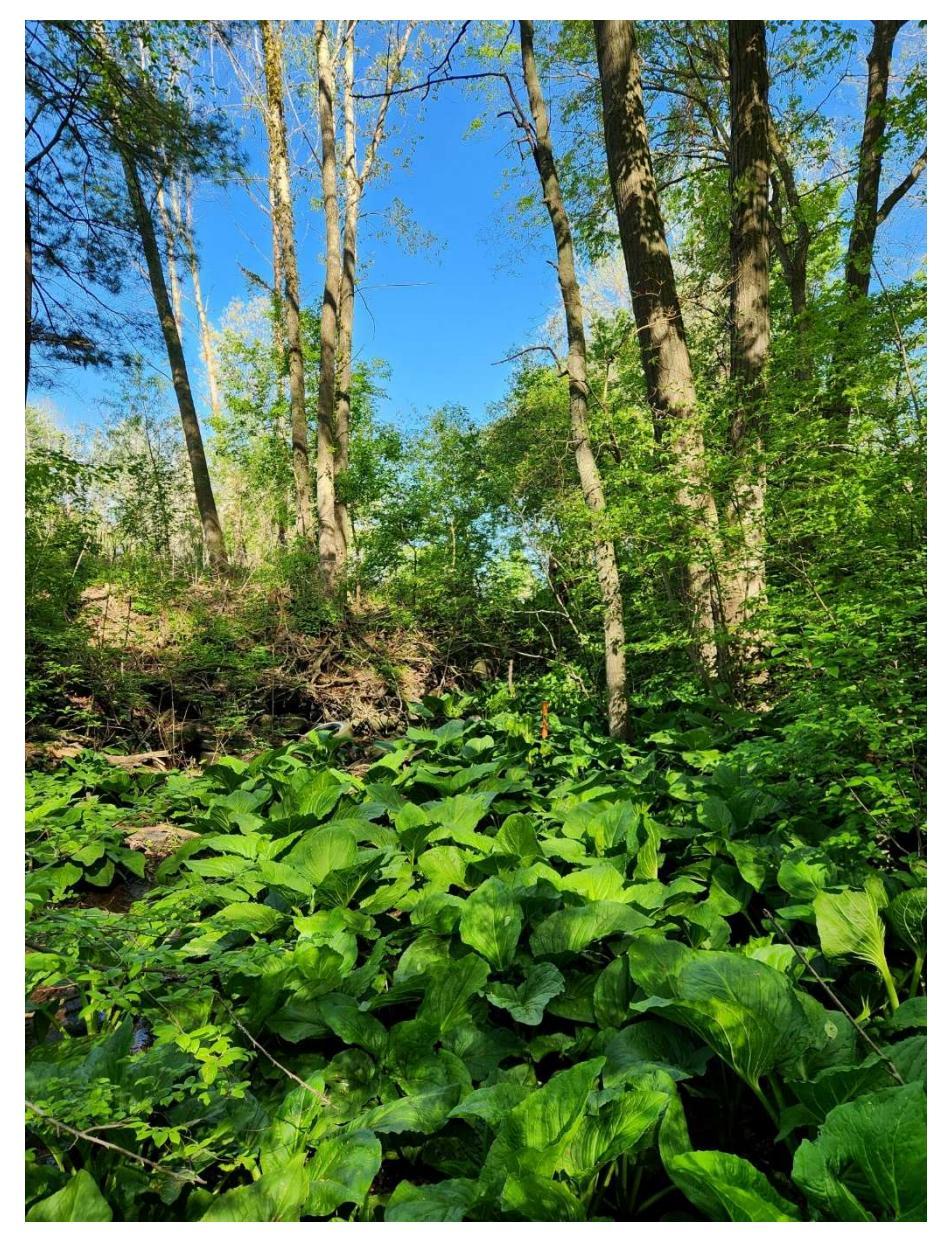
Small potential groundwater seepage found near location of photos 4 and 5 as evidenced by some iron soil staining. Installed a stake for a proposed piezometer #4 location. Despite the soil staining, there was no observable flow seeping out of the soil at this location.

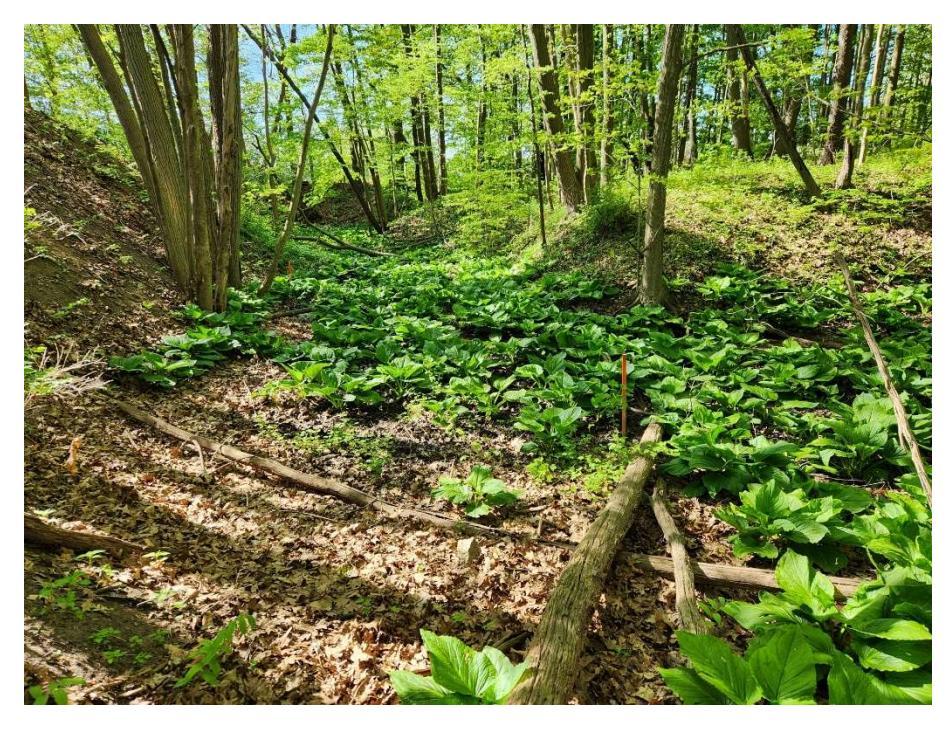
Installed stake for proposed piezometer #3 near photo 1 location. This appears to be the point along the south watercourse where the stream meanders closest to the landfill mound. Stake installed under Photo 2 description is evident in the background.

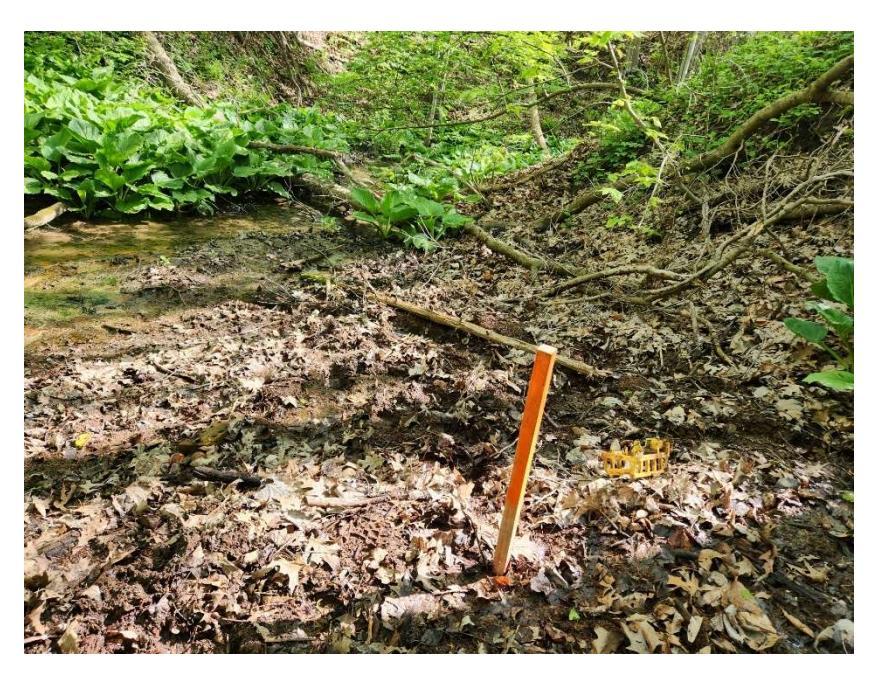
#### Photo 10

Stake installed at proposed piezometer #2 location. This is also Point 2 referenced in the April 23 and May 1, 2025 site visit notes. Note, once again the ground at this location was found to be saturated but there was no evidence of any surface overland flow (seepage) occurring.

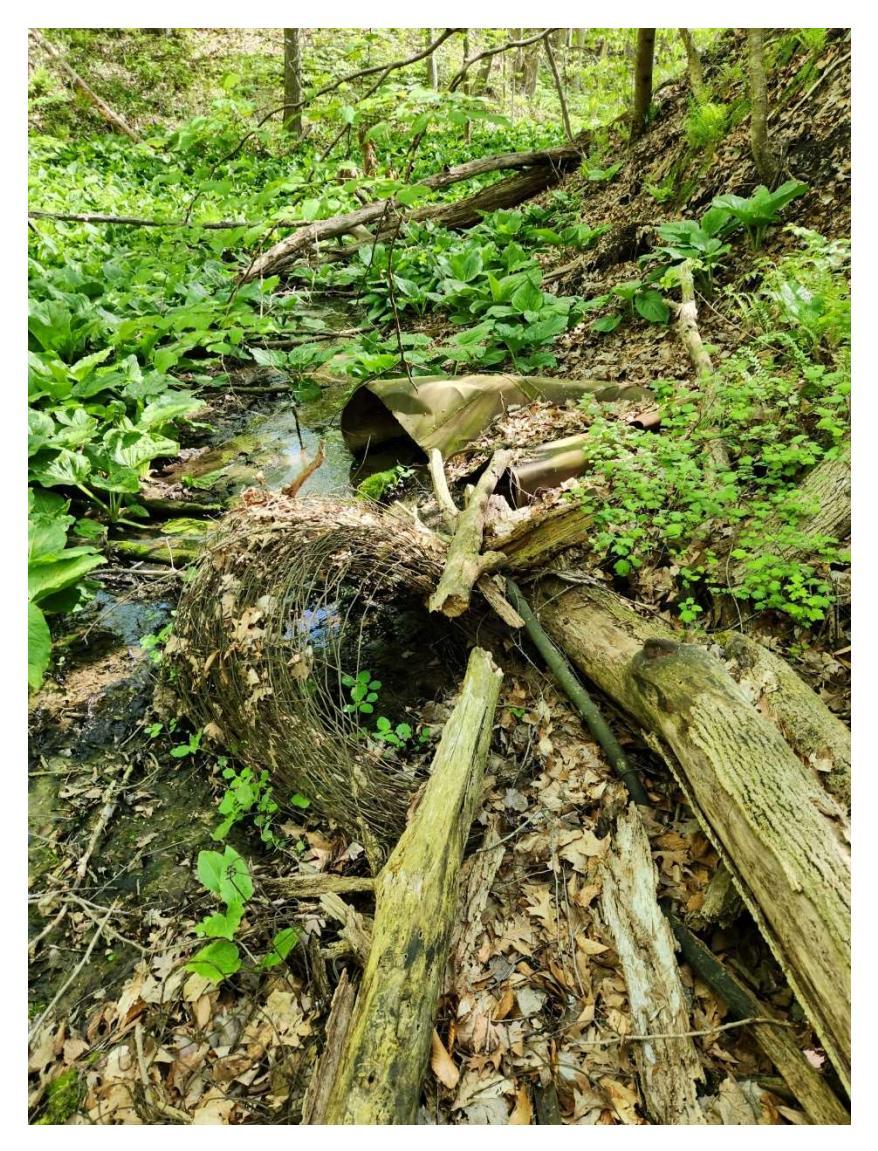
Point 3 identified by the MECP as a potential seepage location and referenced in the May 1, 2025 site visit notes. There was no observable flow seeping out of the soil at this location at the time of visit.

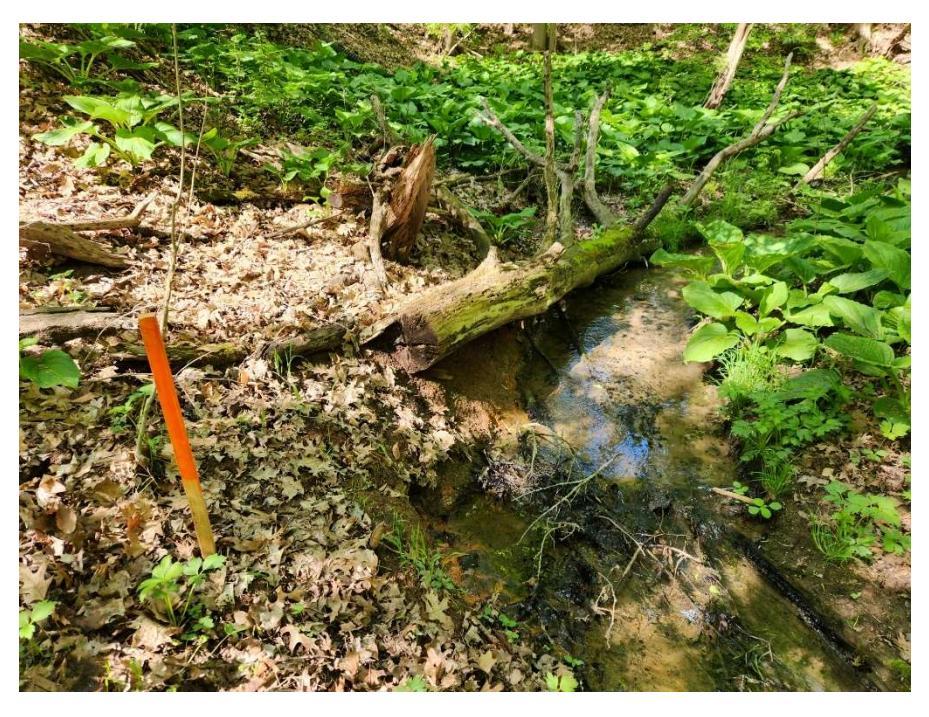
Photo of stake installed at proposed piezometer #1 location. Similar to piezometer #2 location, saturated conditions but no obvious overland flow observed.

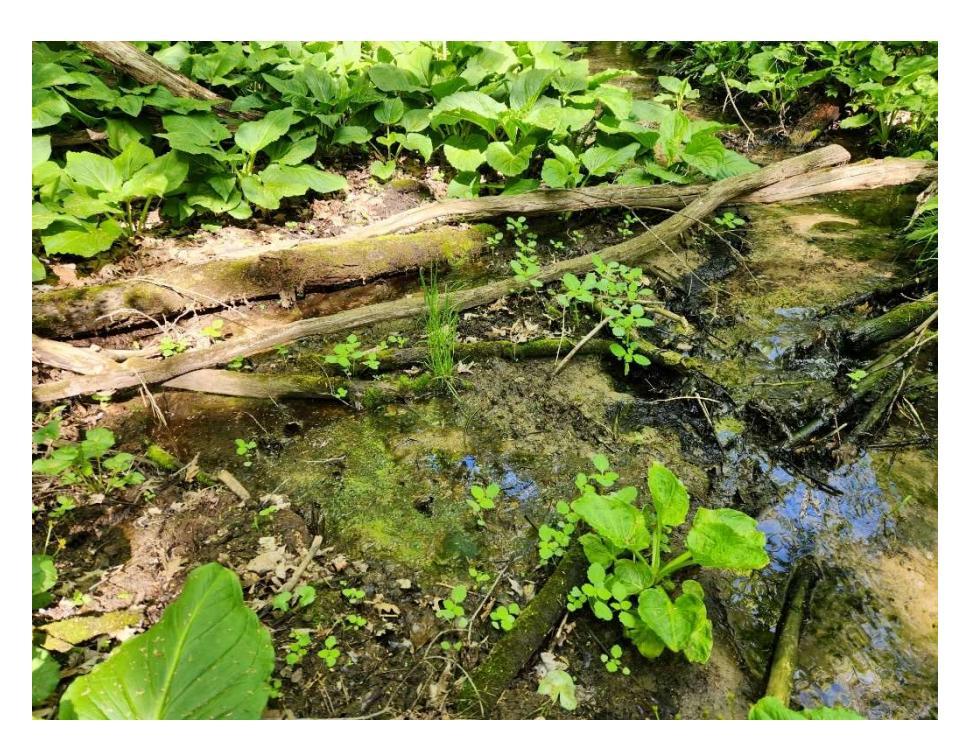
## Photo 13

Location on the stream bank where there had been some ponded water. It was dried now and there appeared to be an algae deposit left behind.

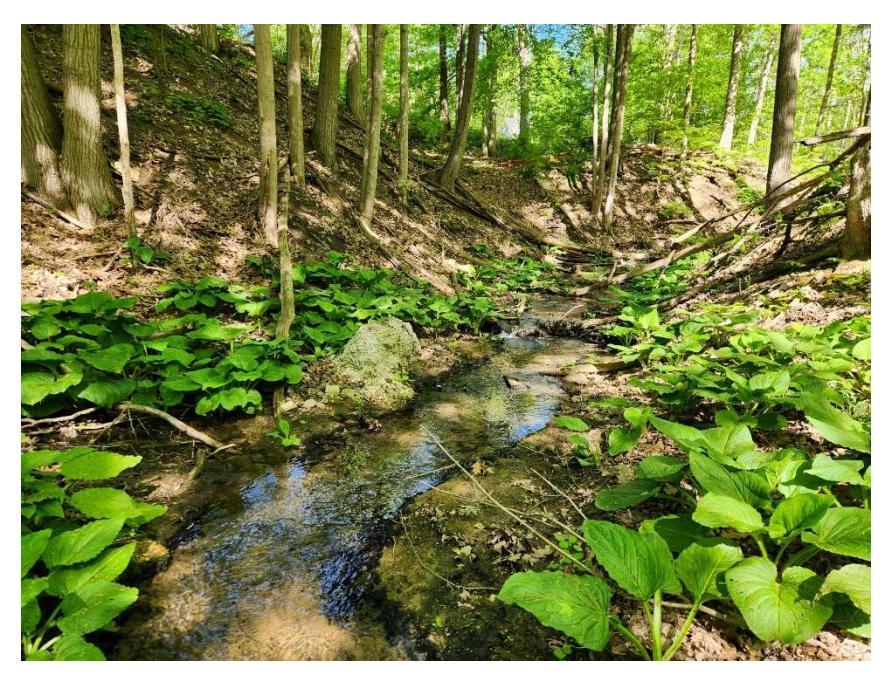
Typical watercourse vegetation growth conditions between Photo 13 and the STP outfall. In general, less skunk cabbage and saturated conditions as the valley depth decreases.

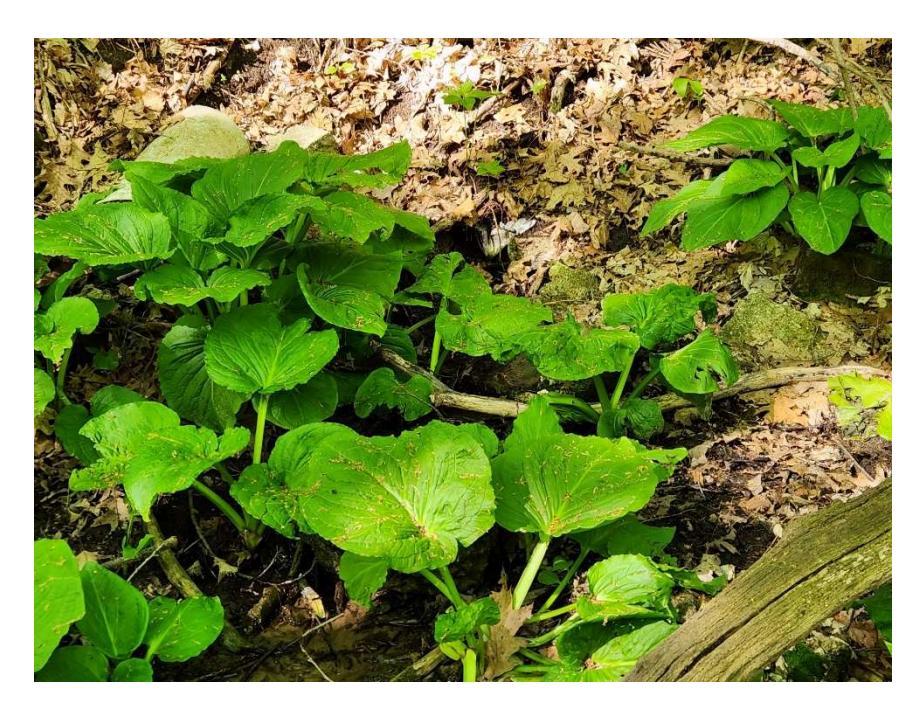
#### Photo 15

Photo of Point 1 as referenced in the April 23 and May 1, 2025 site visit notes. The culvert end continued to have some flow discharging, although the flow appeared to be less than at either previous visits.

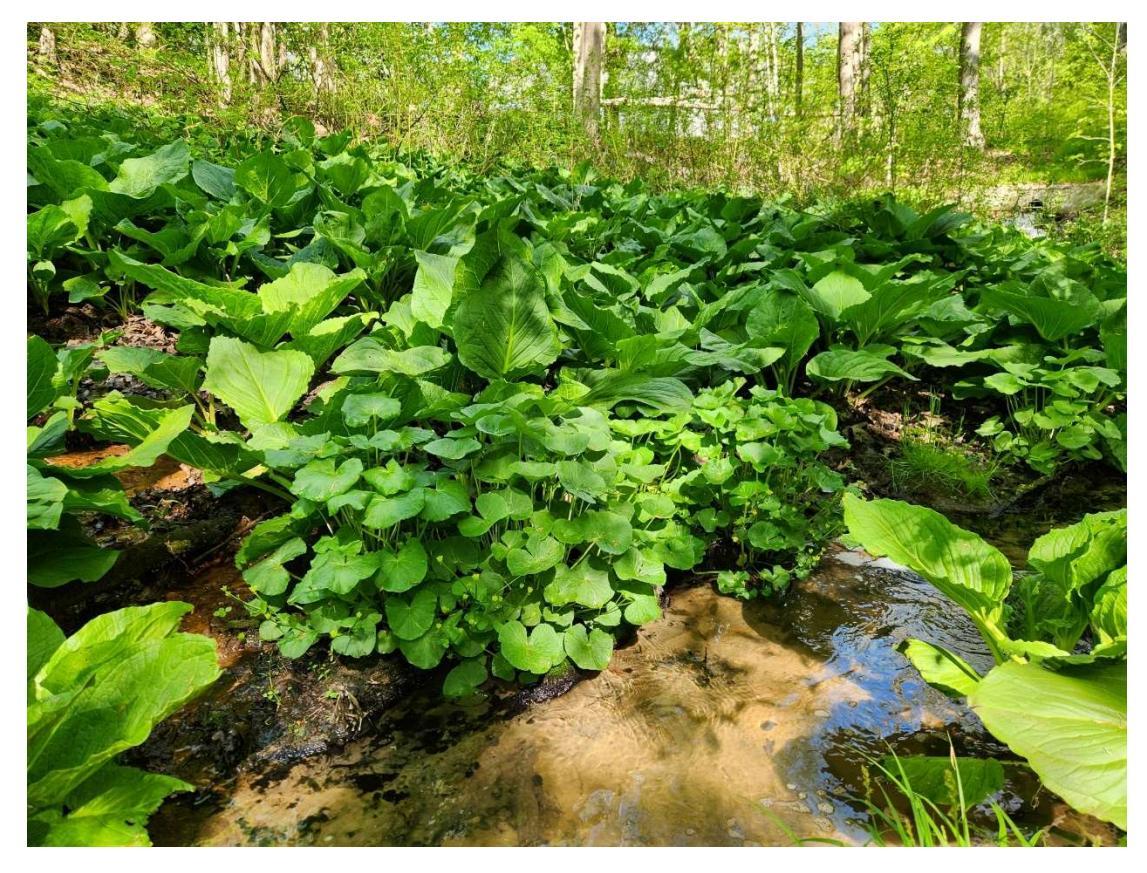
Wastewater Treatment Plant outfall noted at right side of photo. Small potential groundwater seepage location noted at left side of photo with some localized brown soil staining. Location was not large (i.e.  $1m^2$ ) and there was not overland flow present.

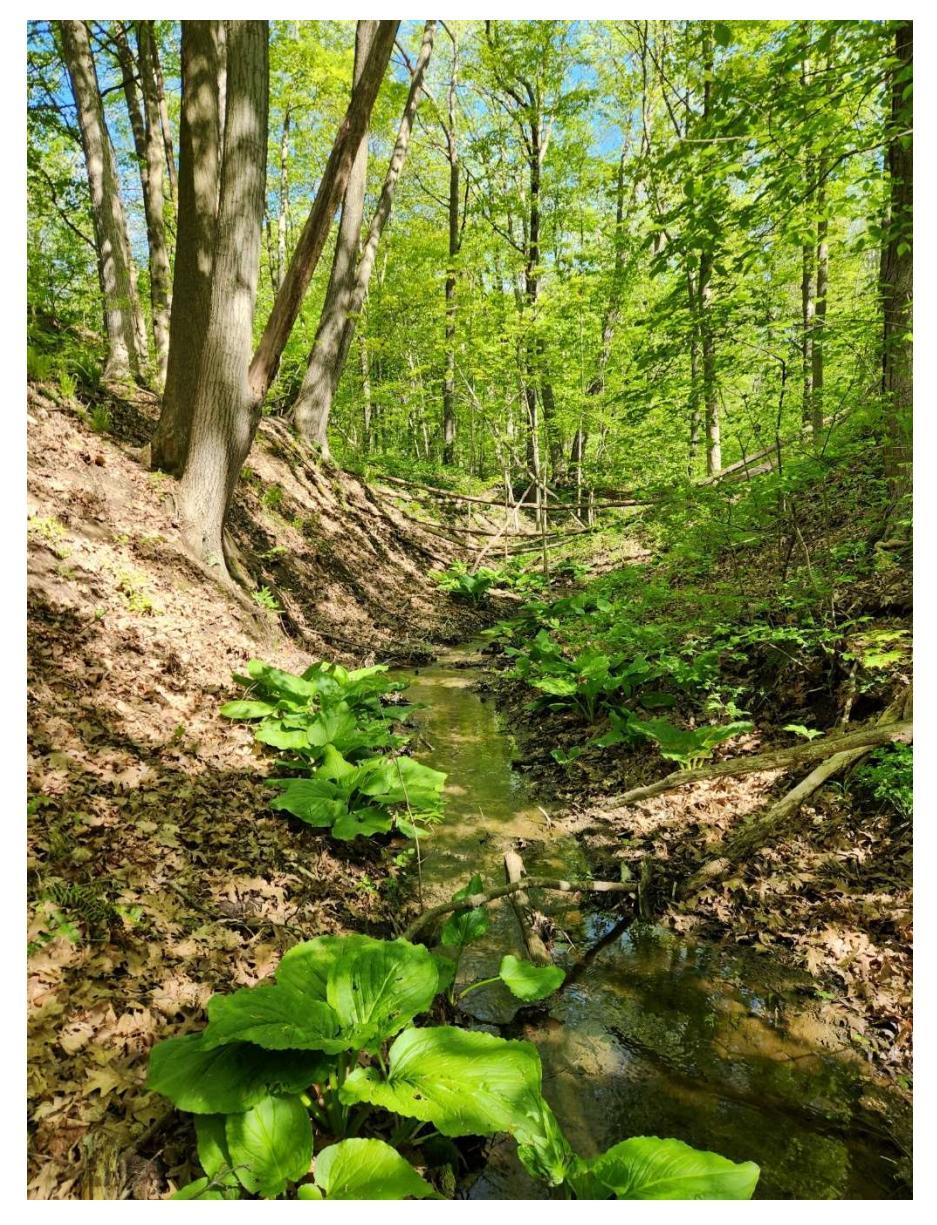
Skunk cabbage again thinning out as I moved upstream further and the valley again decreased in depth.

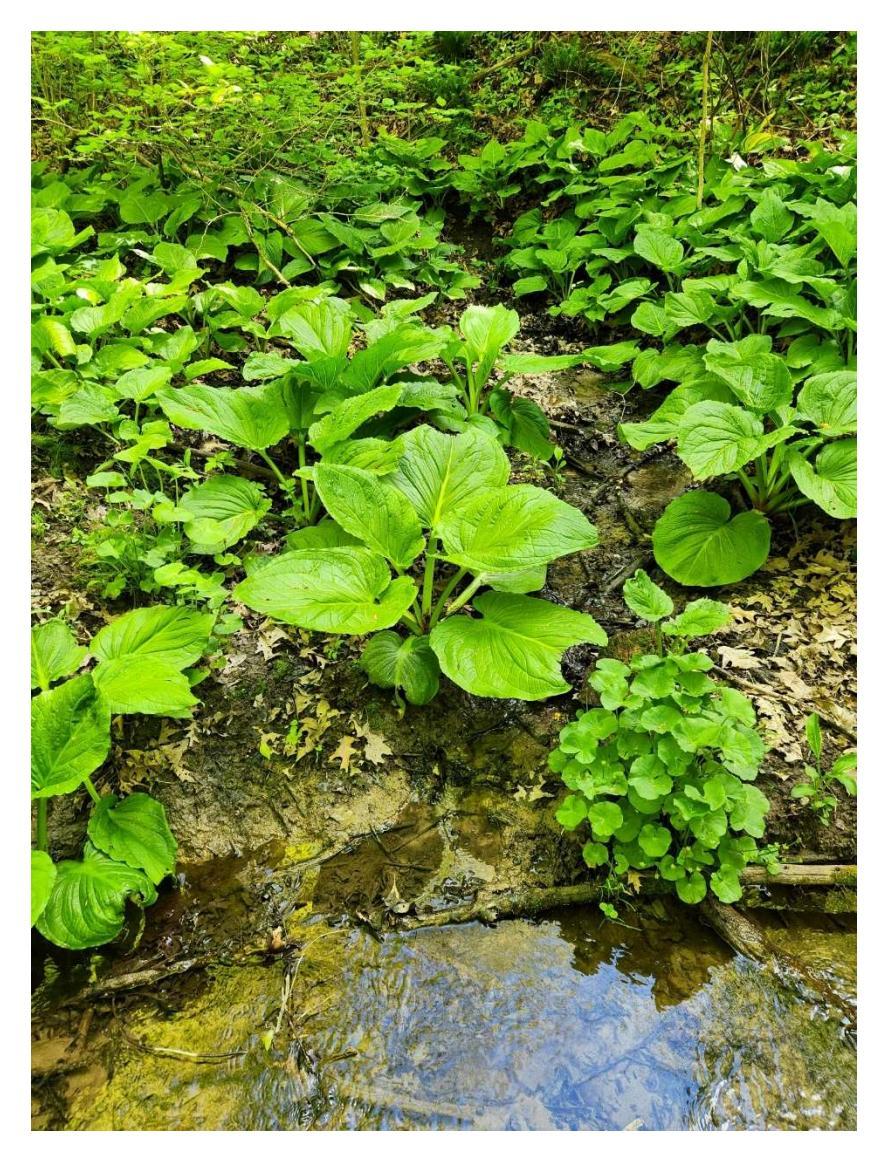
Small stream offshoot noted heading in the north/south direction.

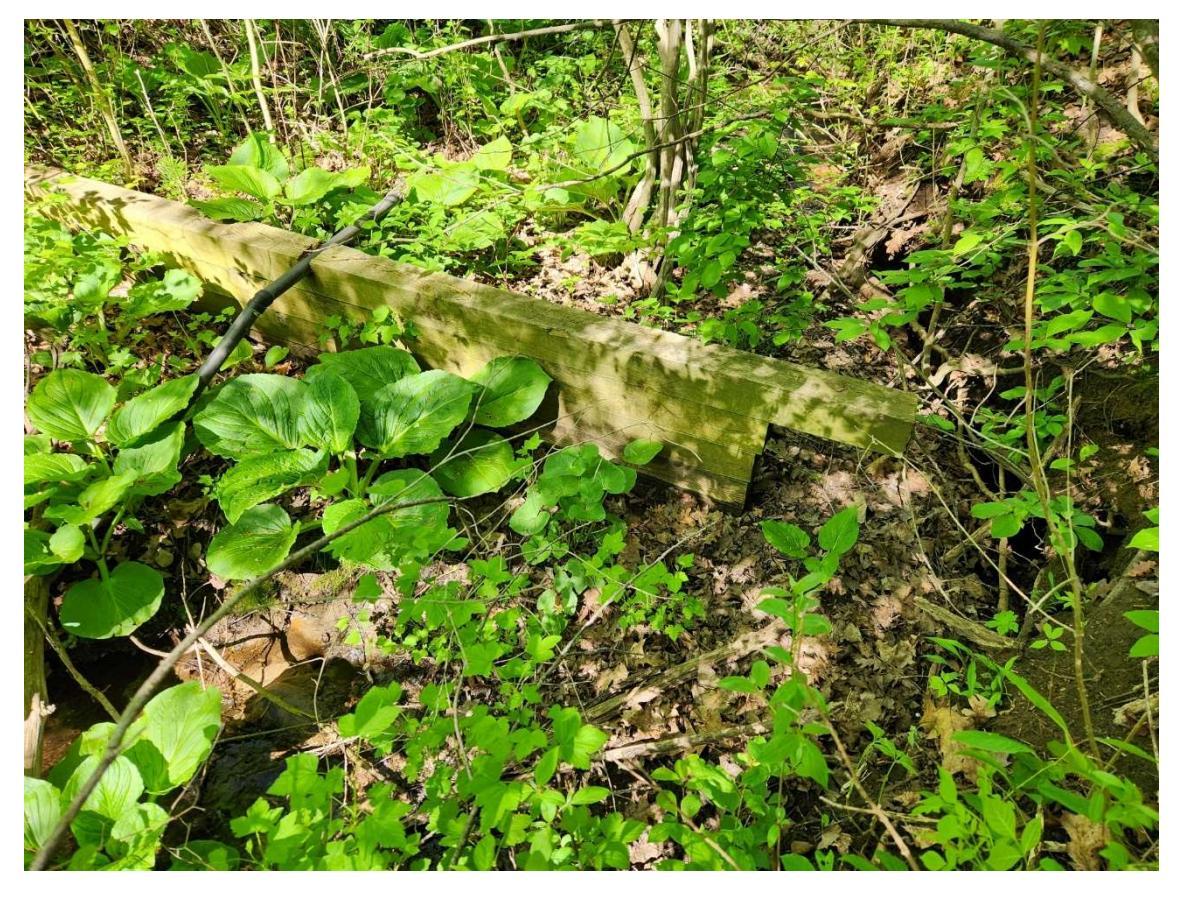
Former dam and likely irrigation suction line discovered. Now appears to be abandoned.
