GEOTECHNICAL INVESTIGATION

**PROPOSED RESIDENTIAL DEVELOPMENT
MN 6 LOCKE HEIGHTS, STRATHROY, ONTARIO**

LDS PROJECT NO. GE-00286

FEBRUARY 12, 2024

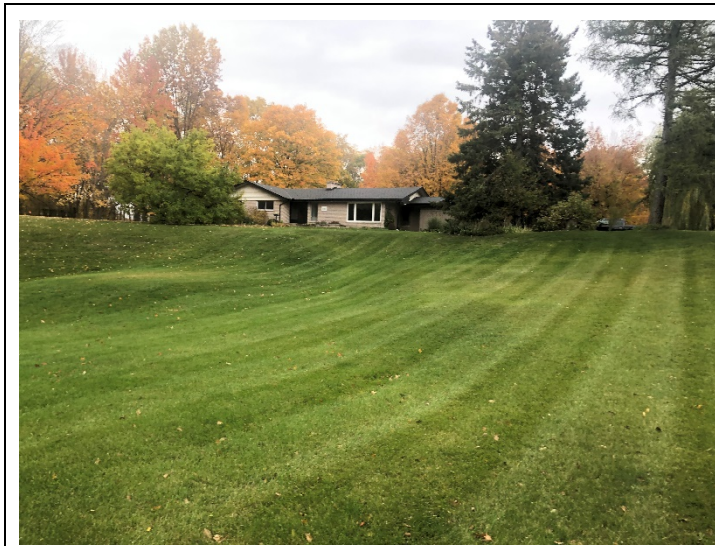
Photograph 1:

Looking north towards the existing residence from Hull Road.

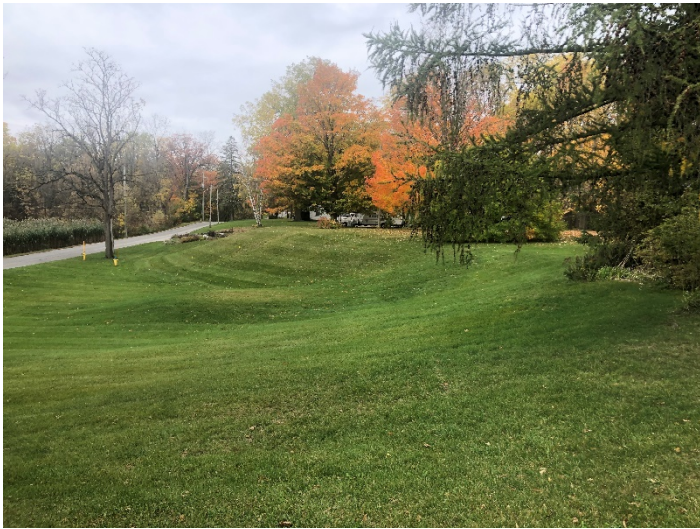
Photograph 2:

Looking west along Hull Road. Note the grade change from the lot to the current road alignment.

Based on existing site conditions, it is expected that some site grading activities will be required, particularly in the front of the property to raise grades onsite and to match the proposed grades along Hull Road. Upwards of 3+ metres of fill is anticipated in this regard.

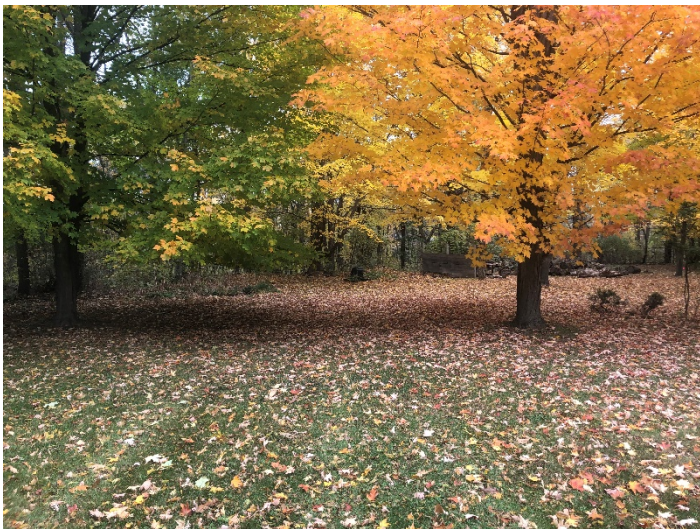
Photograph 3:

Looking across the rear yard area, towards the existing slope crest along the north side of the property.

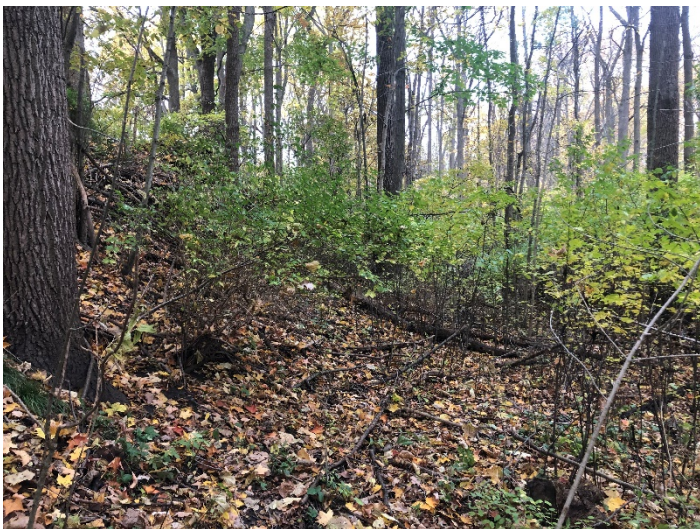
Photograph 4:

Typical view of valley slope along the north side of the property.

A site review was carried out on October 25, 2019. At the time of the site reconnaissance visit, the slope was observed to be well vegetated with a mixture of young and mature trees. No water seepage or signs of significant overland erosion were observed. Select photos were taken at the site to document slope conditions, and are appended for reference.

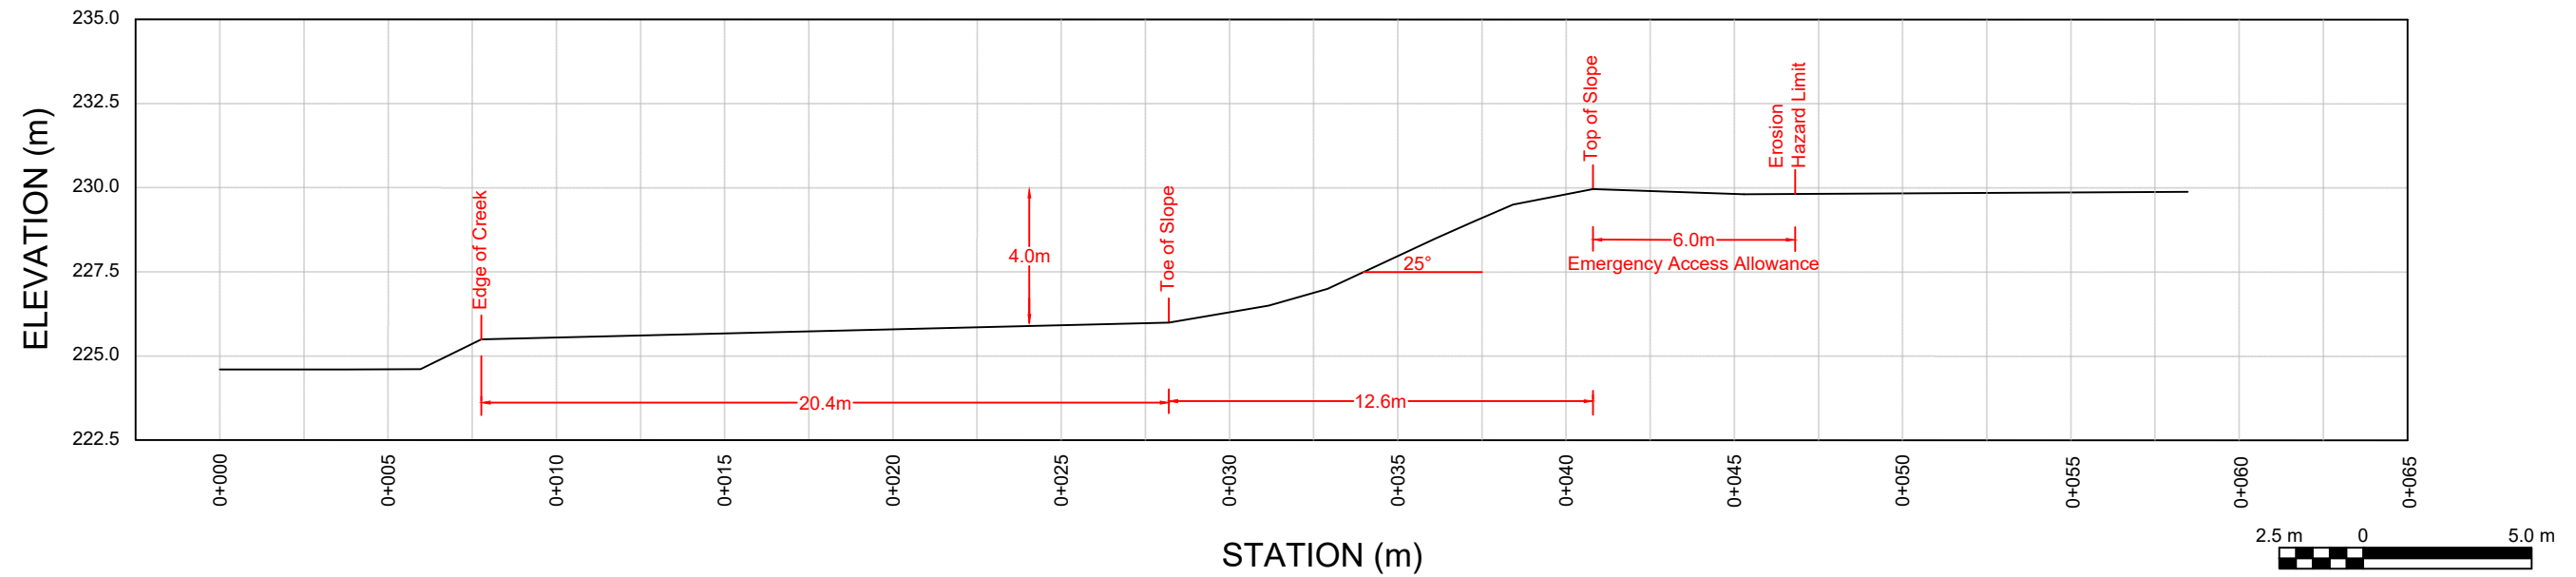
SLOPE PROFILE A-A'

The lowest factor of safety occurs for a shallow sliding failure in the middle to upper part of Section Profiles A and B, which is the most steeply inclined part of the slope in each case. The slip plane intersects the less steep slope at the mid-slope height, and would result in localized slumping. The factors of safety for medium and deep rotational failures are above 2.3, which is indicative of an overall stable slope condition.
