CONSOLIDATED GEOTECHNICAL INVESTIGATION & HYDROGEOLOGICAL ASSESSMENT REPORT

**FOREST VIEW SUBDIVISION
ROUGHAM ROAD & PARKHOUSE DRIVE
MOUNT BRYDGES, ONTARIO**

LDS PROJECT NO. GE-00103

MARCH 25, 2024

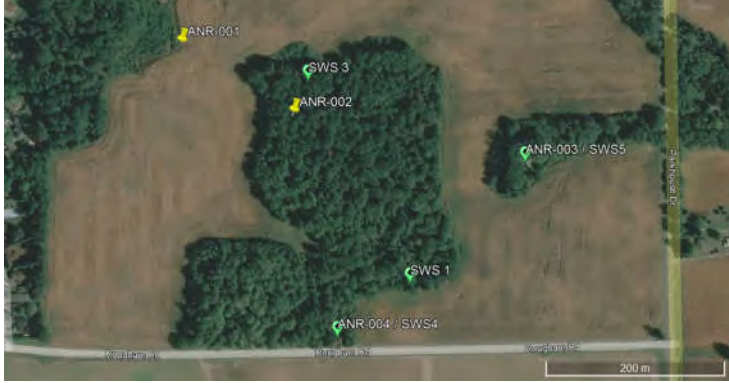
An aerial photograph of a wooded area with several monitoring points marked. ANR-001 is a yellow star in the top left. ANR-002 is a yellow star in the center. ANR-003/SWS5 is a green star in the center-right. SWS 1 is a green star in the bottom center. ANR-004/SWS4 is a green star in the bottom left. A scale bar at the bottom indicates 200 m. A vertical yellow line is on the right side.	<p>Surface Water and Anuran Monitoring Points established in consultation with NRSI.</p>

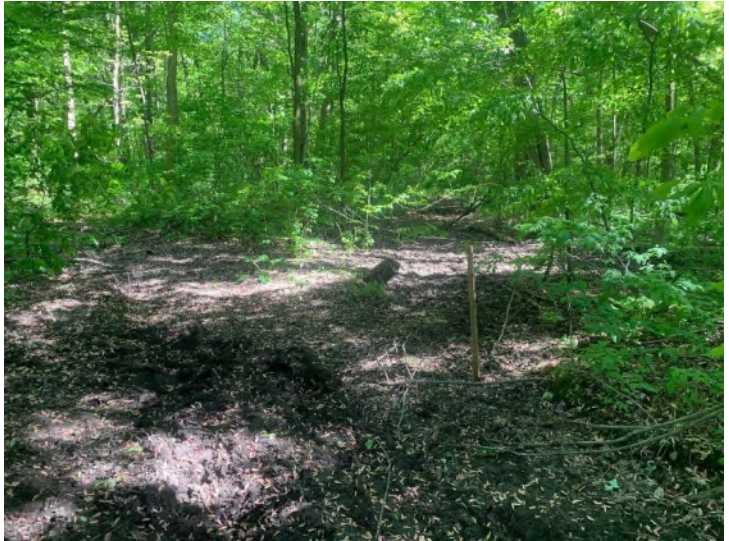
A photograph of a forest floor with a small streamlet. The ground is covered in fallen leaves and twigs. The trees are tall and thin, with green foliage. The streamlet is narrow and flows through the forest.	<p>ANR2 Existing wetland feature in northeast corner of central woodlot, near the shared Edgewood / Forest View boundary.</p>

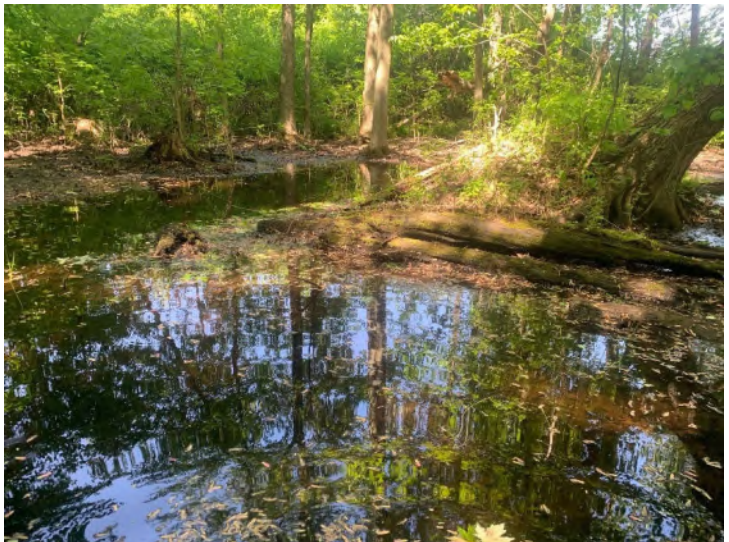
A photograph of a larger stream in a forest. The water is calm and reflects the surrounding trees and sky. The banks are covered in fallen leaves and twigs. The trees are tall and thin, with green foliage.	<p>SWS3 Existing wetland feature in northeast corner of central woodlot, near the shared Edgewood / Forest View boundary.</p>

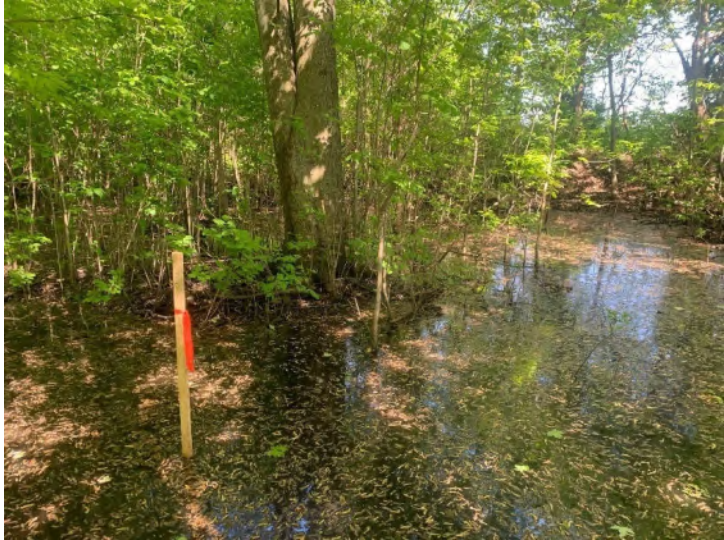
<p>ANR4 / SWS4</p> <p>Existing wetland feature located in west end of central woodlot on Forest View Subdivision lands, near Rougham Road.</p>

Groundwater contributions to the wetland pockets within the central woodland parcels arrives from the site from the permeable surficial soils which are upgradient of the wetland area. It was observed at the piezometer locations along the edge of the wetland area, that during the dry summer months, the groundwater table generally lies below the wetland substrate, except in those instances where localized recharge from high volume rainfall events causes groundwater elevations to rise close to, or above, the ground surface.

Due to the surface water flows that occur under current conditions, and the base flow contributions from upgradient areas around the wetland features, it is anticipated that both surface water and groundwater contributions help to sustain the form and function, and recharges the wetland features.

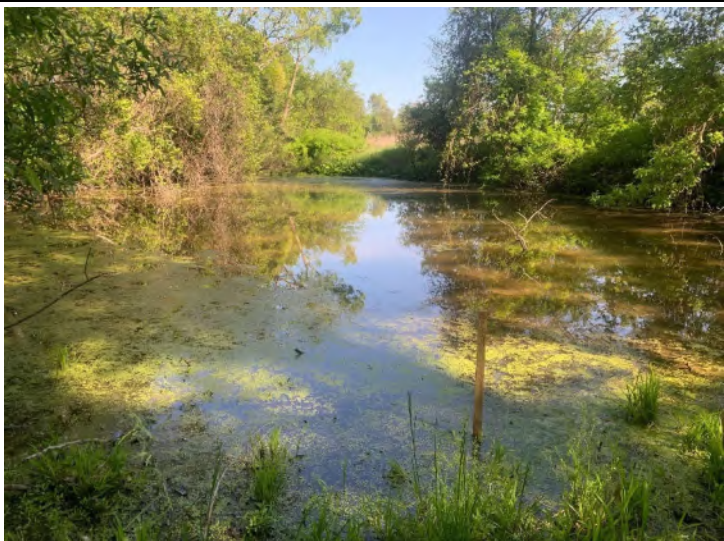
<p>ANR3 / SWS5</p> <p>Existing pond in south wooded area located within Forest View Subdivision lands.</p>

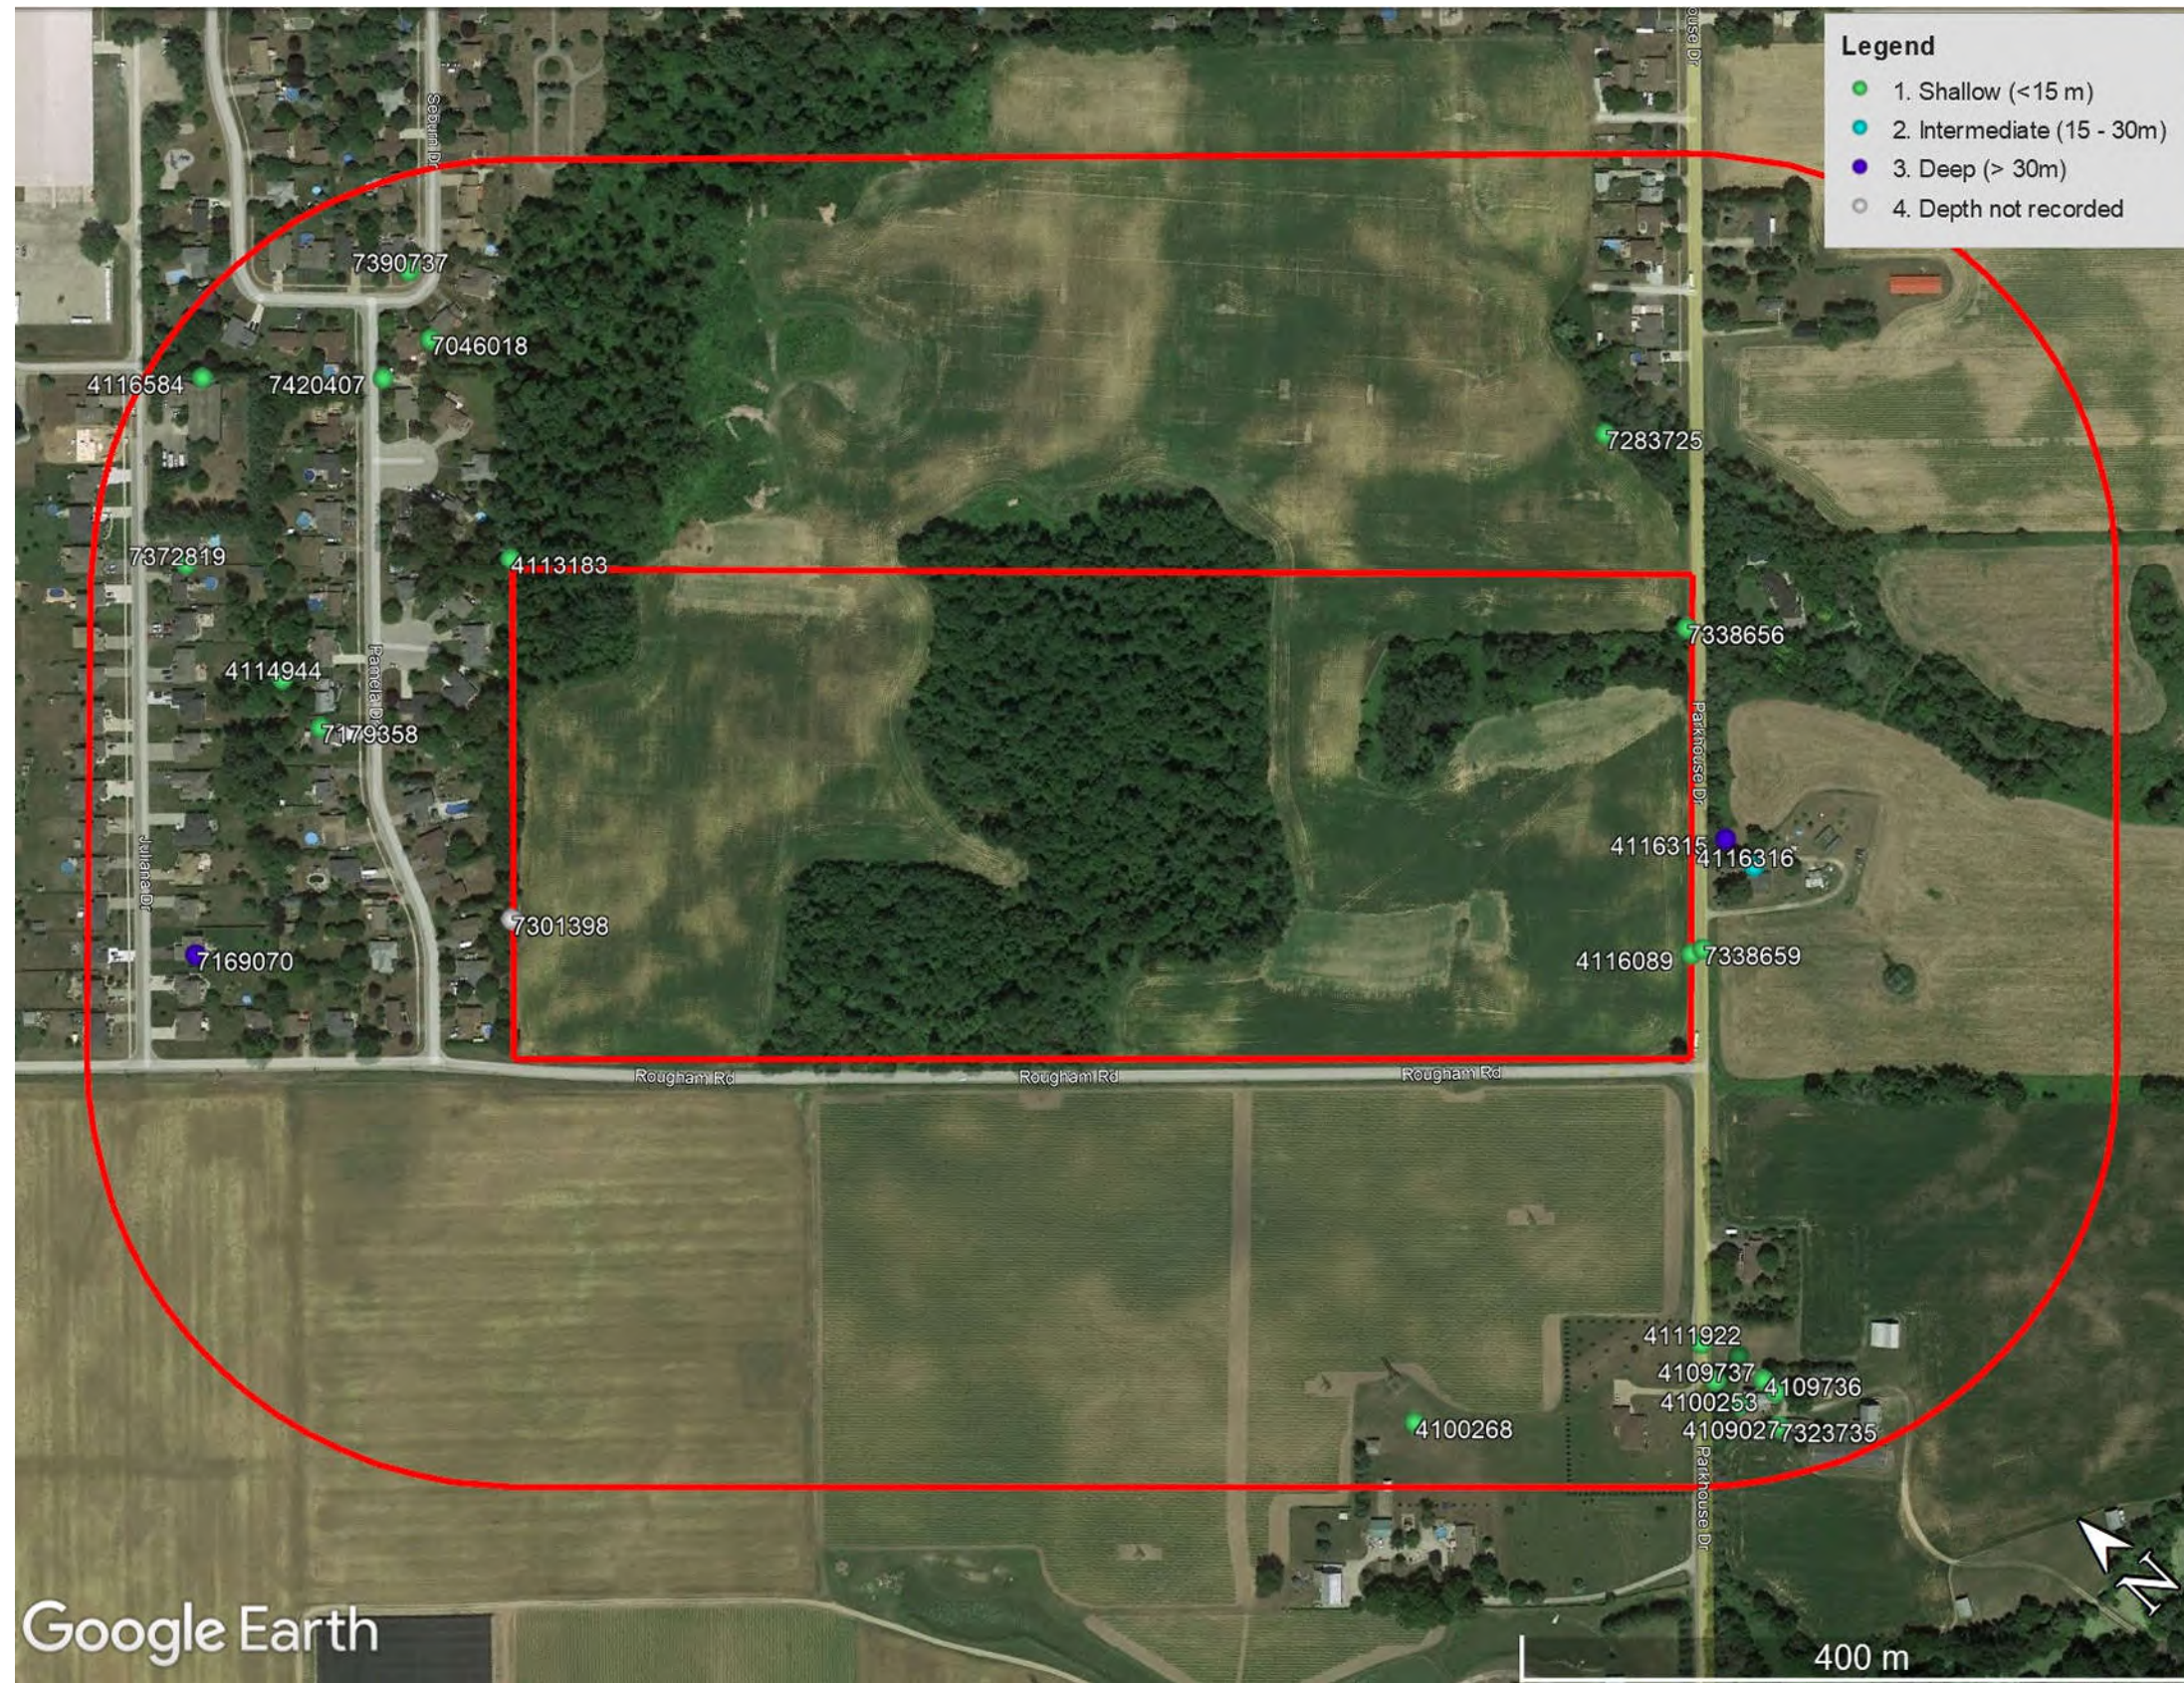
DATE March 2024	DRAWING NO. 4
---------------------------	-------------------------

SOURCE
 Ministry of Environment, Conservation and Parks
 Current to January 2024 (Google Earth Pro – imagery date, July 2018)
[/www.ontario.ca/environment-and-energy/map-well-records](http://www.ontario.ca/environment-and-energy/map-well-records)

Drawing 4 (in Appendix A) shows the location of wells (with Well Registration No.) which are in close proximity to the site. A summary of the well records is provided in Table 1, (refer to the following page). Water supply wells are typically set into shallow (less than 10 m deep) deposits of sand. Cluster observation wells were also noted near the site, with similar depths. Static water levels in the water supply wells and observation wells are generally measured at depths of 0.9 to 3.7 m depth. Shallow groundwater conditions are consistent with the water levels recorded in the monitoring wells installed at the site.

Shallow groundwater observed in the boreholes is representative of an unconfined shallow groundwater aquifer. The shallow groundwater flow follows the surface topography, both of which generally slope down towards the southeast. The groundwater flow direction is demonstrated on Drawing 4, in Appendix A.

Within the proposed development area south of the central woodlot, the shallow groundwater flow direction is towards the south end of the site. This follows the surface topography which also falls to the south. In the development area on the north side of the central woodlot, the shallow groundwater flow direction is in a west southwesterly direction, towards the central woodlot and Rougham Road. Groundwater Contour Plans under Spring 2018 conditions are provided on Drawing 6, in Appendix A. Subsequent spring time readings through to 2021 confirm a similar trend in the groundwater flow direction throughout the site.

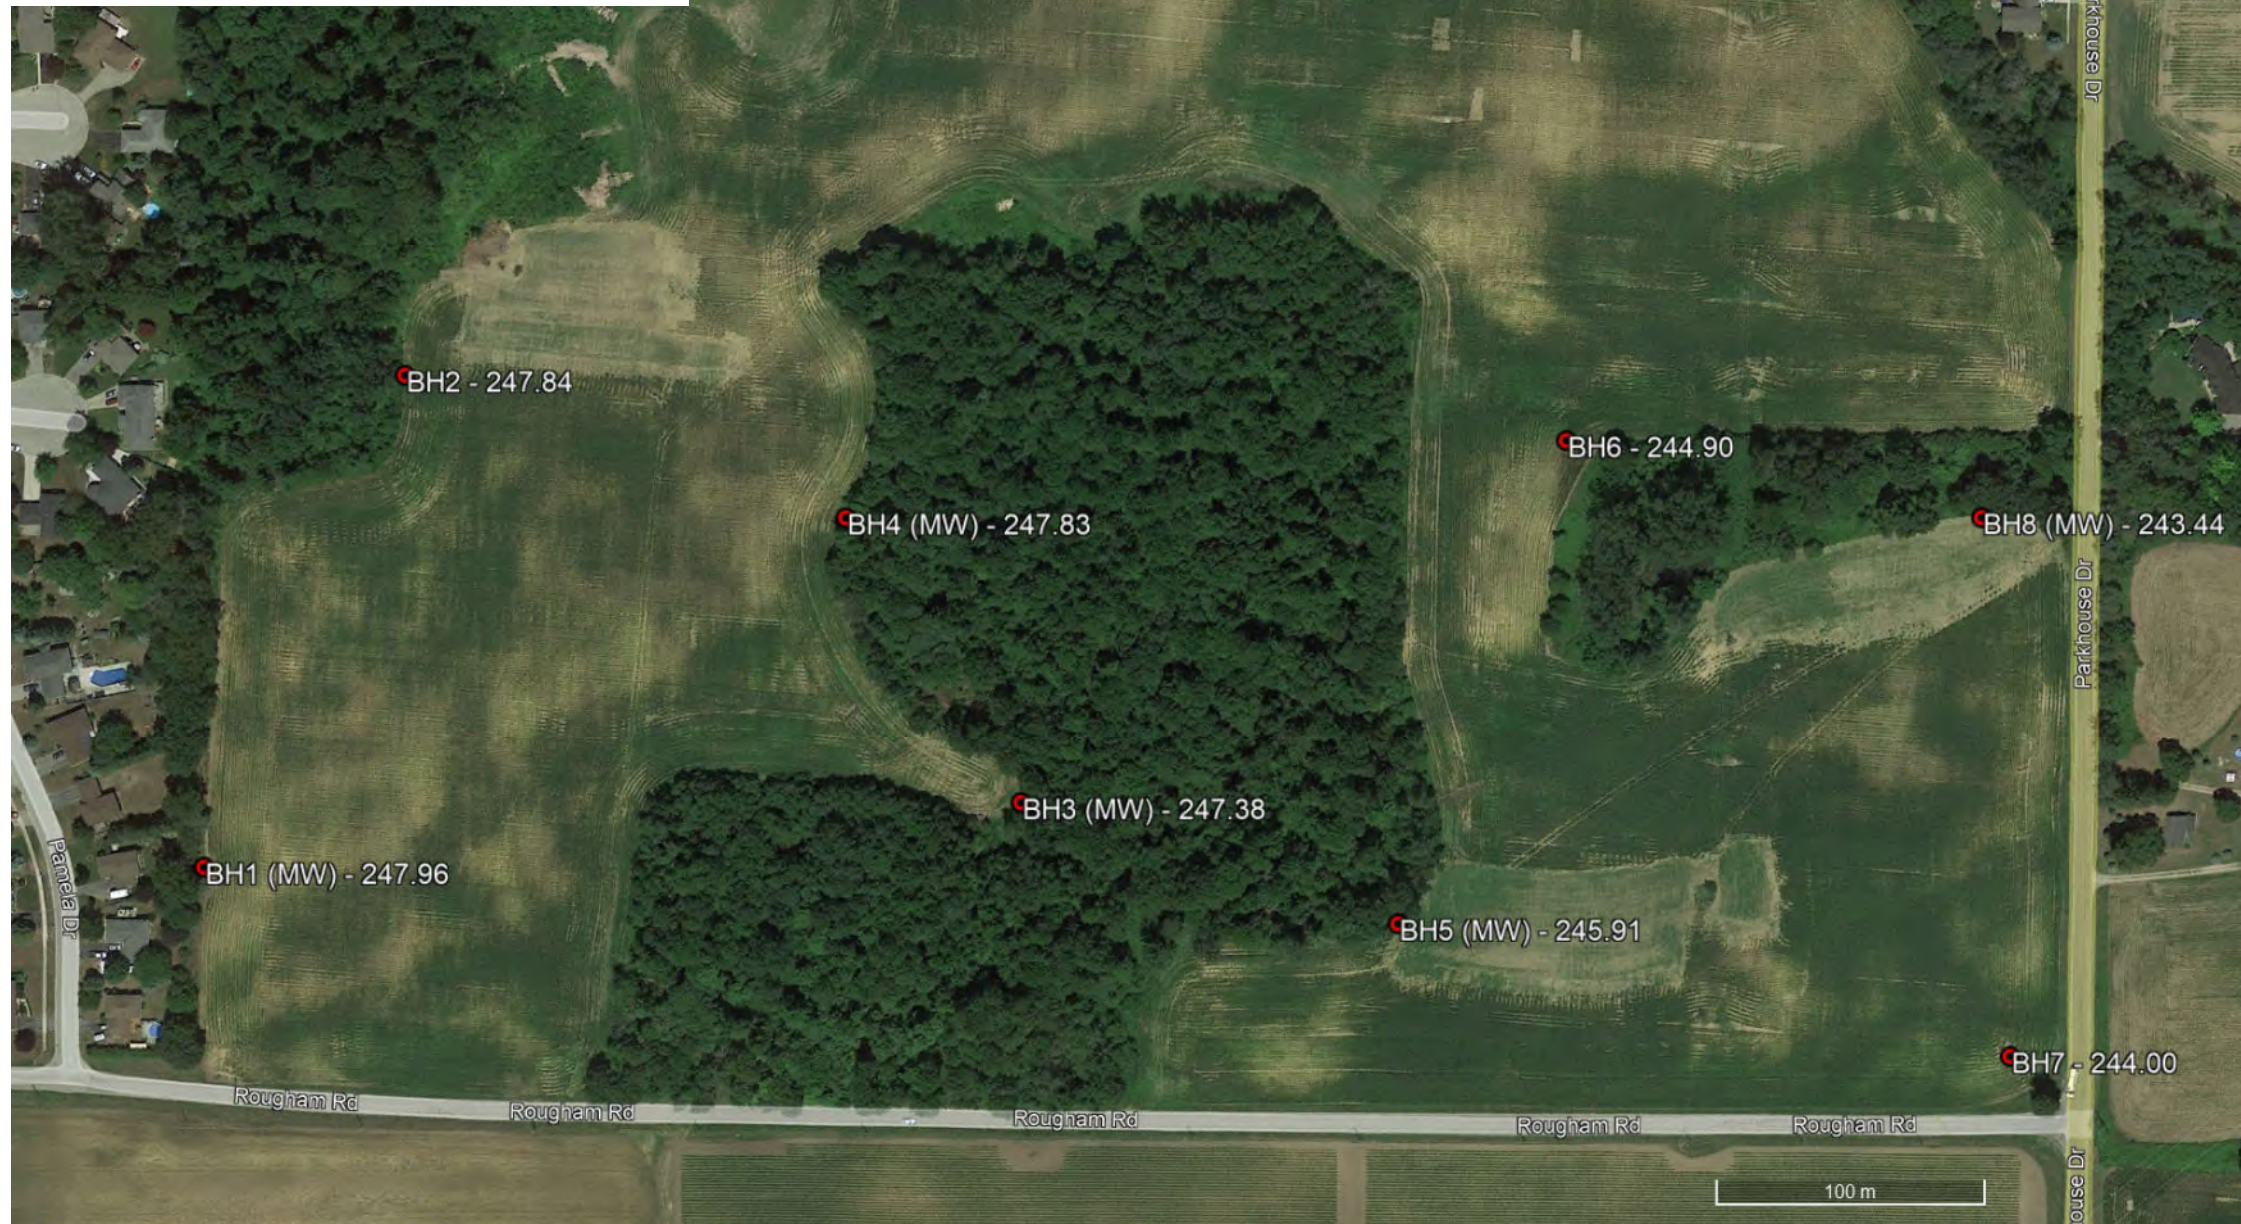
ID	Northing	Easting	Ground Surface Elevation, m asl
BH1 (MW)	4749913.9	459518.7	247.96
BH2	4749989.1	459699.9	247.84
BH3 (MW)	4749717.7	459748.2	247.38
BH4 (MW)	4749837.6	459777.1	247.83
BH5 (MW)	4749587.4	459815.9	245.91
BH6	4749669.5	459986.5	244.90
BH7	4749391.8	459941.1	244.00
BH8 (MW)	4749540.0	460075.0	243.44

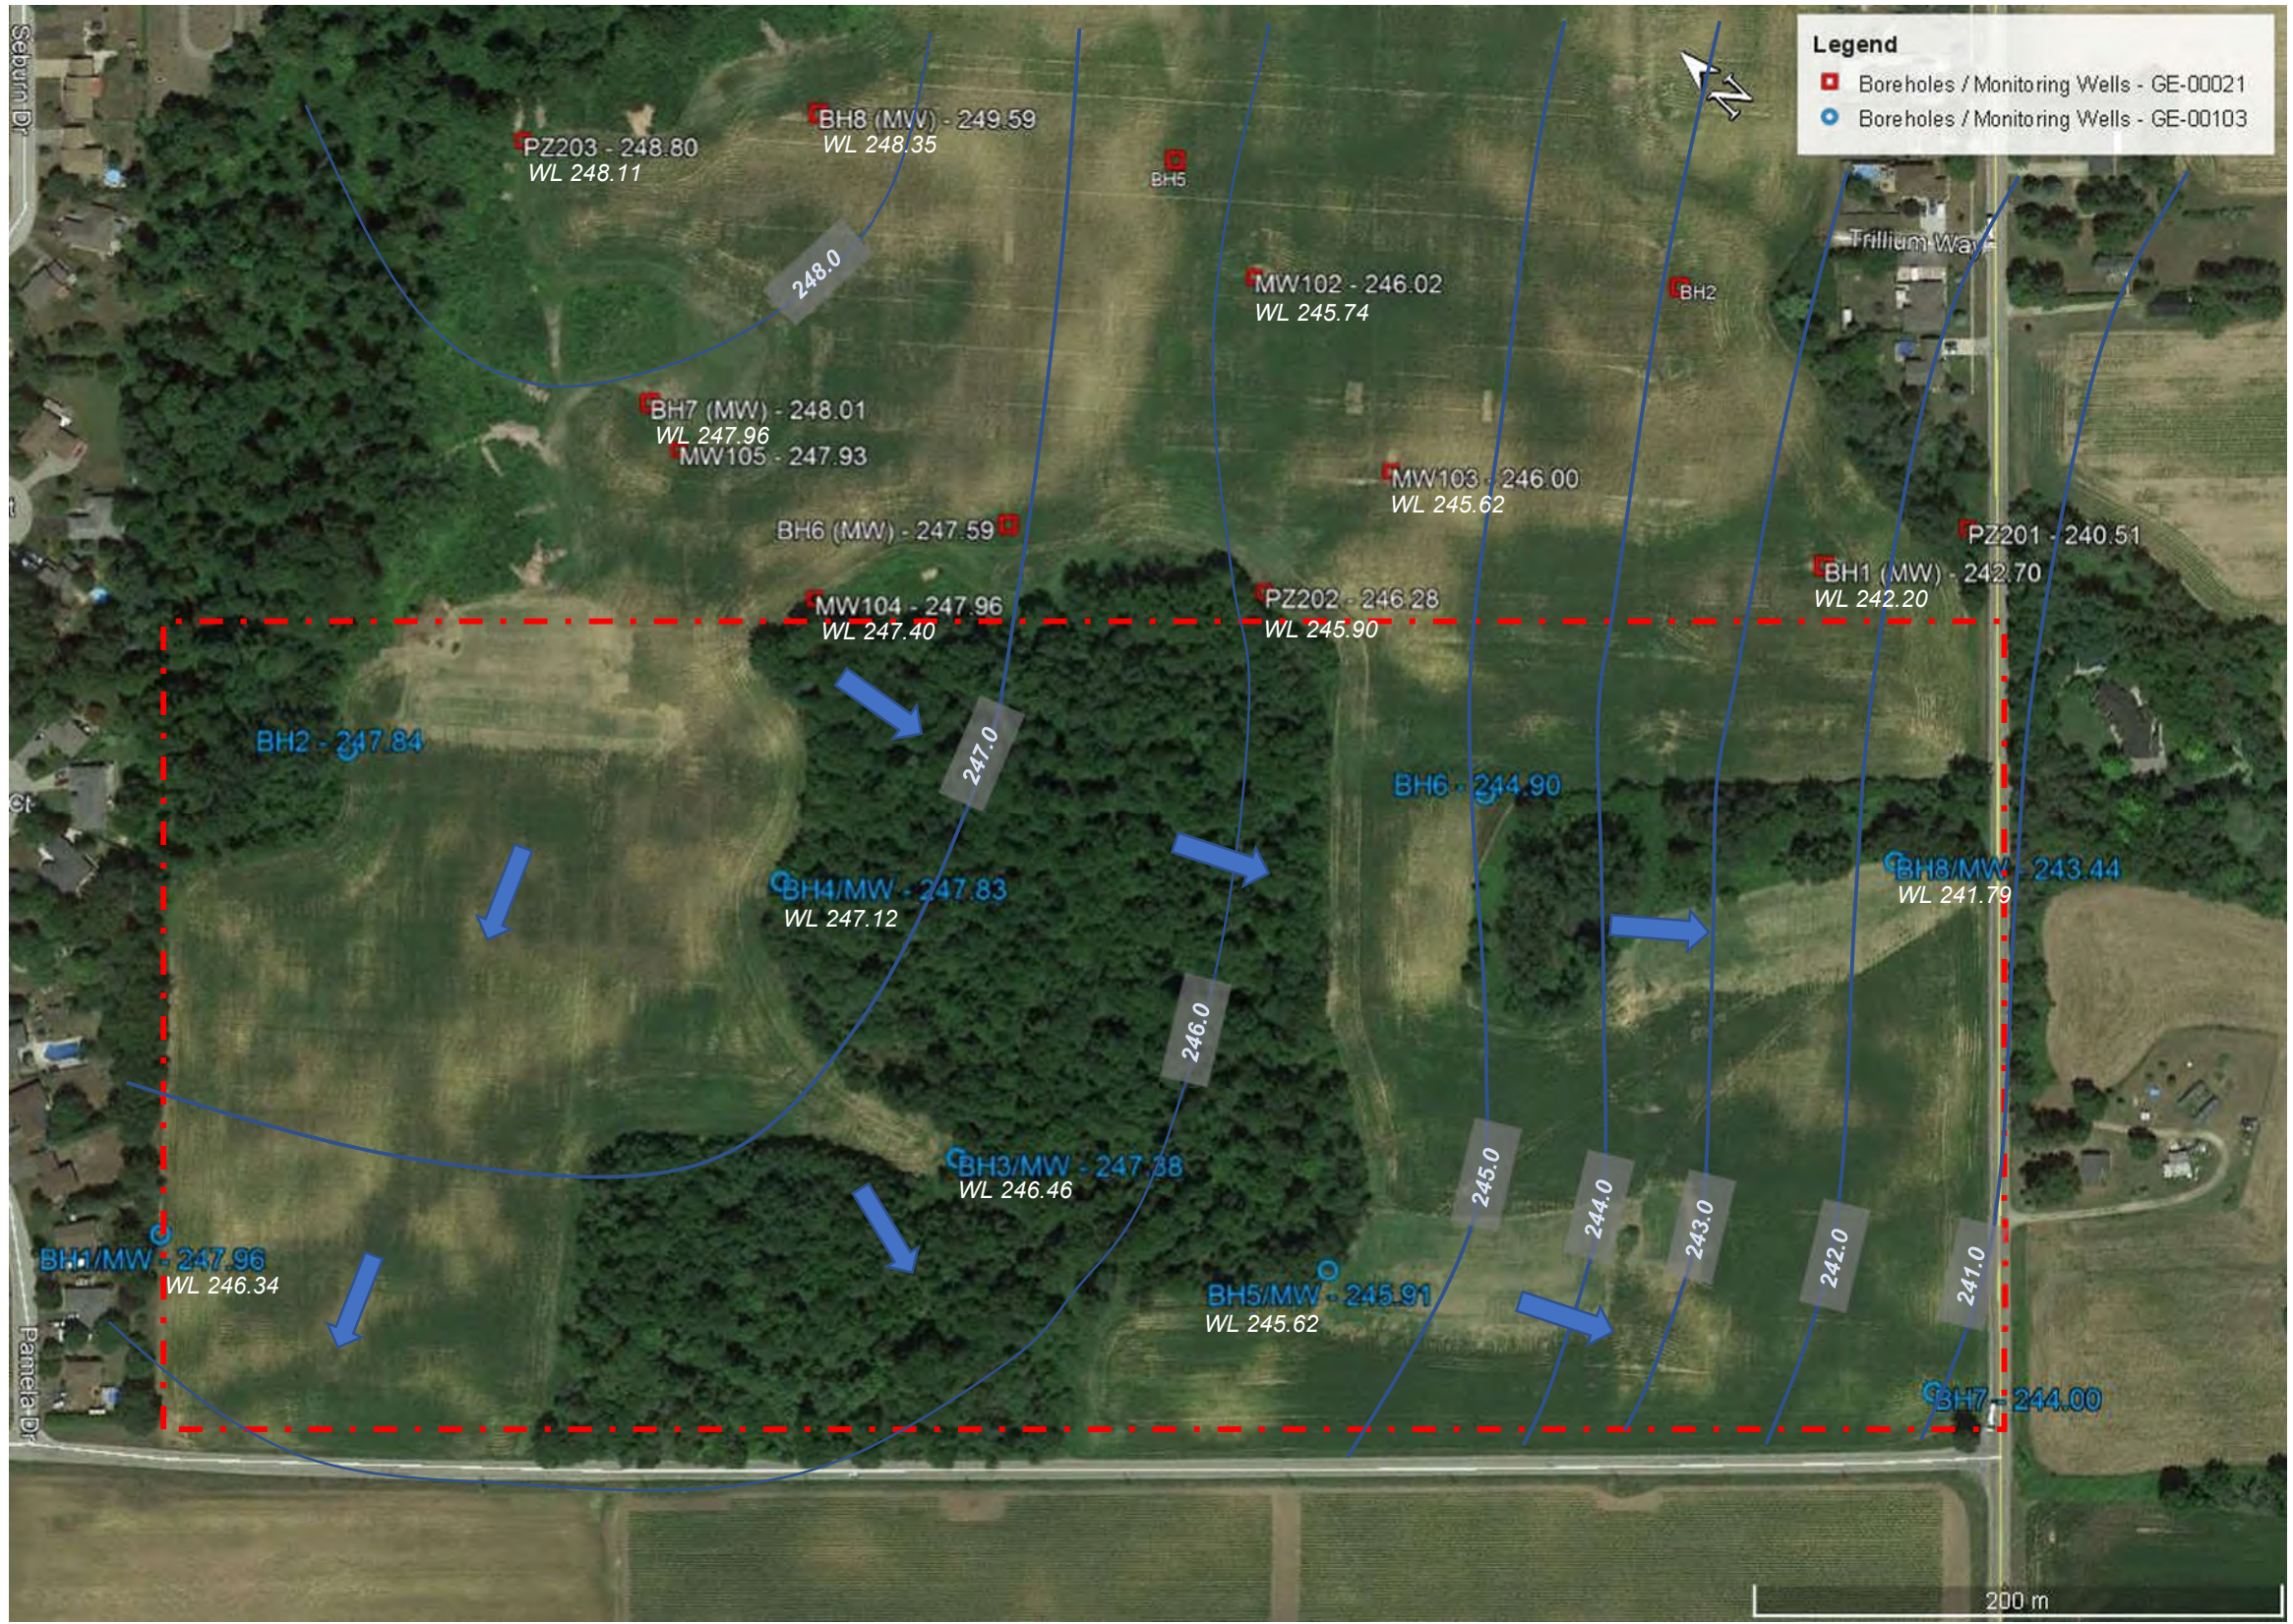
SCALE	PROJECT NO.
As Shown	GE-00103
DATE	DRAWING NO.
March 2024	5

Borehole Location Plan

A series of eight boreholes were advanced at the site to examine the soil and shallow groundwater conditions. Approximate locations of the boreholes are shown on Drawing 3, appended.

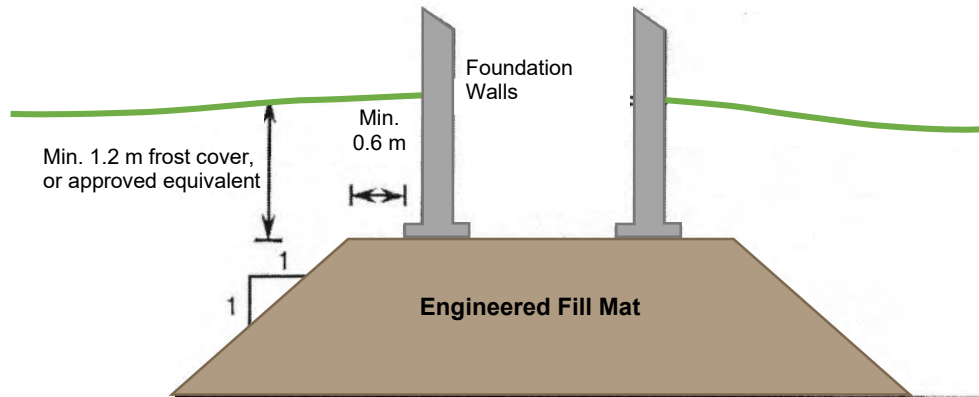
SCHEMATIC DIAGRAM

ENGINEERED FILL PLACEMENT

1. The area must be stripped of all topsoil contaminated fill material, and other unsuitable soils, and proof rolled. Soft spots must be dug out. The stripped natural subgrade must be examined and approved by the geotechnical consultant.

Where exposed subgrade soils are approved by the geotechnical consultant, and grades need to be raised to reach design elevations, it is anticipated that grades will be restored using structural / engineered fill. Engineered fill should consist of suitable, compactable, inorganic soils, which are free of topsoil, organics and miscellaneous debris. For best compaction results, the fill material should have a moisture content within about 3 percent of optimum, as determined by Standard Proctor testing.

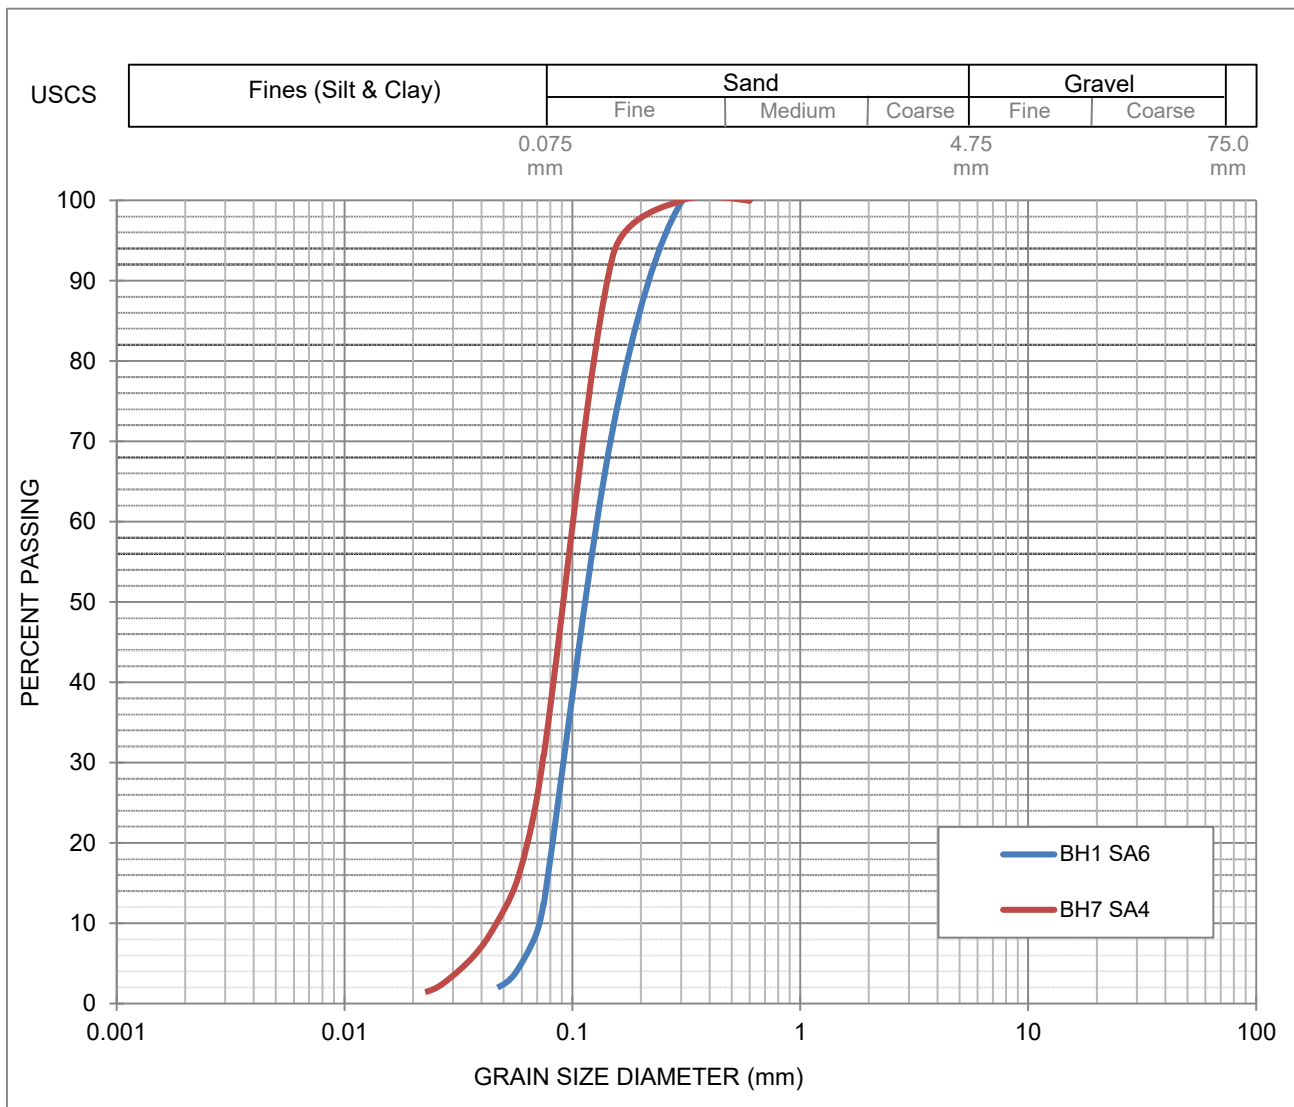
Particle Size Distribution Results of Sieve Analysis

Sample ID	Unified Soil Classification				Moisture Content
	% Clay	% Silt	% Sand	% Gravel	
BH1 SA6	0.0%	12.4%	87.6%	0.0%	22.1%
BH7 SA4	0.0%	30.9%	69.1%	0.0%	23.0%

Based on the gradation results (presented in Section 4.2), the following values for saturated hydraulic conductivity and infiltration rate have been calculated for the collected samples. Hazen’s method was used to correlate the grain size analysis to the hydraulic conductivity of the sand soils. This correlation is based on the following relationship:

Parameter	Fine Sand, some Silt		Sandy silt				Silt, trace Sand	
	BH1, SA6	BH7, SA4	BH2, SA4	BH4, SA5	BH5, SA4	BH8, SA1	BH3, SA4	BH5, SA6
d ₁₀ (mm)	0.07	0.06	0.034	0.020	0.022	0.017	0.021	0.020
d ₆₀ (mm)	0.12	0.10	0.06	0.05	0.04	0.06	0.41	0.049
Saturated Hydraulic Conductivity (m/s)	4.9x10 ⁻⁵	3.6x10 ⁻⁵	1.2x10 ⁻⁵	4.0x10 ⁻⁶	4.8x10 ⁻⁶	2.9x10 ⁻⁶	4.4x10 ⁻⁶	4.0x10 ⁻⁶
Factored Infiltration Rate (mm/hr)	52	48	35	27	28	24	27	27

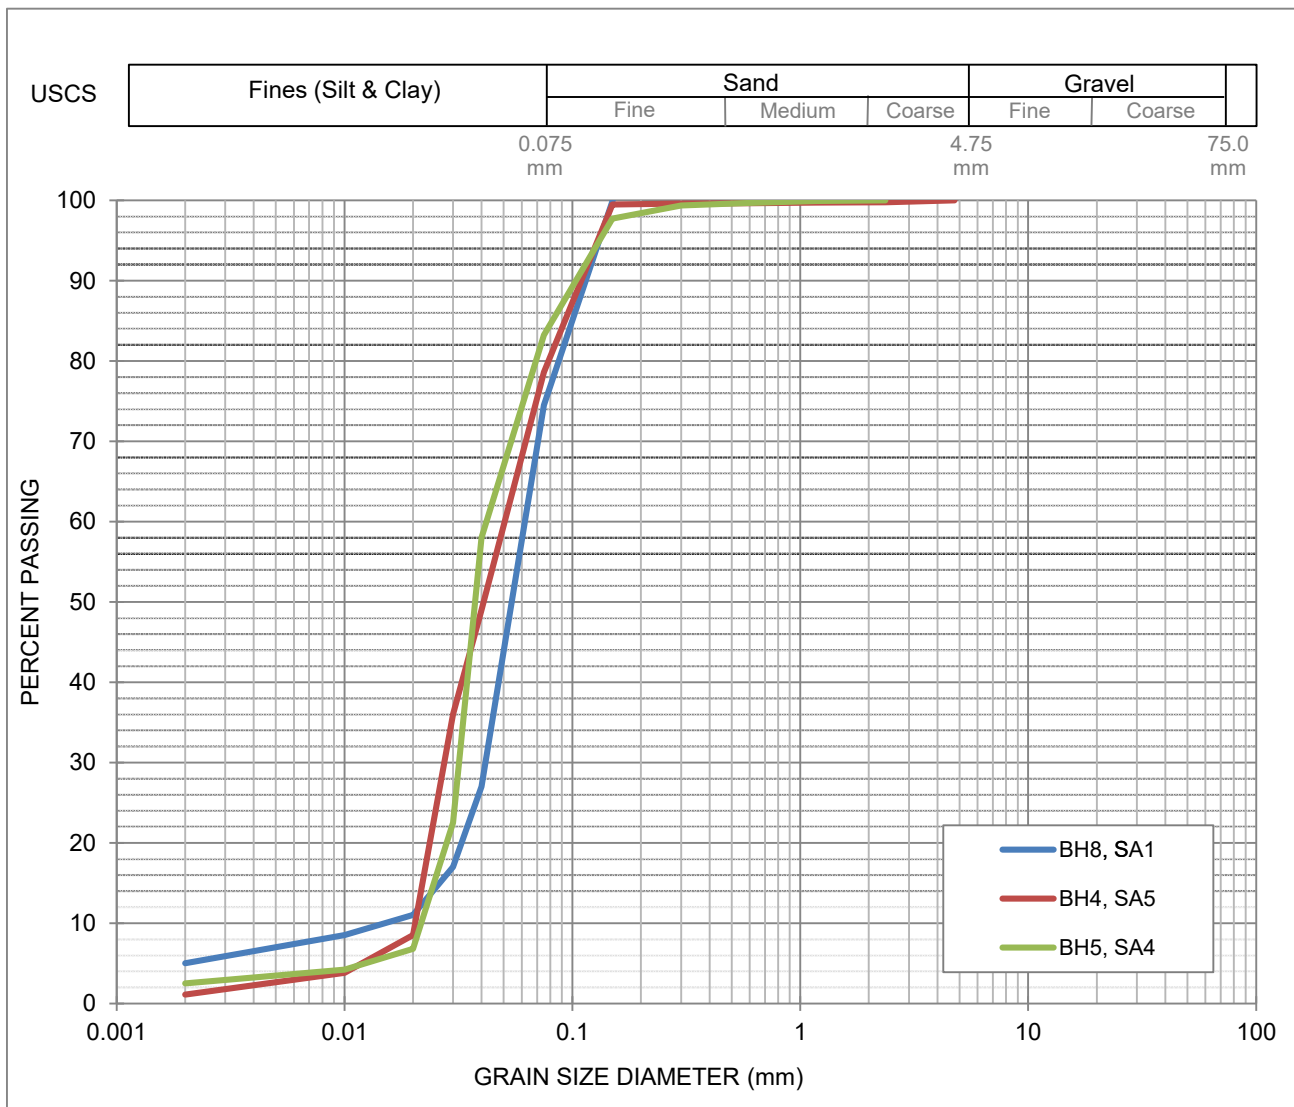
Particle Size Distribution Results of Sieve Analysis

Sample ID	Unified Soil Classification				Moisture Content
	% Clay	% Silt	% Sand	% Gravel	
BH8, SA1	5.0%	69.5%	25.5%	0.0%	9.5%
BH4, SA5	1.1%	77.5%	21.4%	0.0%	N/R
BH5, SA4	2.5%	80.7%	16.8%	0.0%	20.3%

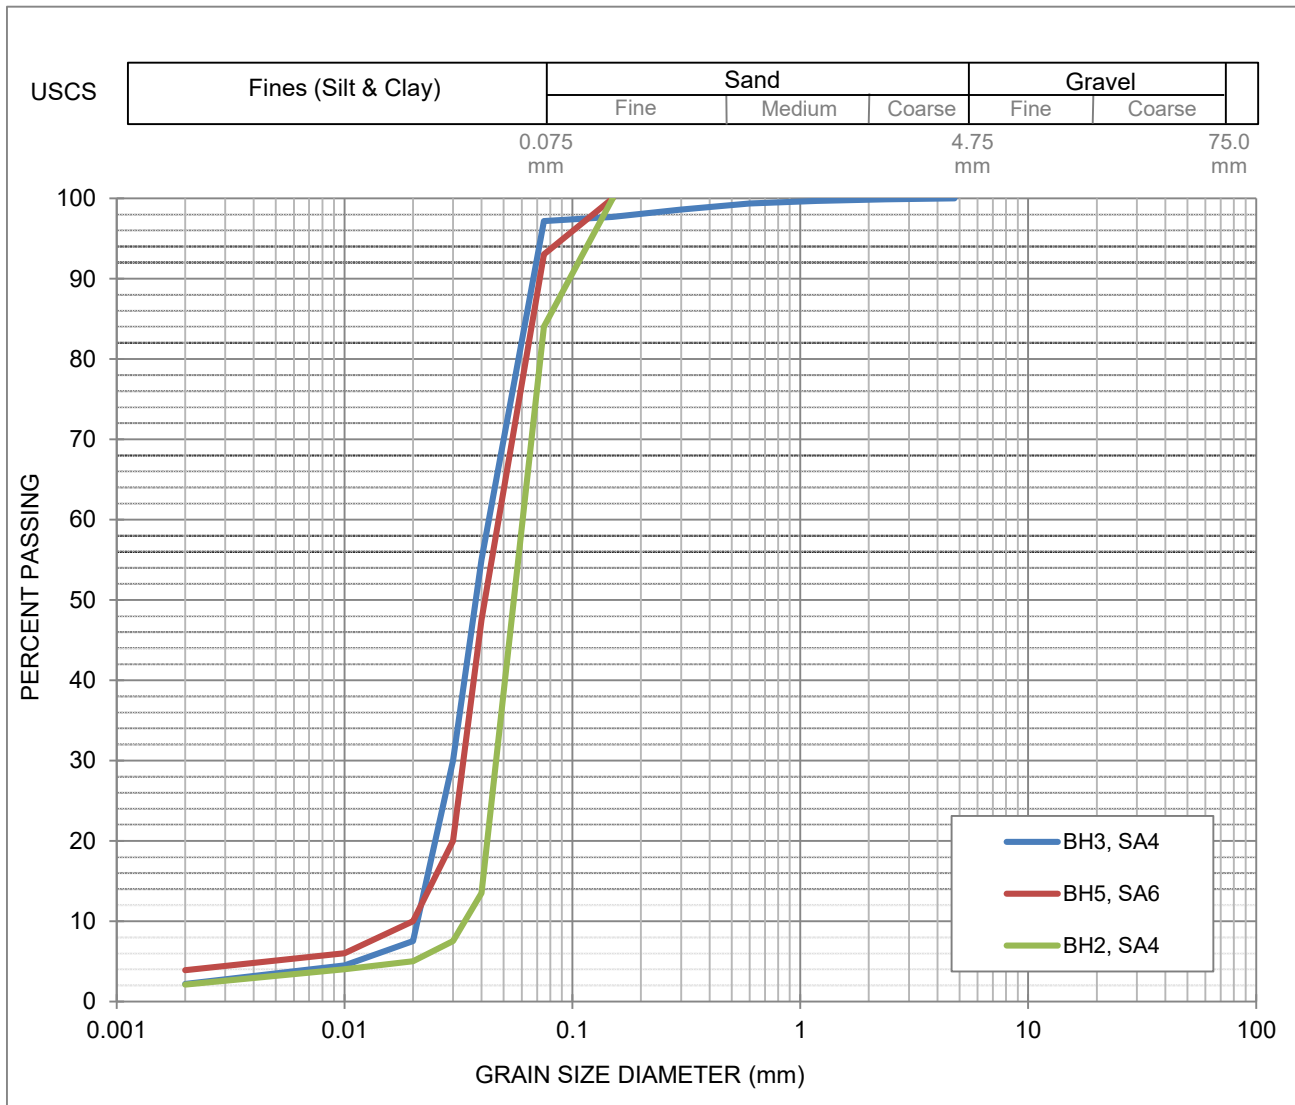
Sample ID	Unified Soil Classification				Moisture Content
	% Clay	% Silt	% Sand	% Gravel	
BH3, SA4	2.2%	95.0%	2.8%	0.0%	24.3%
BH5, SA6	3.9%	89.1%	7.0%	0.0%	21.8%
BH2, SA4	2.1%	81.9%	16.0%	0.0%	23.2%

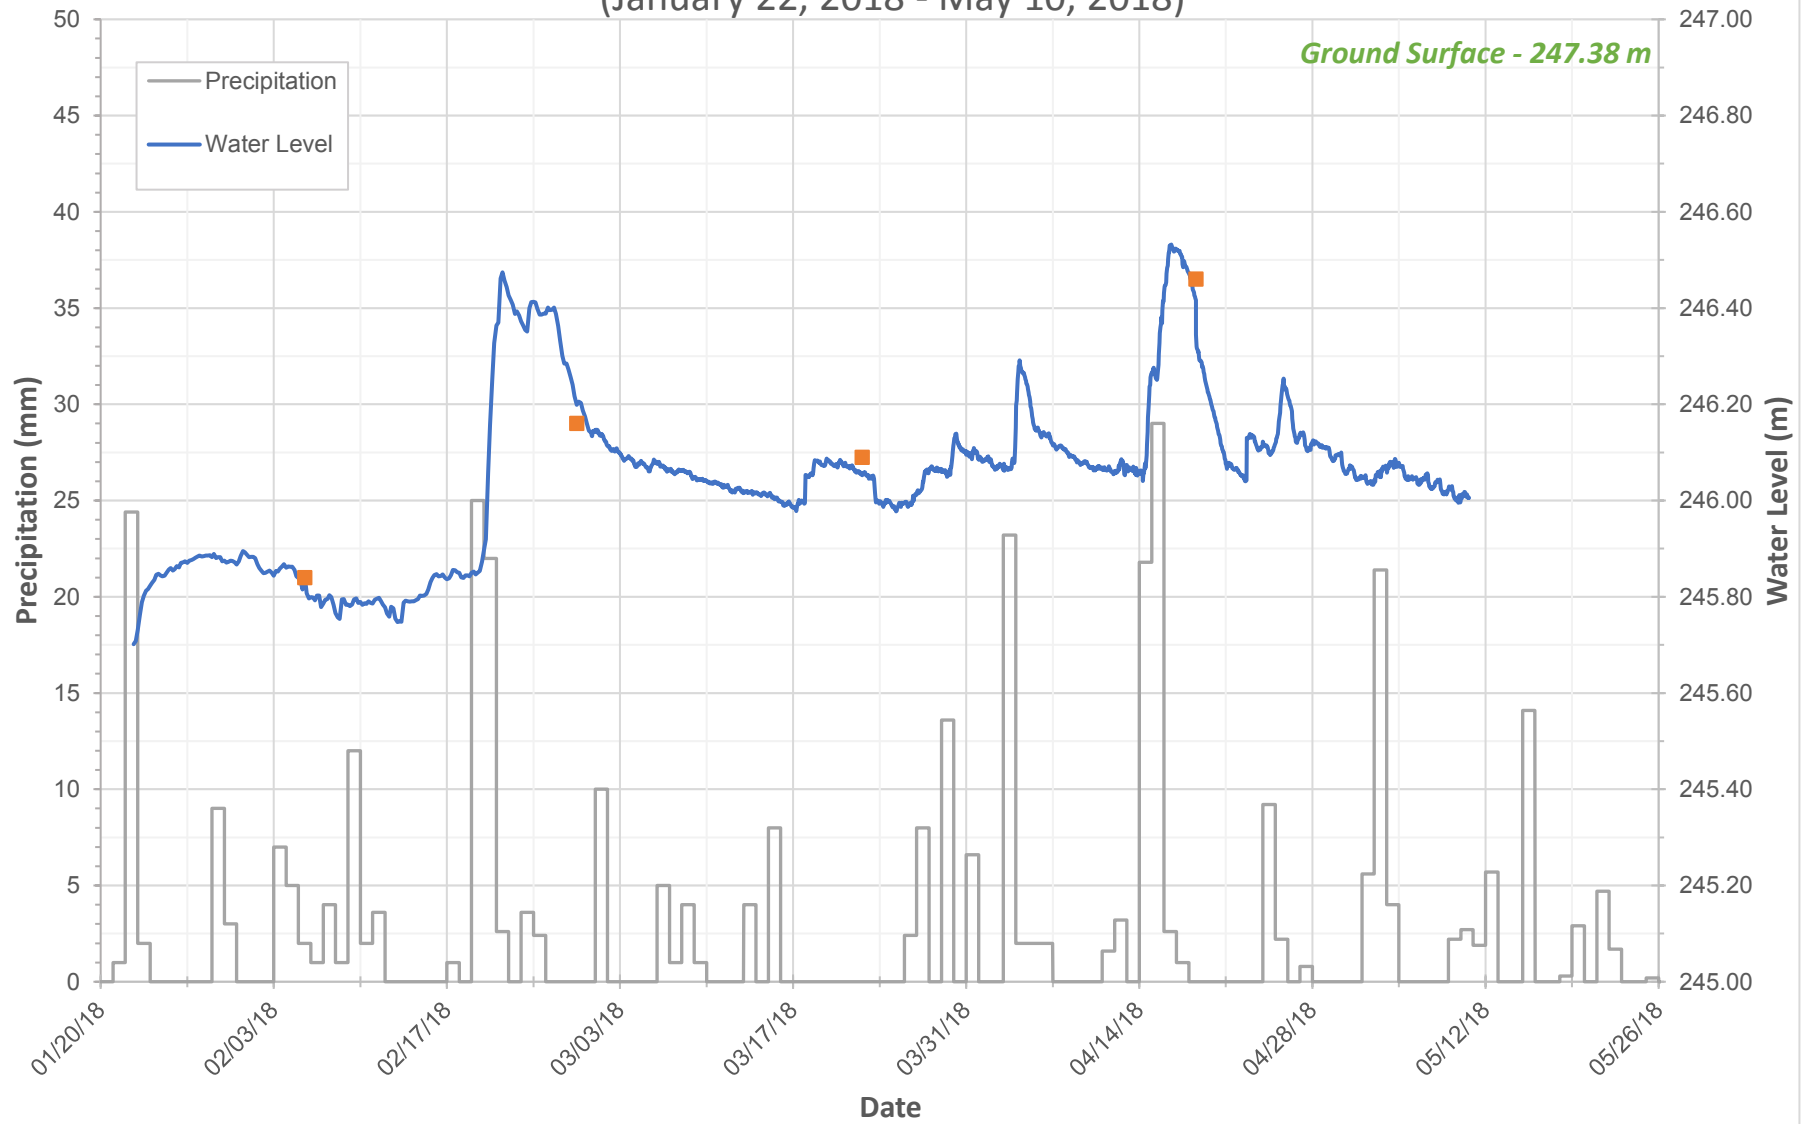
Borehole BH3 / MW

(January 22, 2018 - May 10, 2018)

1. Water Levels collected using Onset Hobo U20L Unit. Pressure Corrections based on hourly atmospheric data from Environment Canada Station at London Airport.
2. Precipitation data sourced from Environment Canada Strathroy-Mullifary Weather Station.

Shallow groundwater conditions are present within an unconfined aquifer, with the stabilized groundwater level in the typical range of 1.5 to 3.0 m depth below existing grade, which varies in response to climatic or seasonal conditions, with higher levels occurring in wet periods/seasons. The unconfined aquifer within the subject property is influenced by the site topography and seasonal precipitation conditions. Groundwater fluctuations and influence from significant precipitation rates have been verified on the shallow groundwater level through continuous water level measurements taken with manual readings and continuous groundwater monitoring (collected from dataloggers installed at the site). Seasonal variations recorded at the site are summarized in the following table.
