CONSOLIDATED GEOTECHNICAL INVESTIGATION & HYDROGEOLOGICAL ASSESSMENT REPORT

**FOREST VIEW SUBDIVISION
ROUGHAM ROAD & PARKHOUSE DRIVE
MOUNT BRYDGES, ONTARIO**

LDS PROJECT NO. GE-00103

MARCH 25, 2024

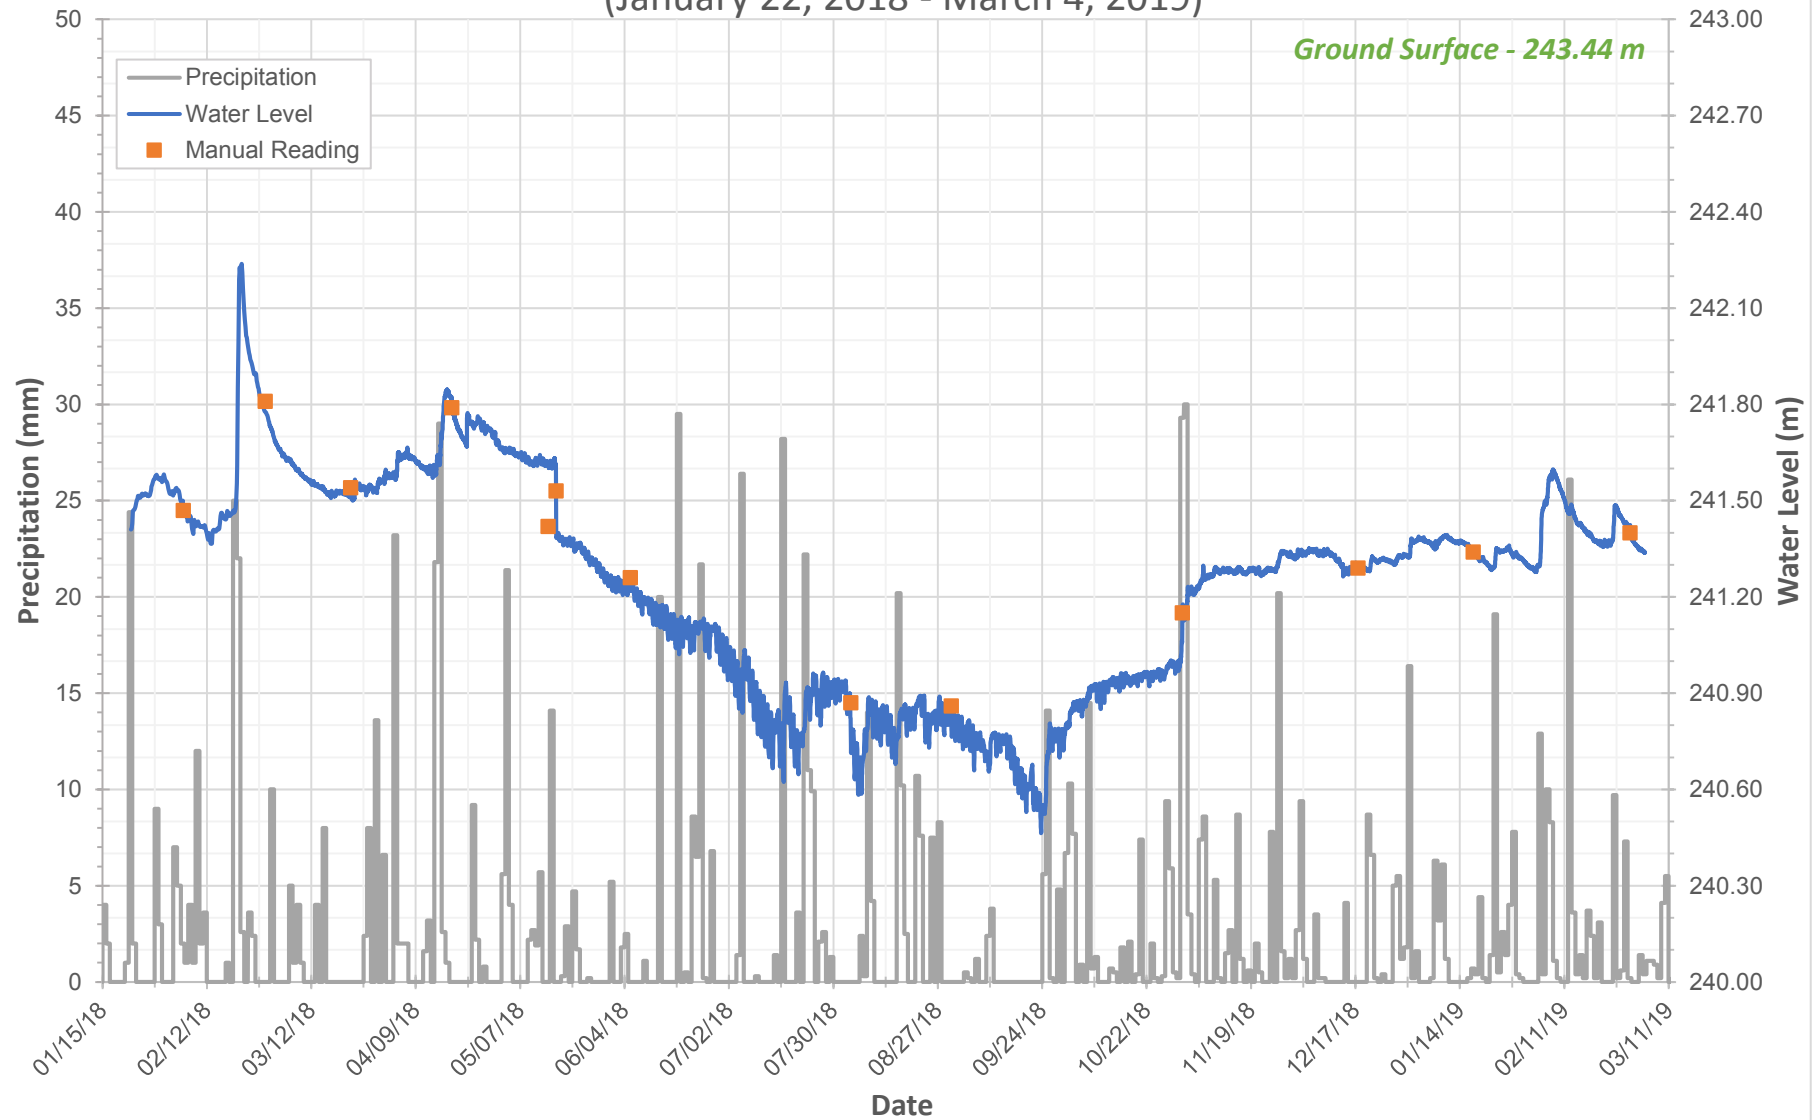
Borehole BH8/MW (January 22, 2018 - March 4, 2019)

1. Water Levels collected using Onset Hobo U20L Unit. Pressure Corrections based on hourly atmospheric data from Environment Canada Station at London Airport.
2. Precipitation data sourced from Environment Canada Strathroy-Mullifary Weather Station.

Shallow groundwater conditions are present within an unconfined aquifer, with the stabilized groundwater level in the typical range of 1.5 to 3.0 m depth below existing grade, which varies in response to climatic or seasonal conditions, with higher levels occurring in wet periods/seasons. The unconfined aquifer within the subject property is influenced by the site topography and seasonal precipitation conditions. Groundwater fluctuations and influence from significant precipitation rates have been verified on the shallow groundwater level through continuous water level measurements taken with manual readings and continuous groundwater monitoring (collected from dataloggers installed at the site). Seasonal variations recorded at the site are summarized in the following table.

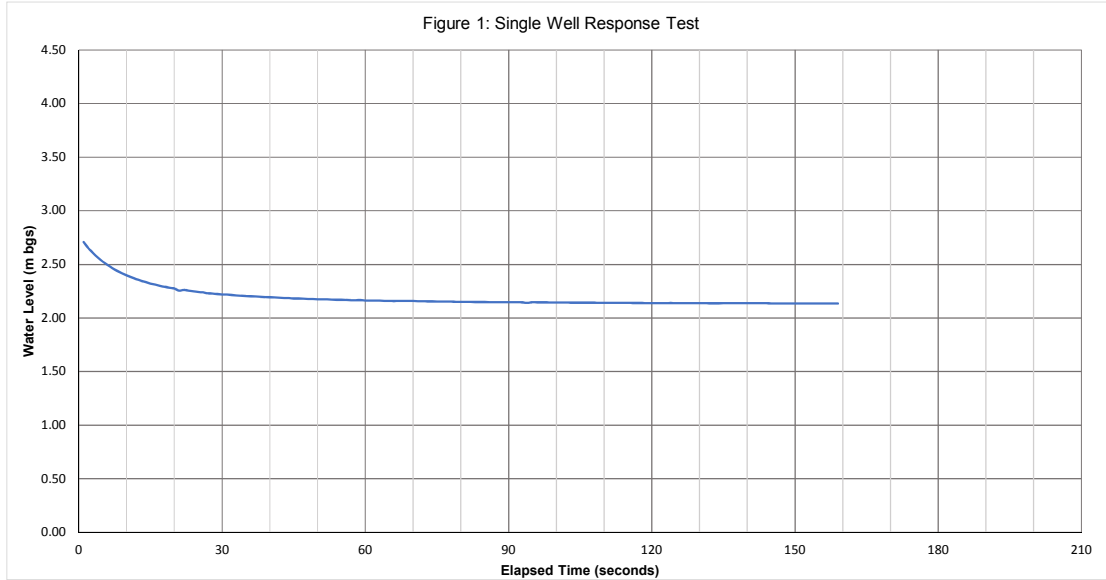
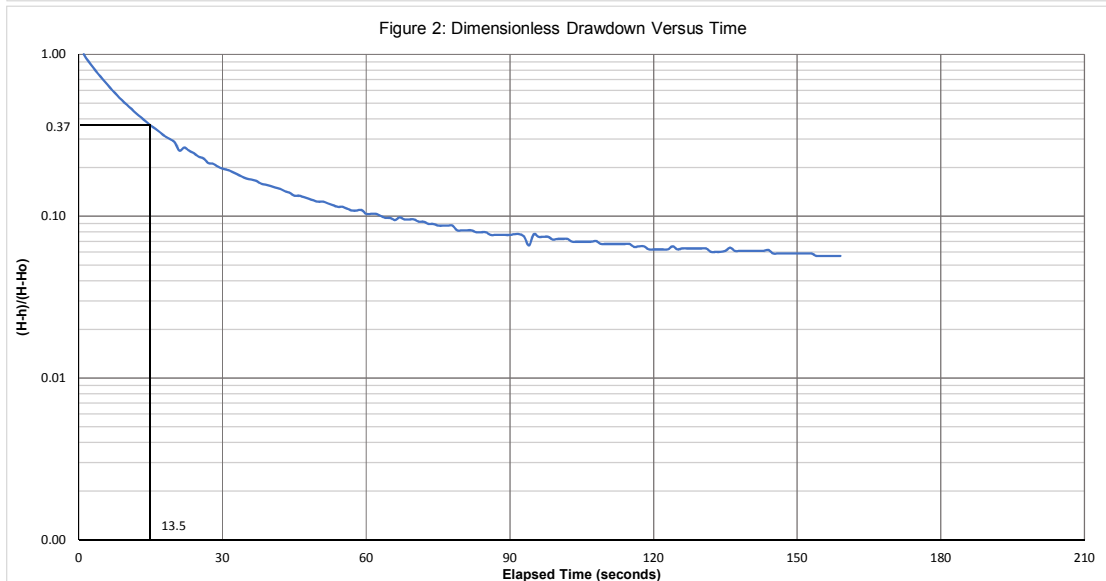
Project No.	GE-00103	Monitoring Well ID	BH1/MW
Project Name	Vansevanant	Date of Testing	19-Dec-18

Well Data:			
Radius of well casing, r, (m) =	0.025	Data Logger S/N:	20246303
Radius of filter pack/borehole, R, (m) =	0.101	Reading Interval:	1 second
Length of well screen, L, (m) =	3.05		
Submerged well screen length, Ls, (m) =	3.05	Gravel Pack Corrector $R_{equiv} = [(1-n)r^2 + nR^2]^{1/2}$	0.070
Static water level, h, (m) =	2.10		
Porosity of Gravel Pack, n (%) =	0.45

Estimation of Saturated Hydraulic Conductivity From Hvorslev's Equation

Hvorslev's Equation:
$$K = \frac{r^2 \ln(L/R)}{2(T_0)L}$$
 for $L/R > 8$

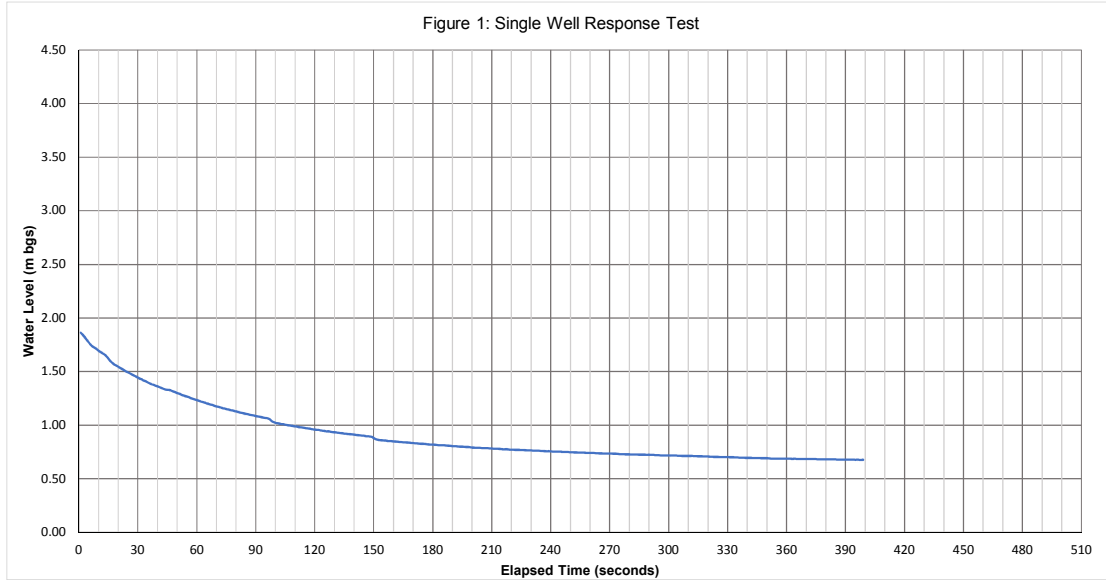
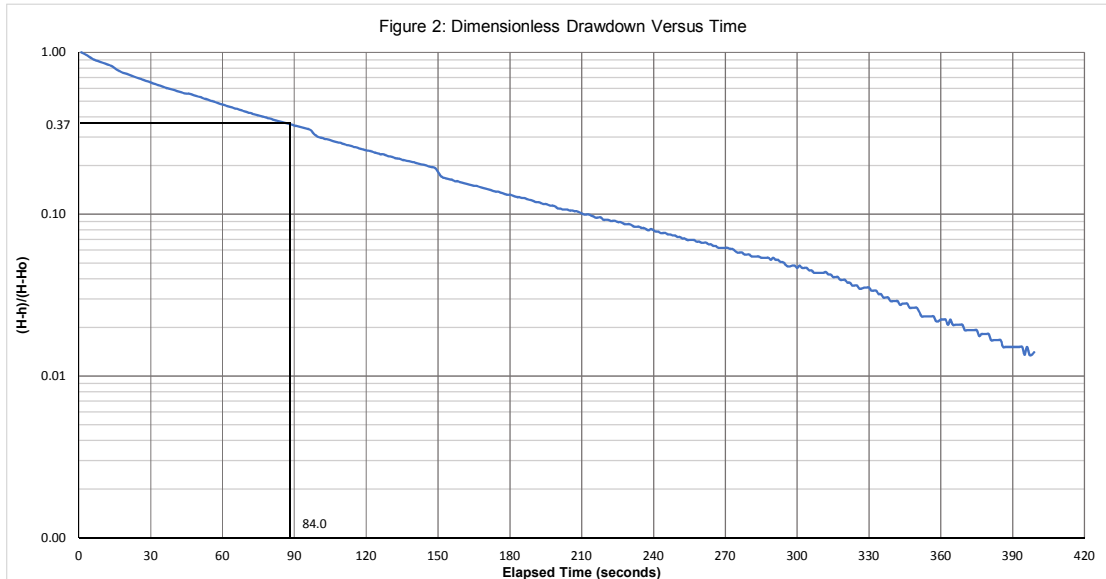
Project No.	GE-00103	Monitoring Well ID	BH5/MW
Project Name	Vansevant	Date of Testing	19-Dec-18

Well Data:			
Radius of well casing, r, (m) =	0.025	Data Logger S/N:	20246303
Radius of filter pack/borehole, R, (m) =	0.101	Reading Interval:	1 second
Length of well screen, L, (m) =	3.05		
Submerged well screen length, Ls, (m) =	3.05	Gravel Pack Corrector $R_{equiv} = [(1-n)r^2 + nR^2]^{1/2}$	0.070
Static water level, h, (m) =	0.66		
Porosity of Gravel Pack, n (%) =	0.45

Estimation of Saturated Hydraulic Conductivity From Hvorslev's Equation

Hvorslev's Equation:
$$K = \frac{r^2 \ln(L/R)}{2(T_0)L}$$
 for $L/R > 8$
