WolfAJM Holdings Inc.
48 Front Street,
Strathroy, ON
N7G 1Y6

Phase I&II Environmental Site Assessment (Rev2)

24546 Adelaide Road
Strathroy, ON

Project Number
LON-00016790-EN

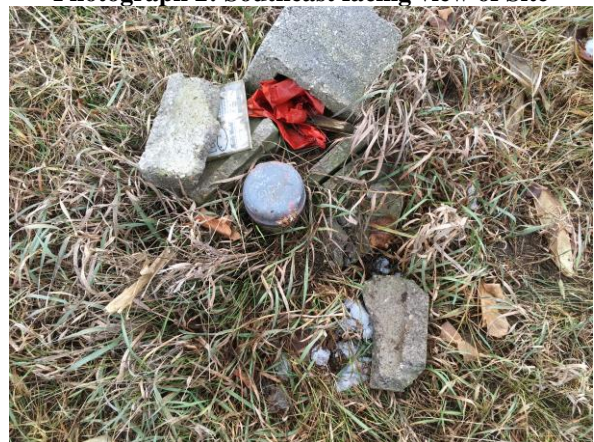
Photograph 4: Suspected filler pipe on northwest corner of the Site just south of the driveway

A metal pipe was noted on the northwest corner of the Site, just south of the driveway. According to Mr. Jim Brother (the current Site owner who provided information to EXP over the telephone) the pipe is a drilled test water well that was installed to monitor water levels when Union Gas was dewatering to install the gas pipelines on the south portion of the Site. No other abandoned or existing potable water wells were observed on the Site during the Site visit. A search of the Ministry of the Environment's Well Records conducted on December 17, 2018 revealed several irrigation wells in the surrounding area to the south and east of the Site. No records were found for the Site. The general stratigraphy as revealed in the well records from the area was sand.

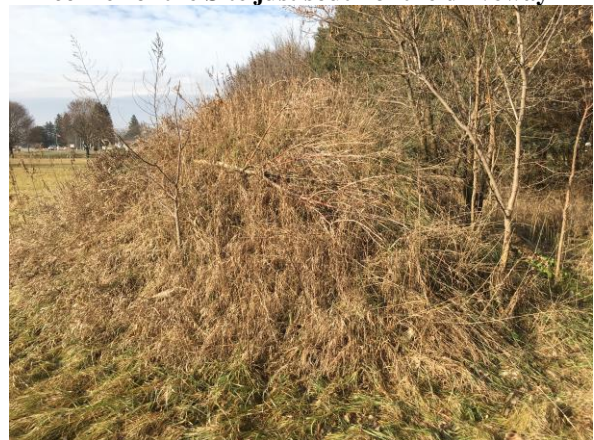
Photograph 6: Fill pile on southeast corner of the Site

The Site was generally level with the surrounding properties. It is suspected that some fill material was imported for Site grading, backfill of former structures and Site servicing. A small fill pile was noted on the southeast corner of the Site.

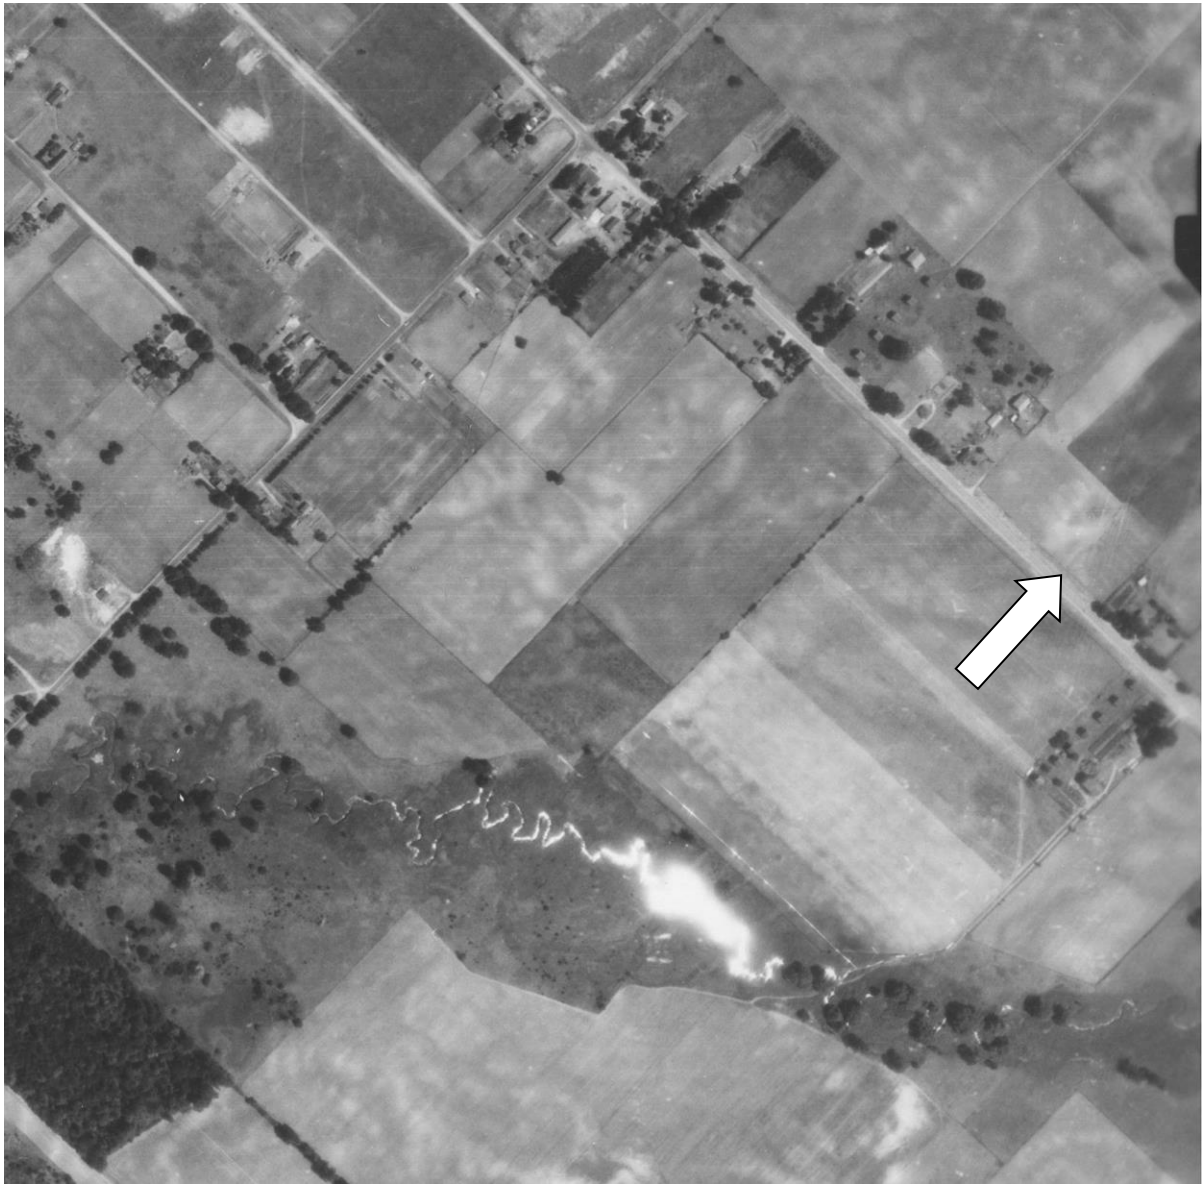
**1955 Aerial photograph
(Arrow indicates Site location)**

Aerial Photograph	Details
1955	<ul style="list-style-type: none">• The Site appeared to be occupied by agricultural land• The surrounding area was mainly occupied by agricultural land, with associated farmsteads along Adelaide Road.
1972	<ul style="list-style-type: none">• As shown on Figure 2, a small structure was noted on the southeast corner of the U-Shaped driveway. Another possible structure was noted to the north of this structure.• The adjacent property to the north of the Site was also occupied by a similar-type structure and possible above-ground storage tank.• A trailer park was noted to the far north of the Site.• Part of the current residential subdivision was constructed to the far northeast of the Site• No other significant changes were noted to the surrounding area.
1989	<ul style="list-style-type: none">• No significant changes were noted on Site or on the adjacent northern property.• The current subdivision to the northeast and east of the Site was now observed more-or-less in its current form.• No other significant changes were noted to the surrounding area.

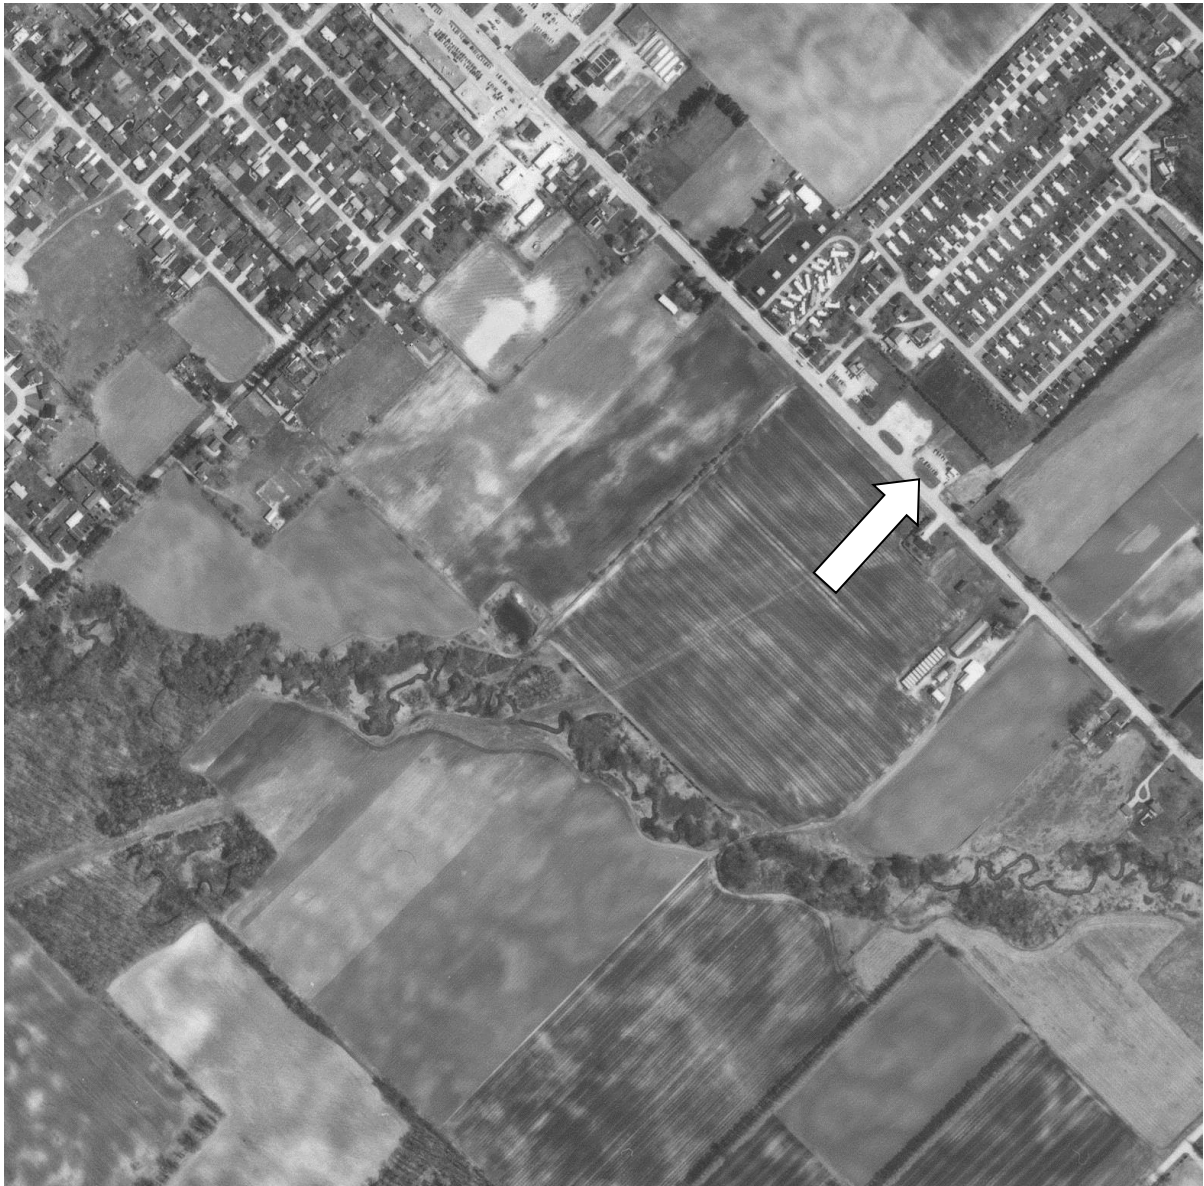
1992 Aerial photograph

Aerial Photograph	Details
1992	<ul style="list-style-type: none">No significant changes occurred on Site, although it was noted that the possible second structure noted on the 1972 photo no longer appeared to be present (if ever present to begin with)The adjacent building to the north of the Site was no longer present.No other significant changes were noted to the surrounding area.
1999-2001	<ul style="list-style-type: none">No significant changes occurred on Site or to the surrounding area.
2006	<ul style="list-style-type: none">The Site building was no longer observed on Site. Some soil disturbance was observed on the southeast corner of the Site.No significant changes were noted to the surrounding area.
2018	<ul style="list-style-type: none">No significant changes to the Site were noted.The residential house to the southwest of the Site was no longer present.No other significant changes were noted to the surrounding area.
