Meeting Date: June 2, 2025
Department: Engineering & Public Works
Report No.: EPW-2025-27
Prepared by: Paul Zuberbuhler, Manager of Environmental Services
Submitted by: Mark Ortiz, Director of Engineering and Public Works
Approved by: Rob Browning, Chief Administrative Officer
SUBJECT: Caradoc Closed Landfill Update

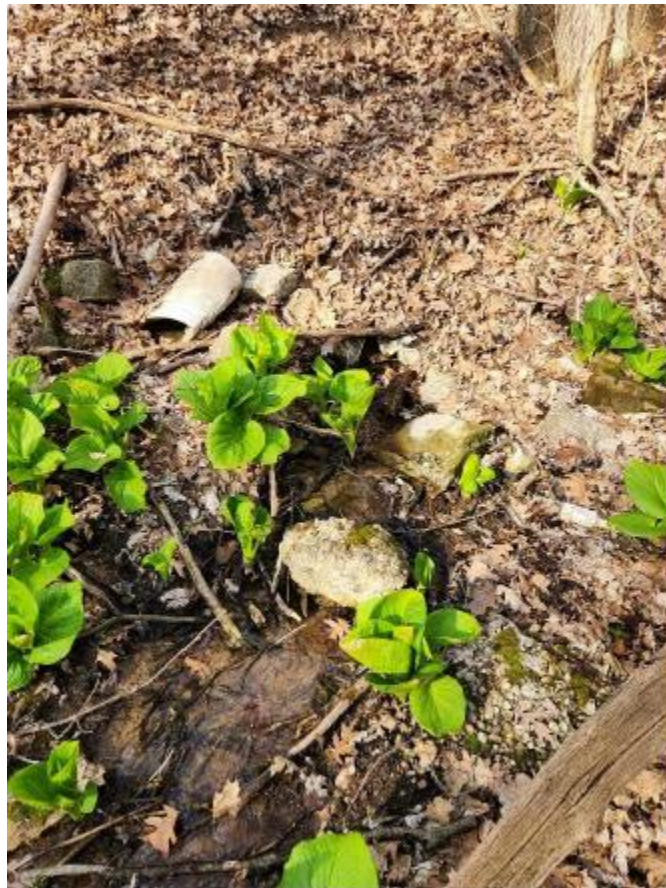
Point 1

- Continues to be groundwater discharge occurring here.
- It appears to be coming a buried culvert or field tile in this location.
- The groundwater discharge rate was small estimated it at less than 1 L/s.

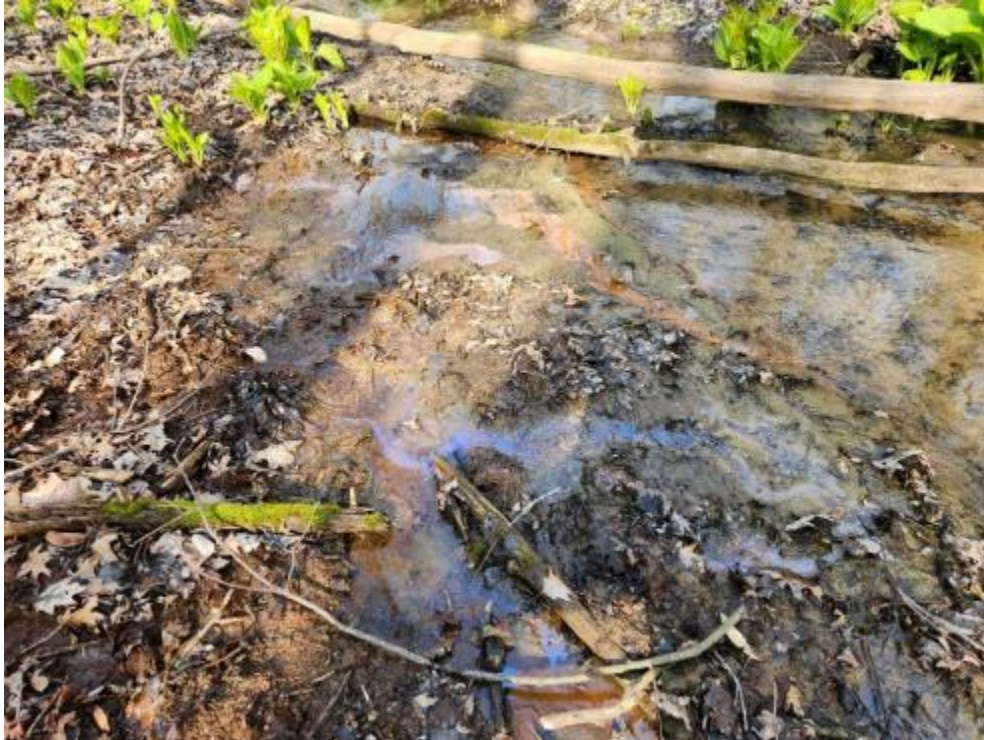
Point 2

- No groundwater discharge
- Evidence that groundwater has discharged here in the past (i.e. a sheen on some of the ponded water and reddish staining see picture below)

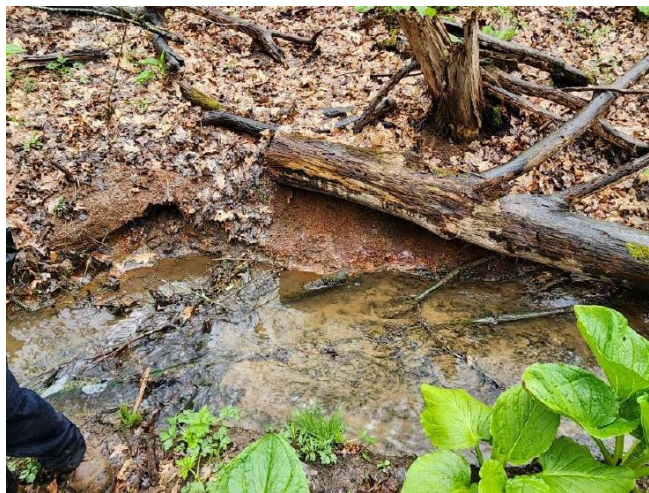
Point 3 and 4

- No visible flow at time of visit
- Previous elevated multi-meter readings and less vegetative cover in the identified area
