Municipality of Strathroy-Caradoc Parks and Recreational Area Condition Assessments Executive Summary Report - November 2024

Re: RFP-2024-132 – Parks & Recreational Area Condition Assessments

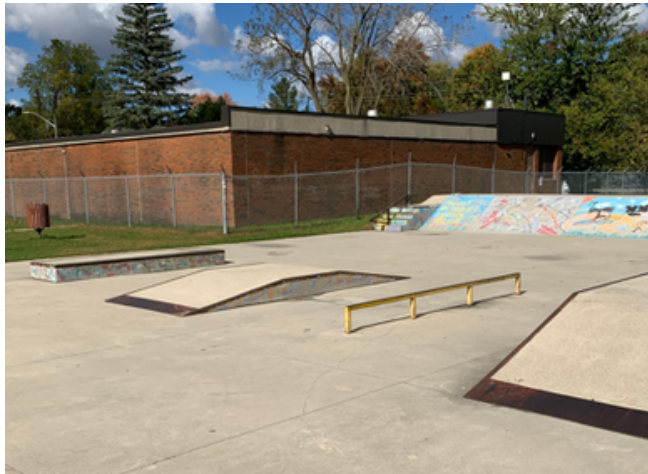
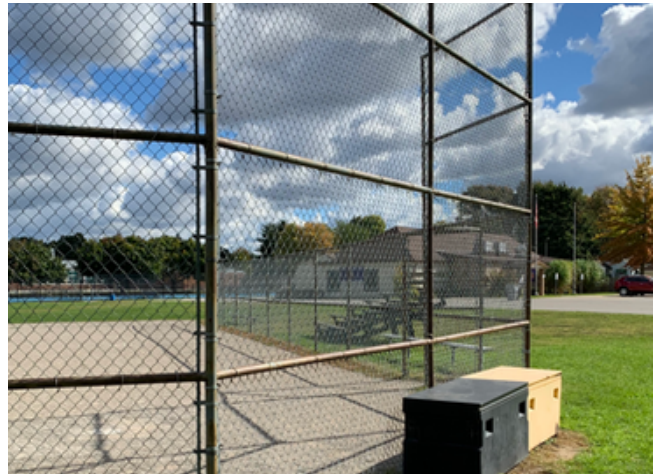
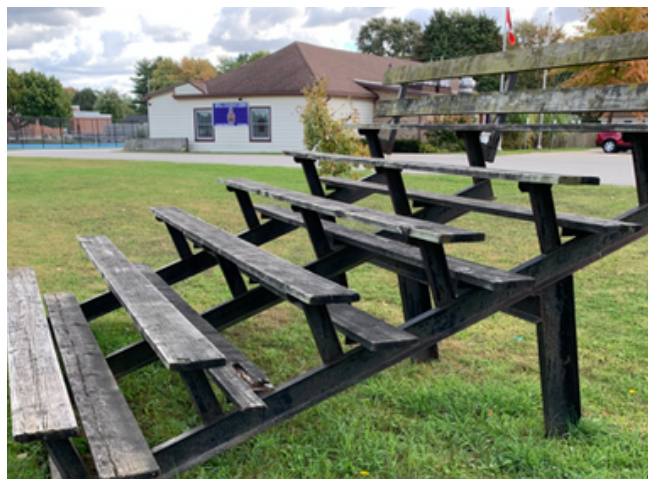
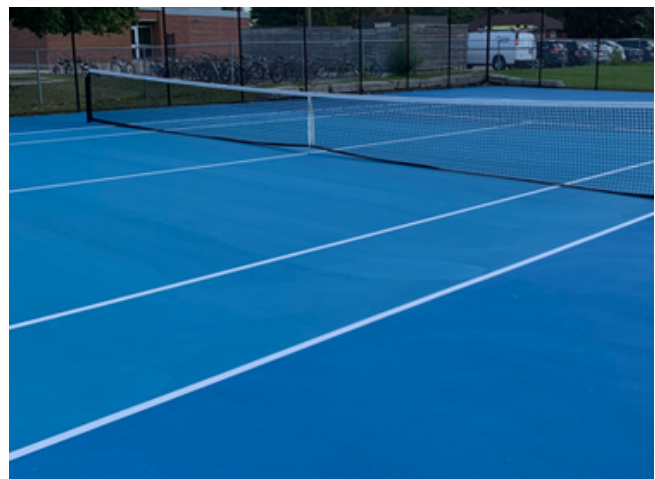
The Mt. Brydges Legion Park, covering 3.44 acres, offers a range of recreational facilities including a baseball field, a skate park, and courts for tennis and pickleball. The skate park, while generally in good condition, shows some signs of wear with chipping at the expansion joints that could potentially pose trip hazards for skaters.

The baseball field has a surface of chips and dust and is without lighting. The fencing is in average to good condition but shows some surface rust, and one post is rotten and requires replacement. The players' benches are in good condition, but a standalone bench along the first base side is in poor shape and should be removed. The outfield's sports turf is in average condition due to weed growth and uneven areas, which affect its overall health. The transition between the infield and outfield is uneven, and it is recommended that the transition height be reduced to improve the playing surface. The bleachers are also in average condition, with some damaged boards needing replacement. It is suggested that side railings be added, the steel frame repainted, and a concrete pad installed under the bleachers to prevent weed growth. A concrete pad behind the backstop has been identified as a trip hazard and should be removed.

In summary, while the park is in good overall condition, there are several areas where improvements can be made. Addressing the trip hazards in both the skate park and baseball field, along with repairing or replacing the damaged infrastructure such as fence posts, benches, and bleachers, would enhance the park's safety and usability. Additionally, improving the baseball field's playing surface and turf health would further elevate the quality of the facility.

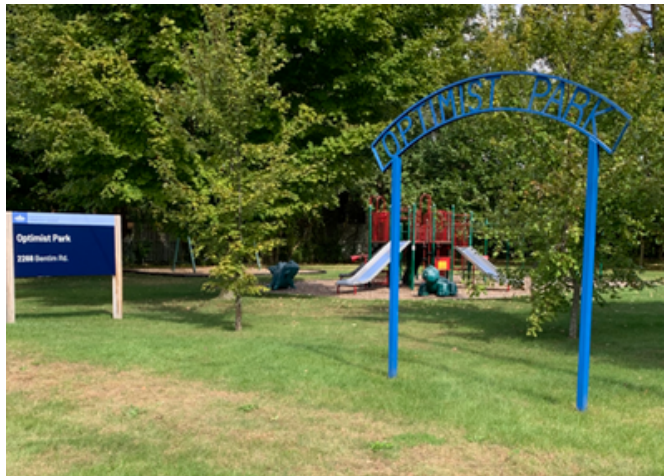
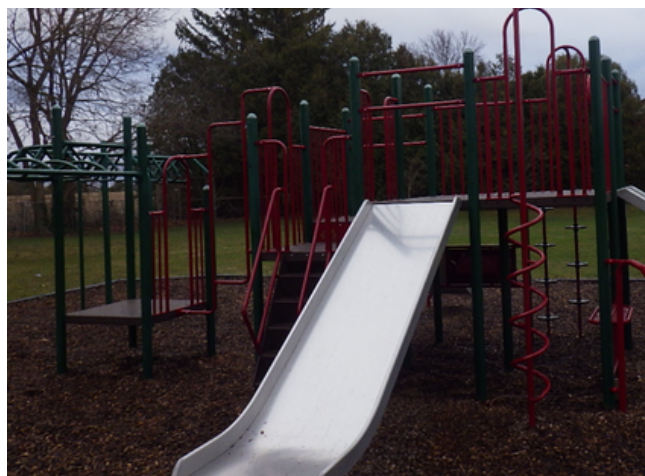
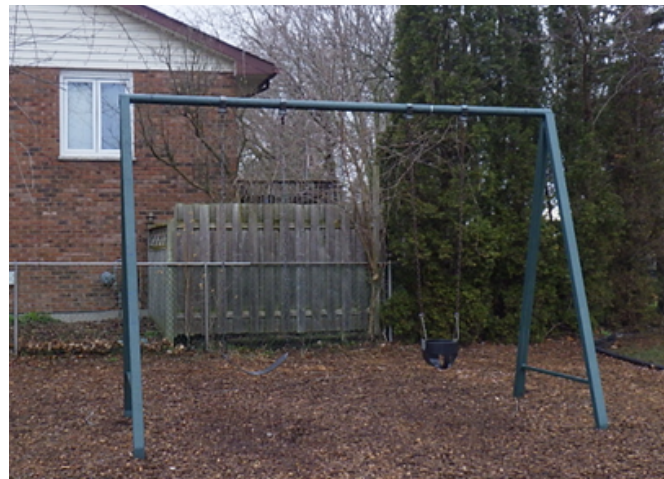
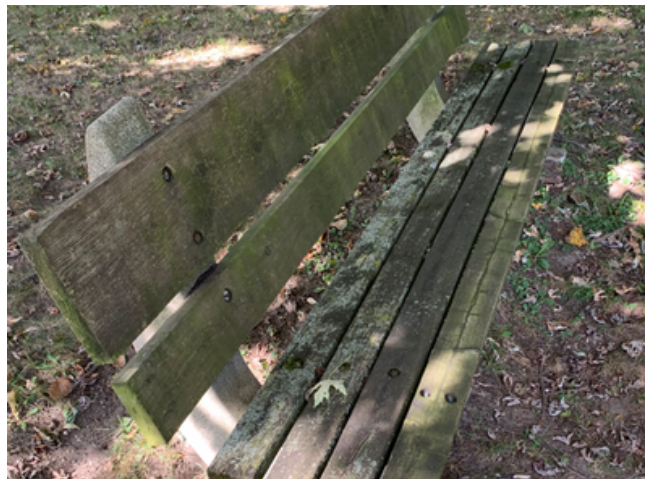
Mt. Brydges Optimist Park, which covers 0.5 acres, features a playground and wooden bench, with the bench's lumber being in poor condition, prompting a recommendation for replacement. The perimeter fencing is in average to good condition, though it requires some minor repairs. An old backstop is noted to be in poor condition, with a suggestion for its removal. The park is well-shaded, with a mixture of mature and young trees, none of which pose a hazard. It is recommended to keep the low tree limbs trimmed to aid in park maintenance and grass cutting.

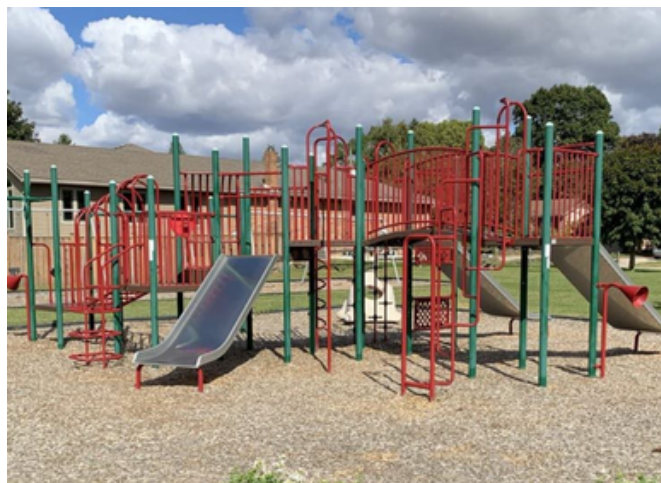
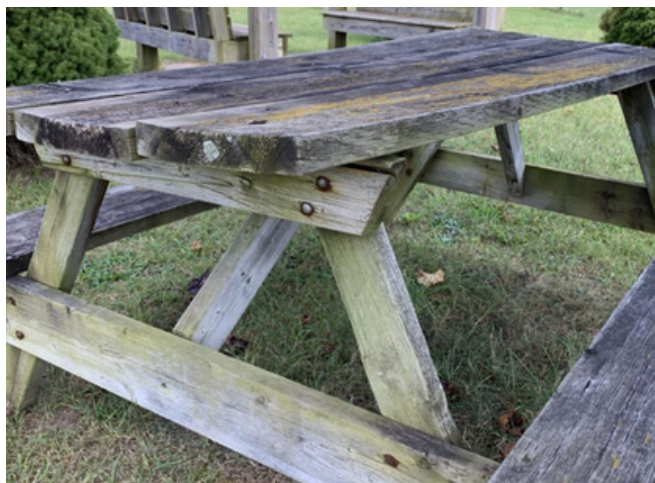
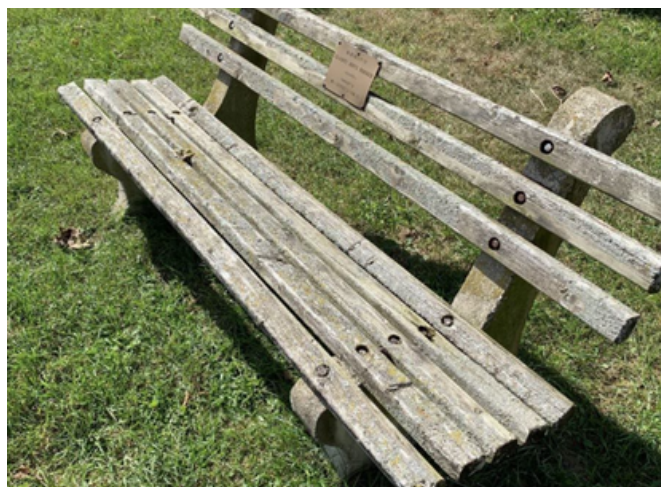
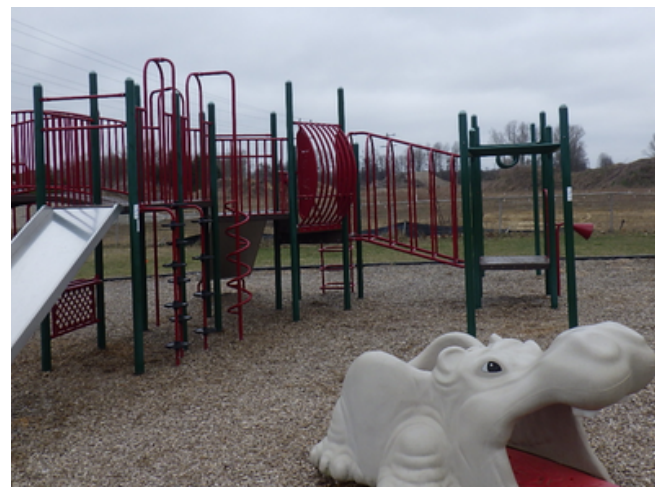
Lioness Park, located in Mt. Brydges, encompassing an area of 0.45 acres. The park features several amenities, including a playground, wooden benches, perimeter fencing, picnic tables, a gazebo, and trees. The wooden benches are noted to be in poor condition, with some lumber requiring replacement due to deterioration. Additionally, while the perimeter fencing on both sides is generally in good shape, minor repairs are necessary for the back property line fence.

The picnic table is in poor condition, and it is recommended for removal to enhance the park's overall safety and aesthetics. In contrast, the gazebo is reported to be in good condition, indicating it remains a viable feature for park visitors.

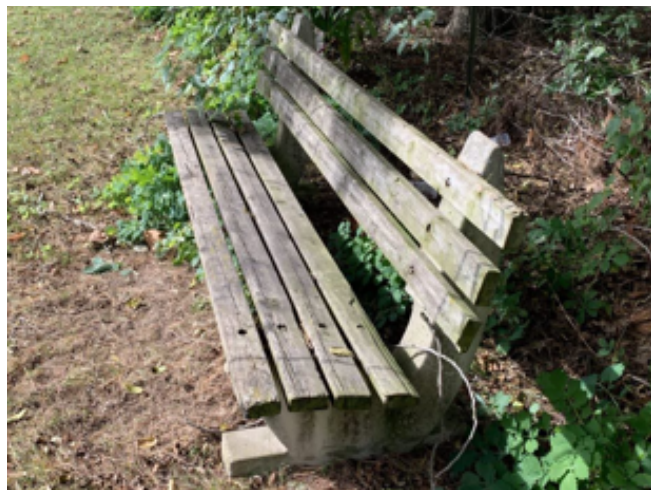
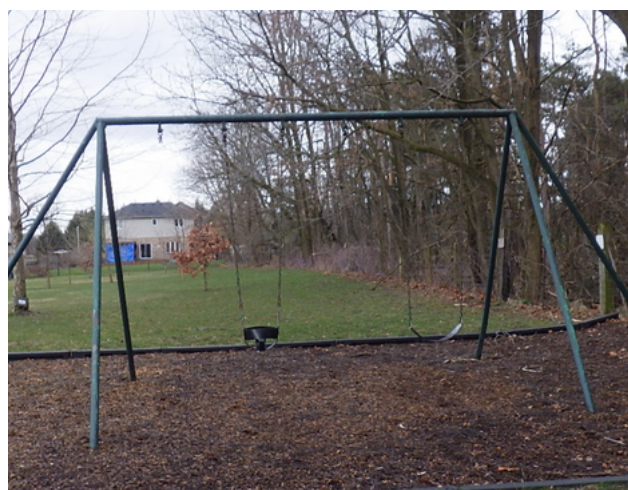
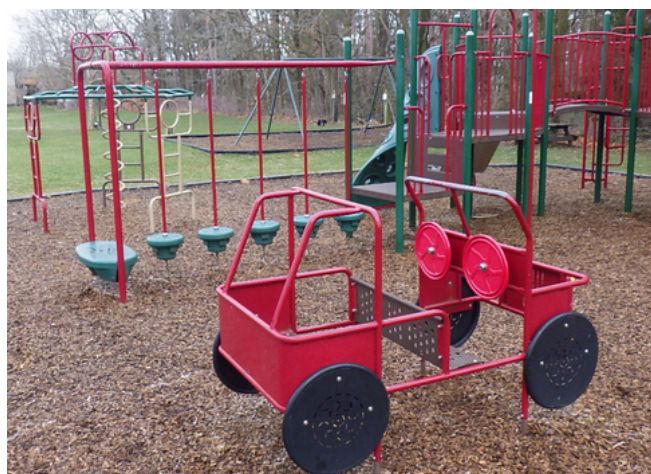
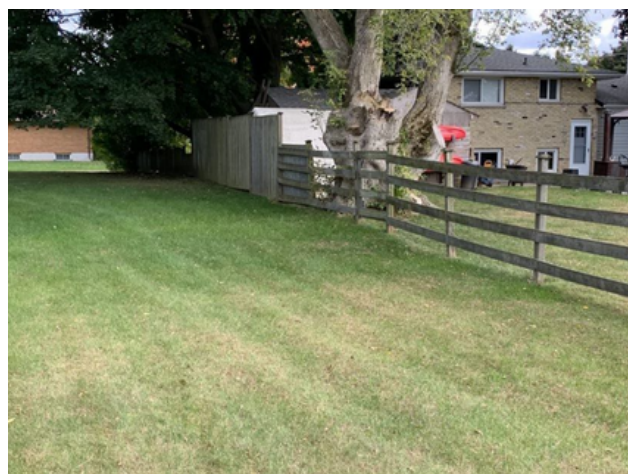
Churchill Street Park spans one acre and includes a playground area that requires further attention. In addition to the playground, the park contains a wooden bench that is deteriorating, with some lumber in notably poor condition and specific planks having failed. This issue warrants the replacement of all the wooden components or possibly a complete replacement of the bench itself.

Perimeter fencing on the north side, which runs along a line of trees, is reported to be in poor condition and has become entangled with overgrowth from an adjacent woodland. Immediate attention may be needed to restore both the fence and the overgrown areas. The fencing along the back and south side of the park is in excellent condition. The park is populated with a diverse mix of trees of various ages, with both mature and young specimens present. However, there are some trees identified as potential hazards due to their location on neighboring property lines; these trees lean over into the park, posing a risk to park visitors if left unmanaged. It is advised that all dead or decaying branches from these neighboring trees that extend into the park be trimmed back to mitigate safety risks. Additionally, keeping lower limbs on trees within the park pruned is suggested to facilitate maintenance activities such as grass cutting, ensuring that these tasks can be carried out safely and efficiently.

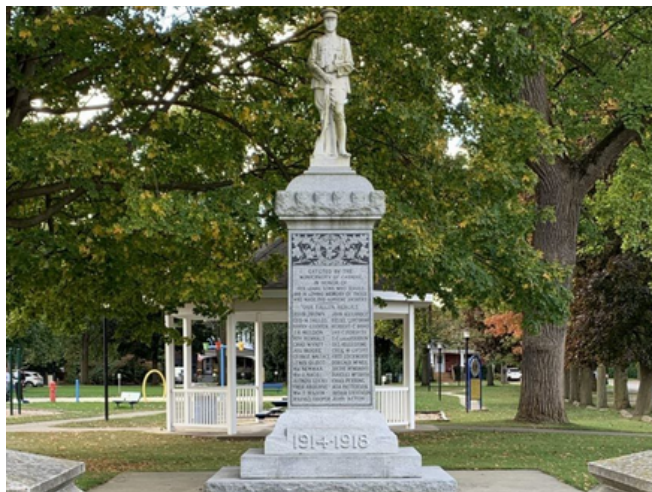
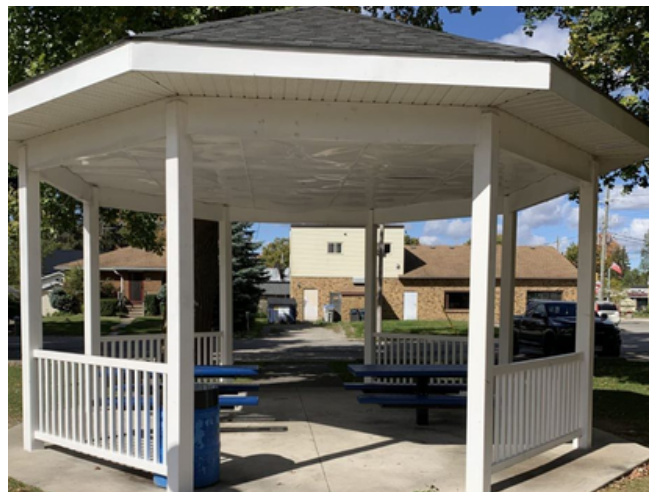
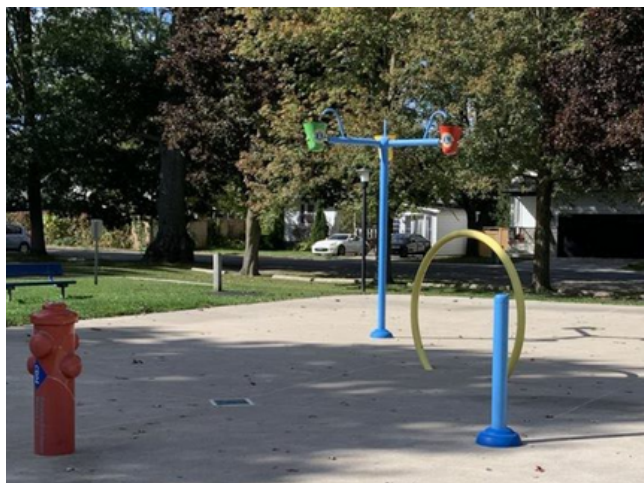
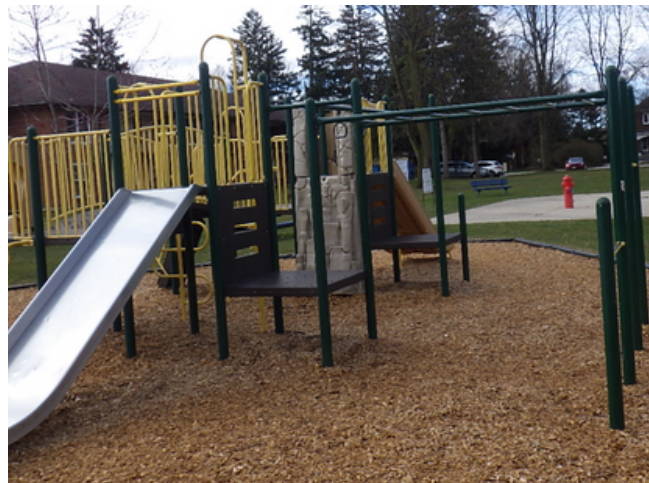
Cenotaph Park in Mt. Brydges spans 1.22 acres and includes a playground, splash pad, pavilion, and open grounds. The playground's condition is referenced for a detailed review by Playcheck inspection. Lighting in the park comprises eight pole lights, all generally in good condition, though 2-3 of the light heads show minor damage that may require future attention to maintain adequate illumination.

The pavilion structure is noted to be in good overall condition; however, the ceiling shows signs of wear along the seams, and it is recommended to continue monitoring these areas to address any potential deterioration that could arise. Park furnishings, including tables and benches, are all in excellent shape, enhancing the park's usability and aesthetics. The park remains accessible from all sides, with no perimeter fencing enclosing it, preserving an open layout for ease of access.

The splash pad appears to be well-maintained and in good working order. The park's landscape includes a diverse range of mature trees with no visible decay, dead limbs, or hazardous conditions identified. Low-hanging limbs are to be kept trimmed to assist with grass cutting and other maintenance tasks, ensuring that the park remains tidy and accessible.

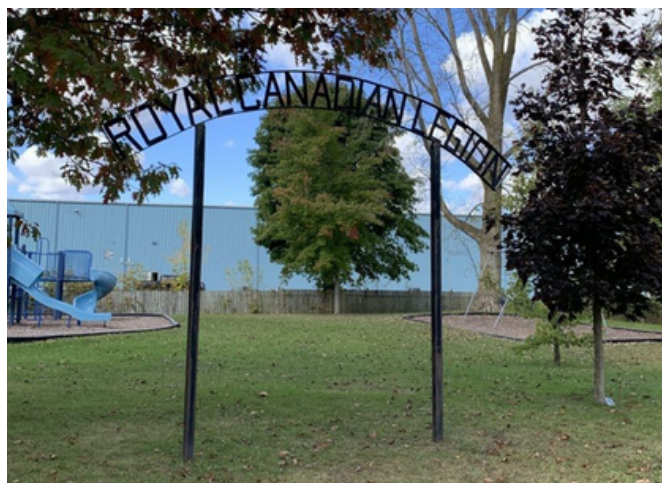
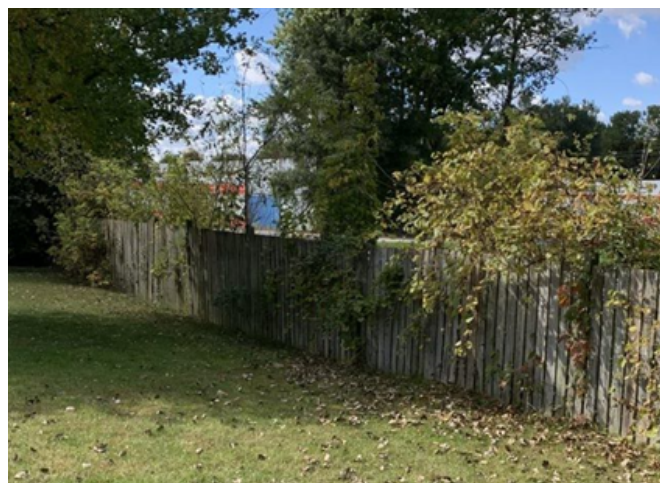
Applewood Park, located in Mt. Brydges, covers 0.49 acres and includes a playground surrounded by a well-maintained natural environment. The park is enclosed by perimeter fencing, all of which is in good condition, providing a secure boundary for visitors while maintaining the park's accessibility. The fencing does not currently require repairs or upgrades, reflecting regular upkeep and maintenance.

The park's landscaping features a mix of young and mature trees, with no identified hazard trees or branches at the time of assessment. The mature trees are in good health, and their structural integrity does not present immediate safety concerns. To facilitate grass cutting and general park maintenance, the report recommends trimming low-hanging limbs and continuing regular inspections during each cutting cycle or after significant windstorms. These inspections ensure any broken branches caught in the mature trees are identified and removed promptly, minimizing potential risks.

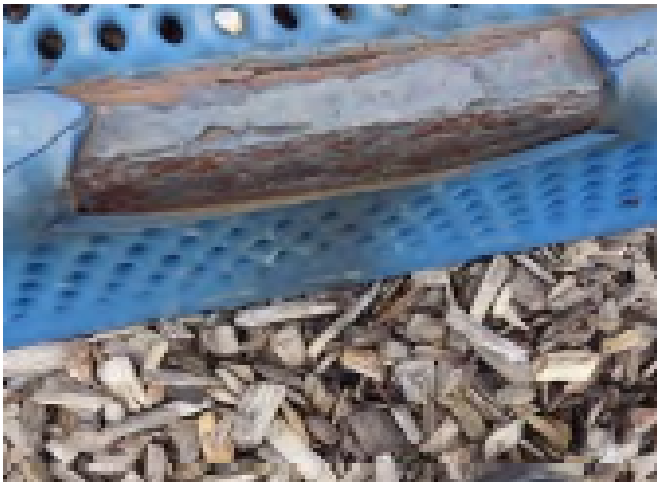
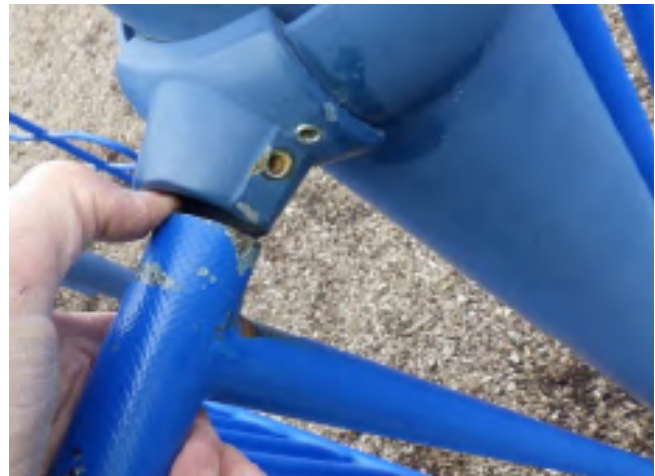
The protective surfacing consists of engineered wood fiber (EWF) but fails to meet the required depth for impact protection. Compacted surfaces were measured at depths of 5 to 8 cm, significantly less than the 15-20 cm required for proper cushioning. This reduction in depth compromises the surfacing's impact-absorbing capacity, increasing the risk of injuries from falls. The wood fiber is contained within "poly timber" walls, which generally keep the material in place, though some areas show erosion and displacement. The report stresses the importance of regular raking and topping-up of EWF to ensure consistent depth.

The park's equipment lacks the required labeling. Labels indicating the manufacturer, date of installation, and age appropriateness are either missing or illegible. Compliance with labeling standards is crucial for risk management, enabling proper maintenance and emergency response.

- Replacing missing components.
- Adjusting equipment to correct heights.
- Securing fasteners.
- Restoring protective surfacing to meet CSA standards.
- Consideration should be given to replace the structures.

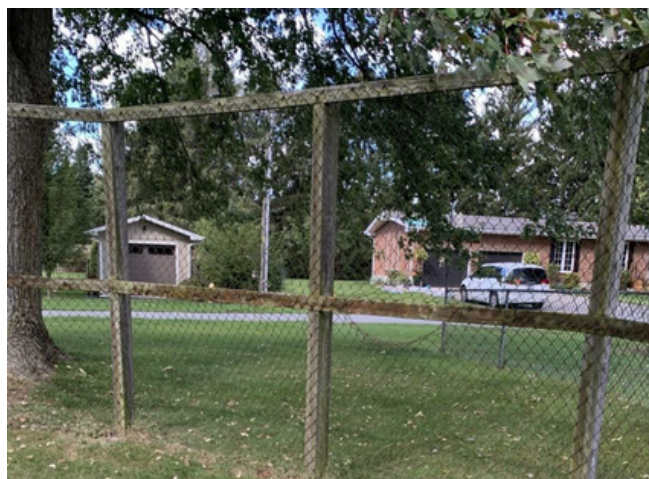
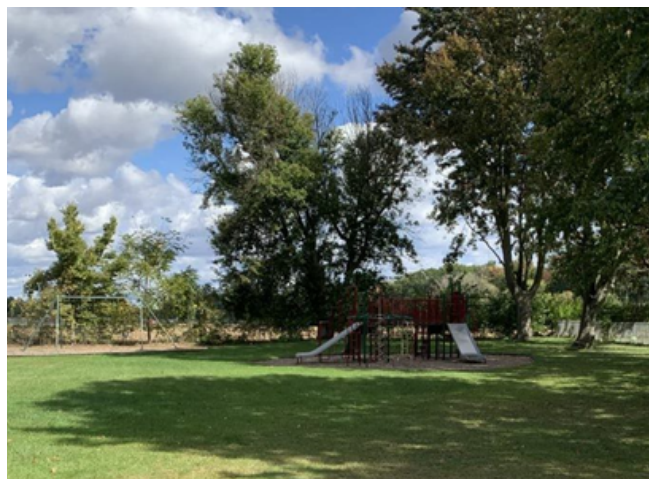
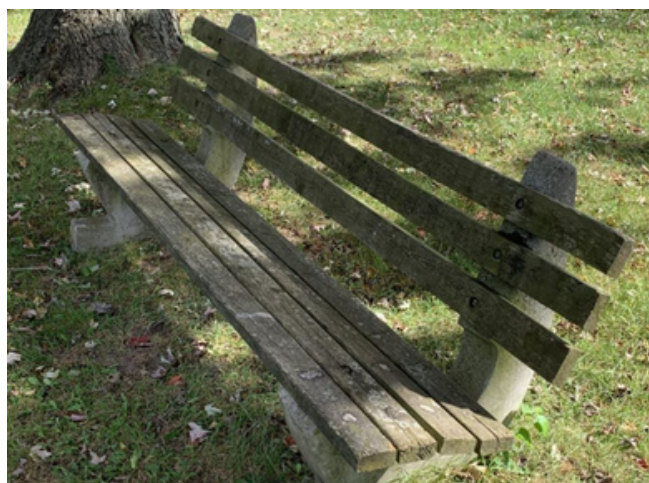
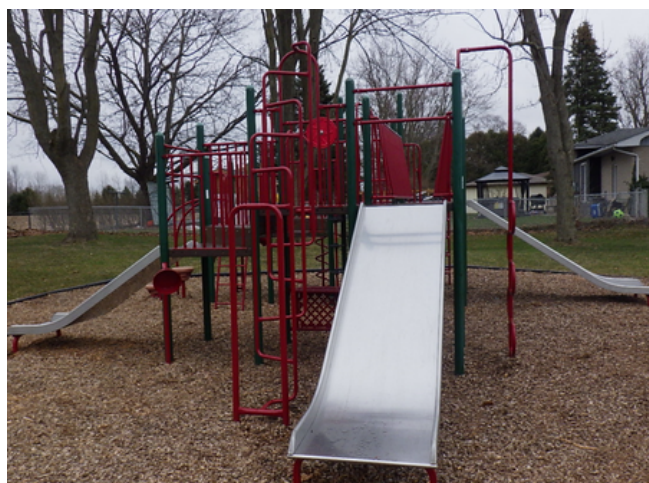
Glover Crescent Park in Mt. Brydges spans 0.69 acres and includes a playground, an old backstop, and various park furnishings. The playground condition requires further evaluation, as referenced in a Playcheck inspection. The park's wooden bench is in poor condition, with deteriorated boards that either need replacement or a complete renewal to ensure safe seating for visitors.

The perimeter fencing is in good condition along one side and the back of the park; however, the park remains open along the front and one side, allowing unrestricted access from the street. The old backstop is in poor shape, with the mesh fence pulling away from its posts, leaving holes large enough for balls to pass through. Given the minimal protection it currently offers, the report recommends either immediate repairs, removal, or a complete replacement of the backstop.

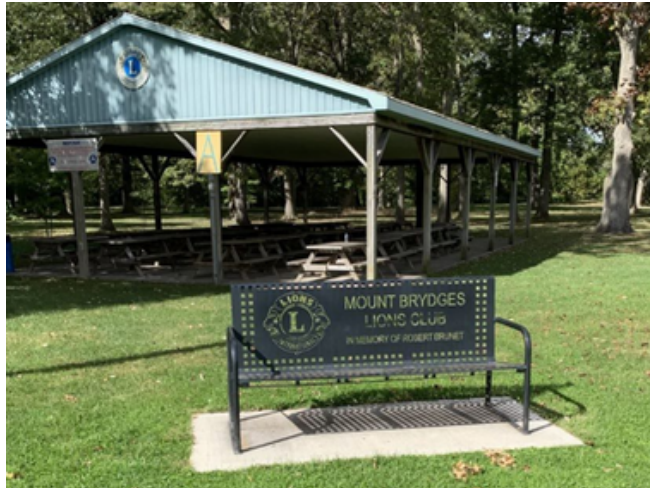
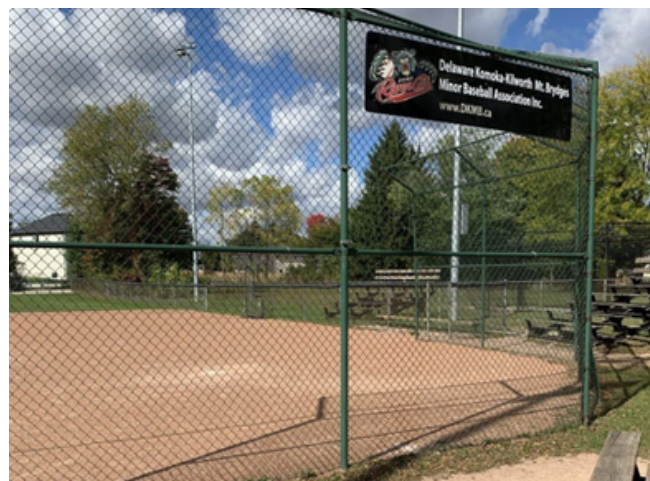
The baseball field is noted to be in excellent condition. The red clay infield provides a well-maintained playing surface, while the fencing, backstop, and outfield sports turf are also in excellent shape. The outfield is level with minimal uneven areas, contributing to safe play conditions. The players' dugout benches are in excellent condition, but the spectator bleachers are rated as average, with some wood rot visible on the seating planks. To enhance safety and usability, the report recommends the installation of side railings on the bleachers. The baseball field lighting has recently been upgraded to LED, providing efficient and high-quality illumination. The transition lip between the infield and outfield is in excellent condition, and ongoing field maintenance is advised to maintain the field's current status. The batting cage is in excellent condition, although it is unclear whether it is municipally owned or managed by the local Ball Association.

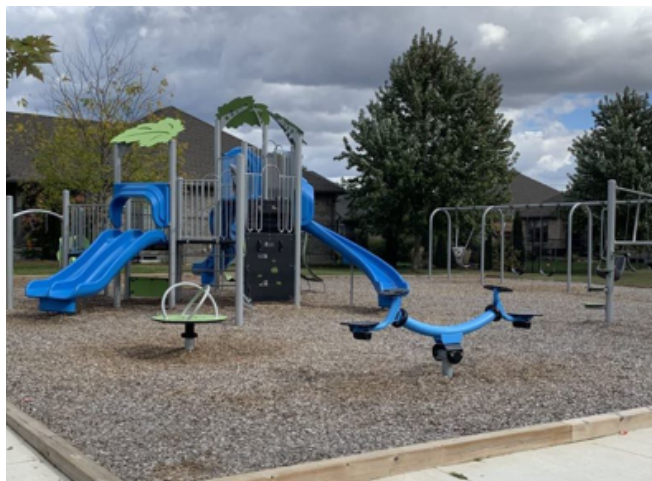
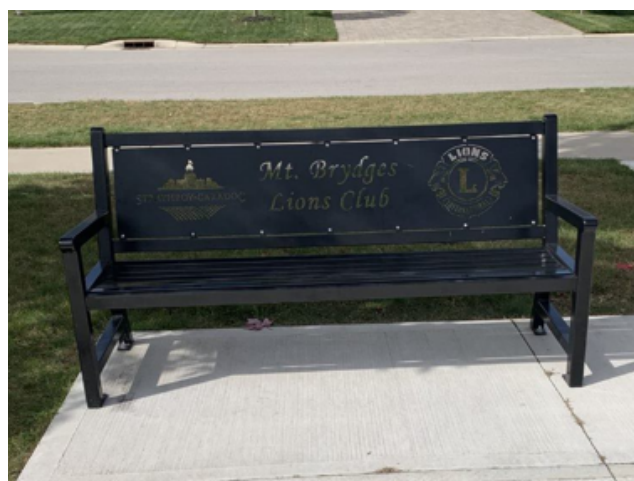
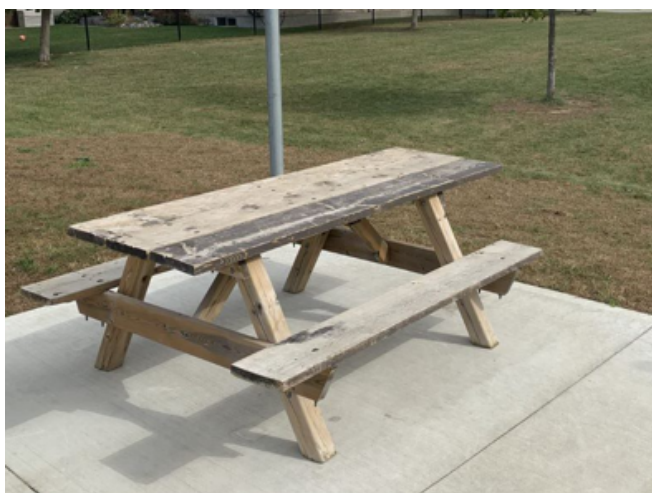
Bennett Crescent Park, covering 0.45 acres, features a playground and a pavilion. The park's perimeter fencing, which exists on only one side, is in excellent condition and requires no immediate repairs. Park furnishings, including benches and picnic tables, are also well-maintained and in excellent condition, offering high-quality seating and gathering areas for visitors.

As a newer park, Bennett Crescent Park has no mature trees, and no hazardous trees or branches have been identified. Regular maintenance of low limbs is recommended to facilitate grass cutting and park upkeep. Given the youth of the trees, it is advised to monitor them during drought periods for early signs of stress. The addition of water bags may be considered to support the trees' healthy development during dry conditions.

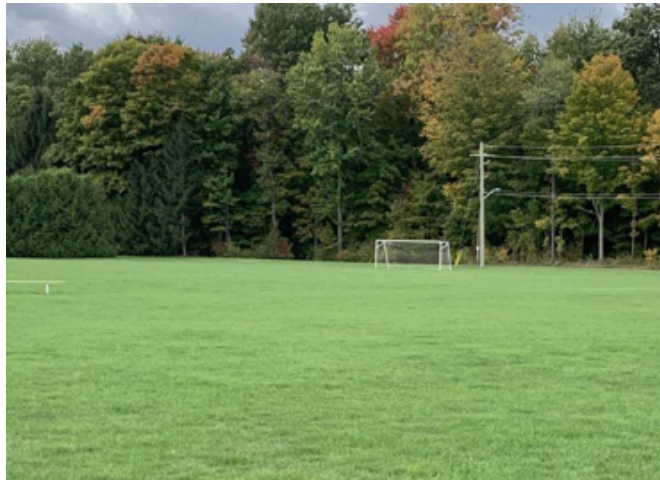
Caradoc Community Park spans 9.31 acres and includes three soccer fields and a single basketball net. The soccer fields are in excellent overall condition, with natural grass turf that has grown well and remains mostly weed-free. Minor restorative work is needed around the goal mouths, but the goal frames themselves are in excellent condition. Player benches are in good condition, though some boards are beginning to show signs of wear, indicating a need for monitoring and potential future repairs.

The spectator bleachers are rated as average, with some boards showing signs of wear and decay. The addition of side railings is recommended to enhance spectator safety. The basketball net is in excellent condition, although it is unclear if it is a municipally owned asset or was donated by a third party.

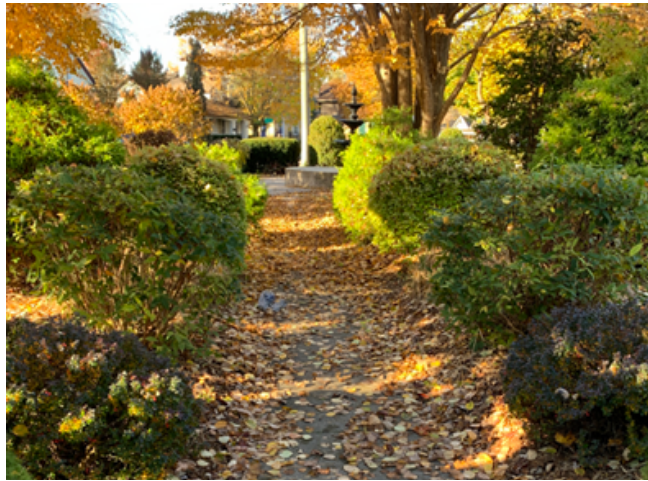
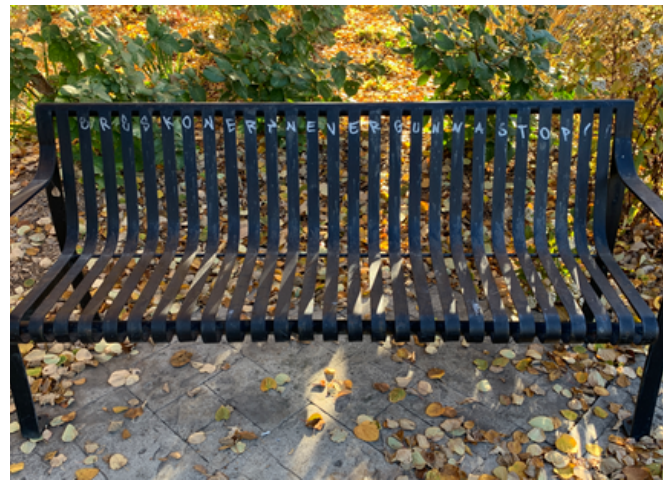
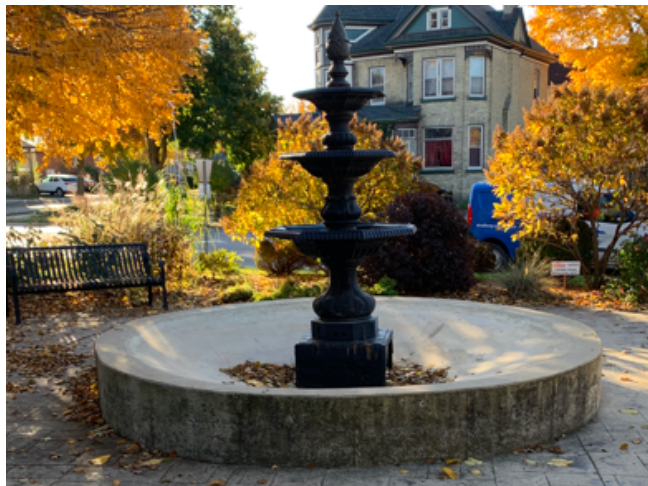
The flower beds are in excellent condition, maintained regularly by the local Horticultural Society. These beds enhance the aesthetic appeal of the park and contribute to its vibrant, welcoming atmosphere. The central fountain is in good condition but will require paint restoration in the coming years to preserve its appearance and structural integrity.

The park lacks perimeter fencing, providing an open and accessible layout. Furnishings include metal benches that are rated as average in condition. These benches show signs of corrosion, and some have been vandalized with graffiti. The report recommends addressing these issues to restore their appearance and usability.

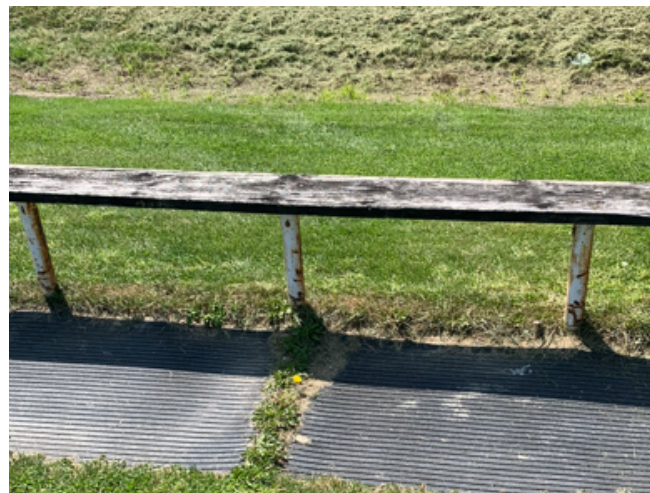
The current field conditions have been assessed as being poor due to the unprecedented rains that affected Southwestern Ontario on July 16th, 2024. Fall and spring maintenance programs are required and should include, dethatching, top dressing and re seeding of the areas affected. The bleachers overlooking the large field are noted in fair condition and consideration should be given to replace these units in the next few years. There are several benches along the trail with a number of benches requiring attention along with the players benches. Consideration should be given to upgrade to newer seating. It was noted that a number of nets are movable. These units should be properly anchored as per 'Bill 99 2023'.

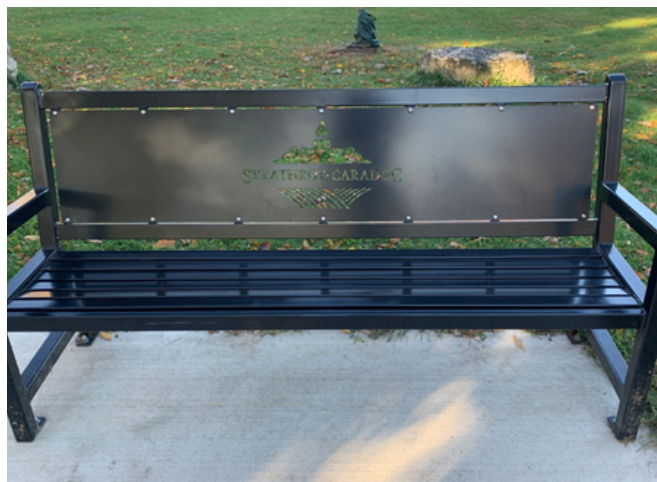
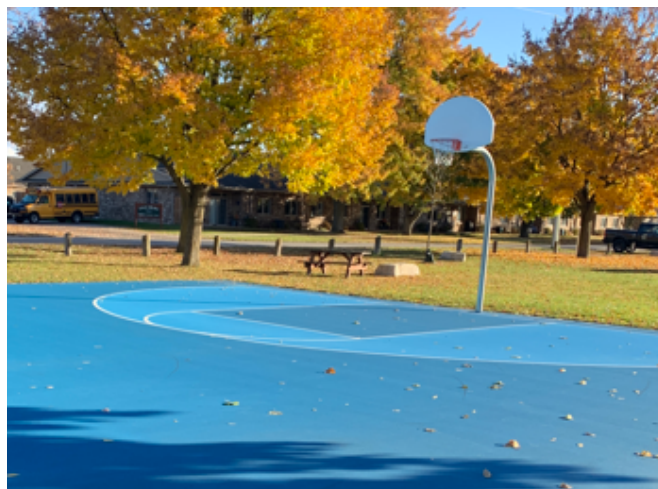
Perimeter fencing is not municipally owned, as all boundary fences belong to adjacent residential properties. Park furnishings are in mixed condition; the metal benches are in excellent shape, enhanced with fitness-related signage, which adds value to visitors. However, the wooden picnic table is showing signs of decay, and the report recommends replacing deteriorating boards to maintain safety and functionality.

The basketball court is a well-maintained feature, with a recent refinishing that adds aesthetic appeal and improves play conditions, making it a strong asset to the park. A large canopy or sunshade covers a substantial area, providing ample shaded space for visitors, and is in excellent condition.

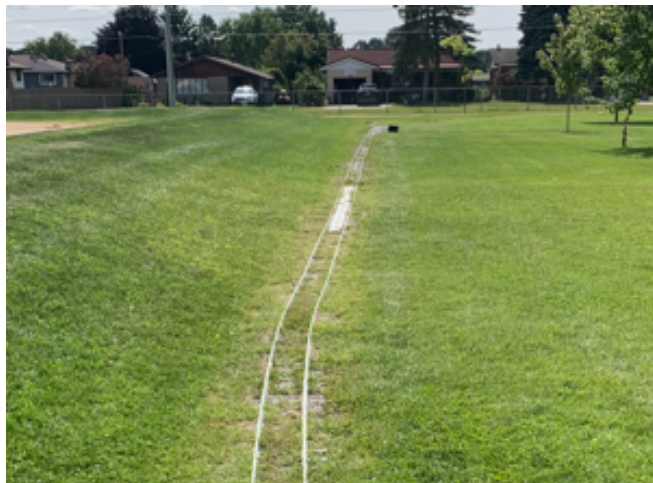
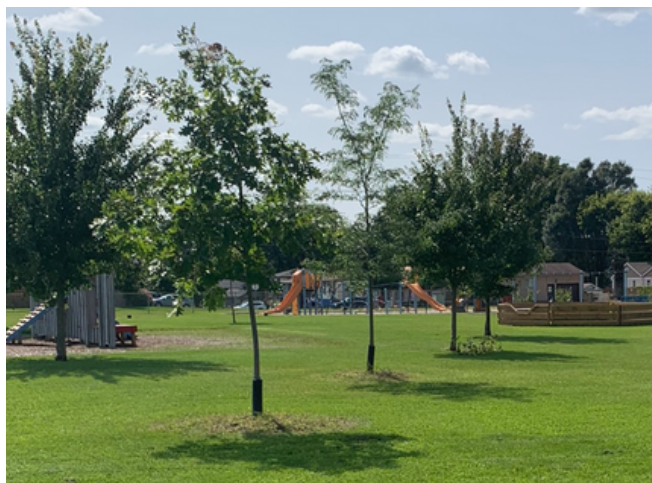
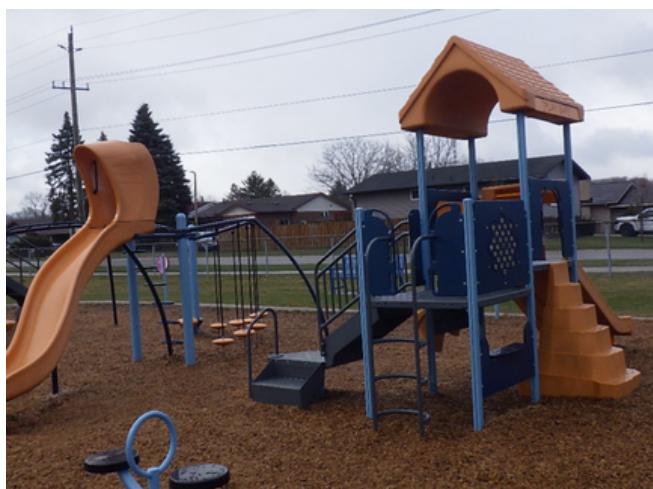
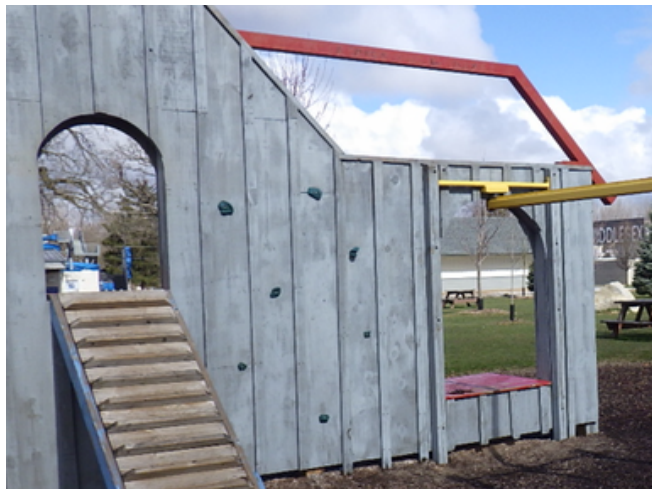
Play space #1 features composite play structures designed for two age groups: 18 months to 5 years and 5 to 12 years, along with independent equipment like swings and spring riders. It includes engineered wood fibers as protective surfacing within concrete curbing. While the general equipment design aligns with age-specific compliance, notable non-compliance issues and maintenance requirements were observed.

One key issue involves a partially bound opening on a slide that fails neck entrapment tests due to shifting of the entrance enclosure. Another issue concerns staircase treads on structures that deviate from the required horizontal alignment, likely caused by settling of base support posts. The slide's slope exceeds the allowable angle, attributed to frost heaving. Manufacturer labels on the smaller structure are missing, and signage identifying the playground owner is insufficient.

Additional concerns include the leaning of a support post for overhead rotating equipment and potential surfacing inadequacies, with HIC and Gmax test results highlighted for further review. Though the inspector rated the hazards as low-risk, resolution is necessary for full compliance and enhanced user safety.

Recommendations involve engaging the original equipment manufacturer to address structural issues and improve labeling and signage for better user guidance and emergency response clarity. Adjustments to support posts and playground surfacing are suggested to mitigate risks. The overall focus remains on balancing immediate compliance with proactive risk management strategies.

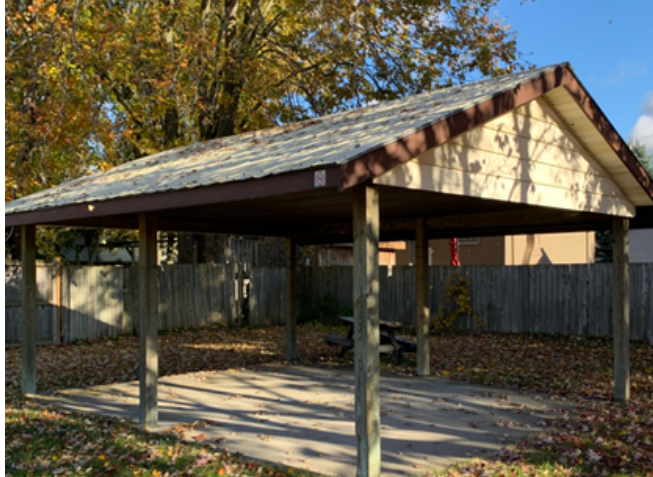
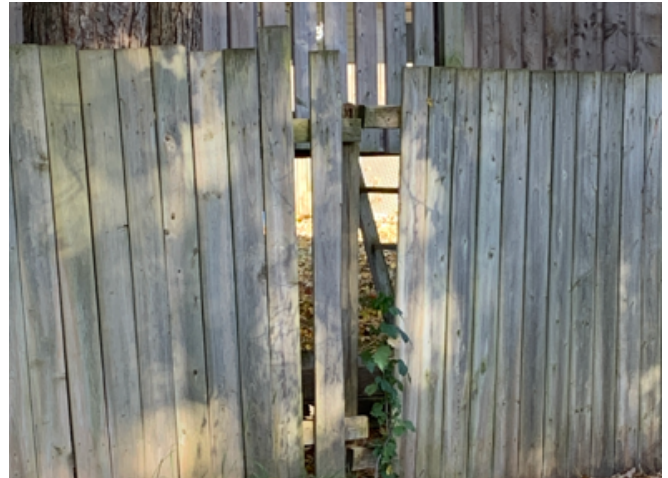
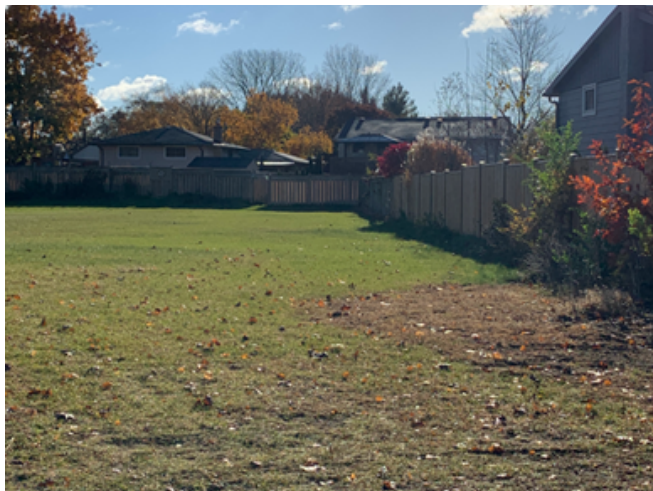
The pavilion is in poor condition, showing signs of age and wear. Due to its deteriorated state, it may require significant repairs or replacement to restore functionality and safety. The park's only wooden picnic table is in very poor condition, with noticeable warping. Removal of the table is recommended to eliminate potential safety risks for park visitors. Tree assessments indicate that the park has a mix of young trees and shrubs, along with one mature tree that appears to be in good health with no visible hazards. While there are no immediate safety concerns regarding the trees, routine monitoring is advised to maintain their health and prevent future risks. This parcel could be considered for future development as a community park, which may enhance its recreational value and provide a more comprehensive range of amenities for residents.

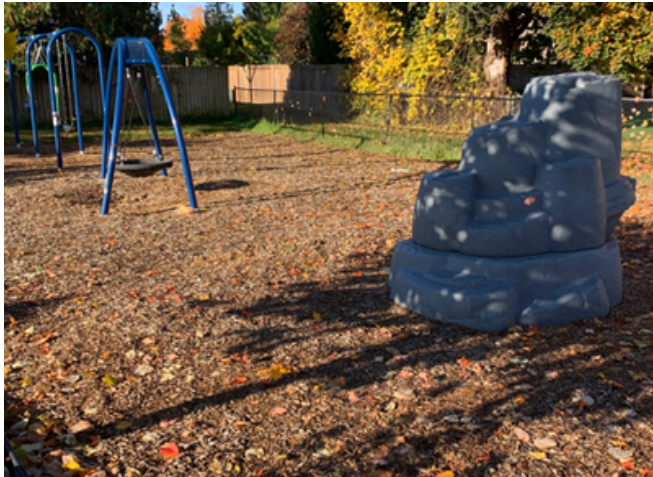
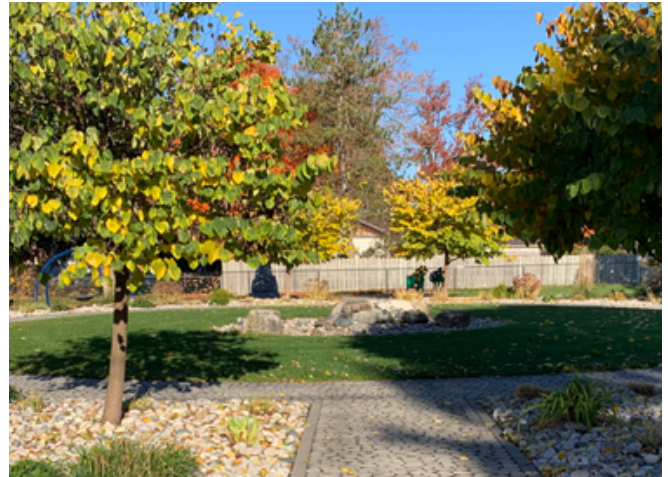
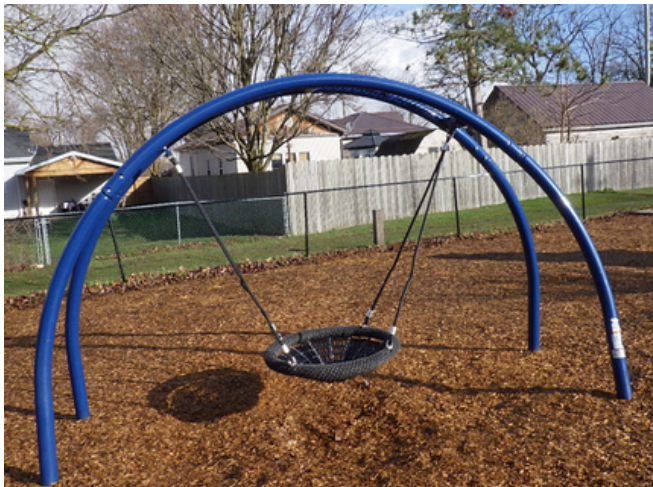
The perimeter fencing around the park consists of chain-link fencing at the rear and a wooden fence along the sides. Both fences are in excellent condition. The park furnishings, including metal benches and a garbage can, are also noted to be in excellent condition. A well-maintained interlock brick pathway runs through the park, enhancing accessibility and adding to the park's aesthetic appeal. Routine maintenance is recommended to prevent weed growth between the bricks, ensuring a clean and unobstructed path.

The park's landscape includes a mix of young trees and shrubs, with no visible hazards identified. These plantings enhance the sensory experience for visitors, adding to the park's appeal. The overall condition of the park amenities, fencing, and landscaping suggests that the park is well-maintained and effectively provides a pleasant sensory environment for visitors.

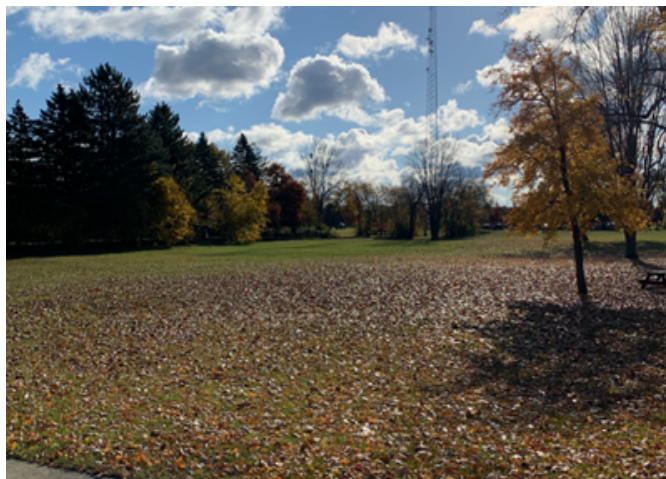
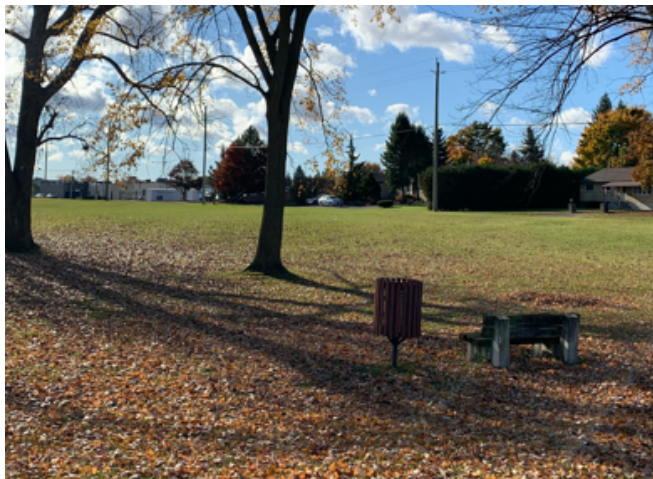
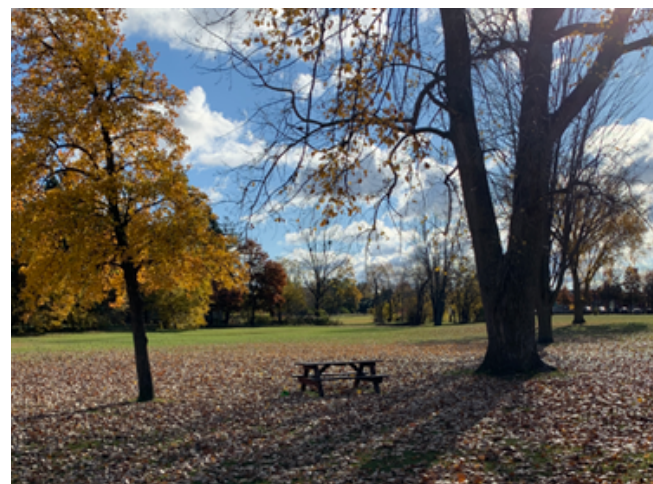
The park furnishings include a single park bench in very poor condition, which poses a safety hazard due to its deteriorated state; removal is recommended. The picnic tables are in average condition, constructed of wood and showing signs of decay. Continued monitoring of these tables is advised, with potential replacement of decayed boards to maintain safety.

The park features a mix of mature trees, none of which have been identified as hazardous, providing shade and natural aesthetics without immediate safety concerns. The parcel should be considered for future development, possibly adding more amenities to enhance the park's functionality and appeal for the community.

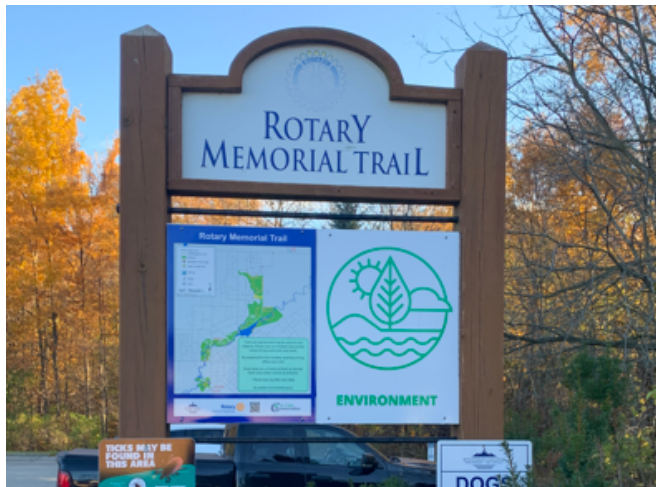
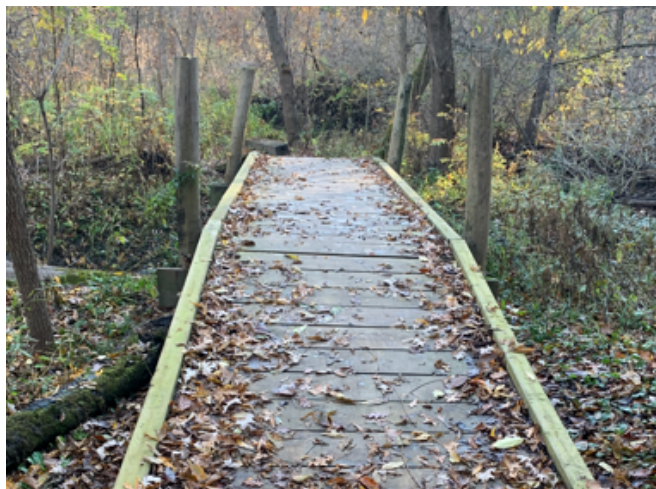
The trailhead is in excellent shape, with a recommendation to install a Practica dog waste disposal bag dispenser at the entrance to promote cleanliness. A stump near the trailhead presents a tripping hazard; it has been marked, indicating a possible removal plan. Grinding or removing this stump would eliminate the hazard.

The trail section from the trailhead to the bridge is in good condition overall, though certain areas are wet and muddy. Adding material, such as mulch, would improve traction and accessibility on these damp sections. The bridge over a small creek is rated as fair, with some areas of wood showing signs of decay. The far side of the bridge exhibits excessive bounce, and the absence of a railing raises safety concerns, especially given that the wood surface becomes very slippery when wet. Installing a railing and replacing decayed wood are recommended actions to enhance stability and safety.
