Municipality of Strathroy-Caradoc Parks and Recreational Area Condition Assessments Executive Summary Report - November 2024

Re: RFP-2024-132 – Parks & Recreational Area Condition Assessments

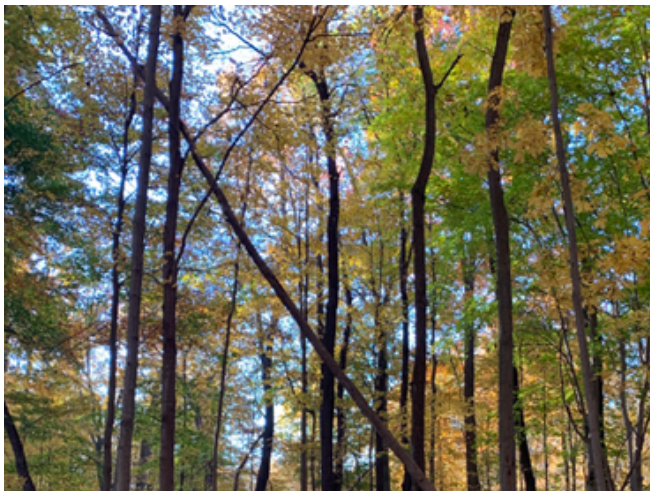
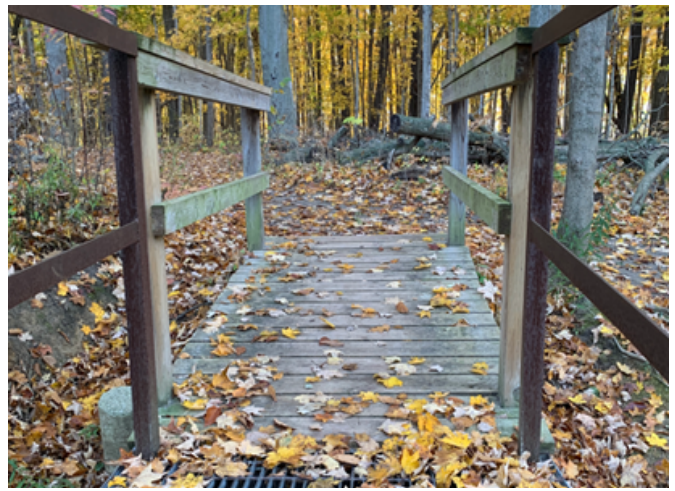
The trail section from the bridge to the stairs is in poor condition, with frequent muddy and wet areas. To improve trail usability, adding mulch or other material to build up the trail in these sections is advised. The stairs themselves are in good condition, featuring slip-resistant steel steps. However, the top landing has a slippery wooden surface, where adding a traction strip would enhance safety. The stair railing also requires painting to prevent deterioration and ensure longevity.

The final stretch of the trail, running through a mature forested area, is in good condition. It offers a scenic walking experience with mature trees and a pleasant natural environment. Regular maintenance is recommended to keep fallen trees clear of the trail, ensuring unobstructed access. Weekly inspections are advised to promptly address any downed trees or other issues. The wooded section includes several leaning trees that may need to be set down to prevent potential safety risks. The initial part of the trail traverses wetland areas with shrubs and younger trees, adding ecological variety to the park's landscape.

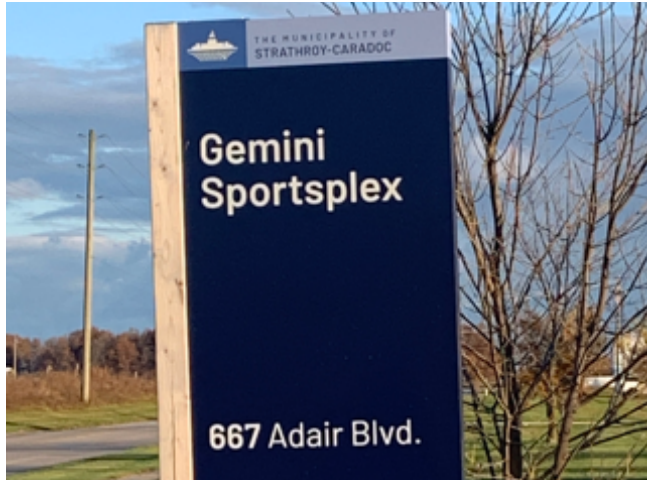
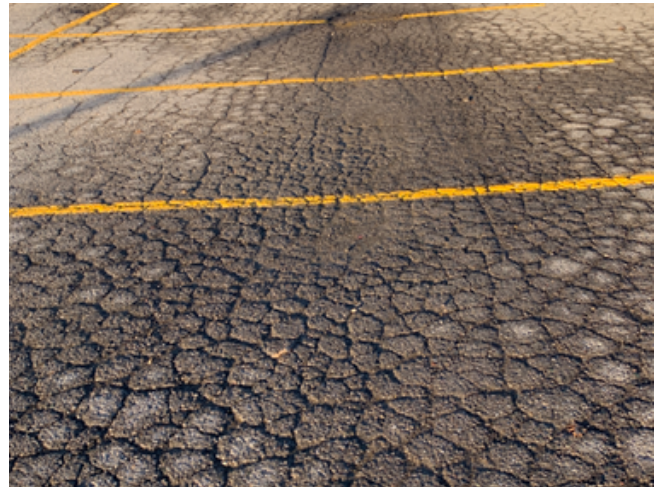
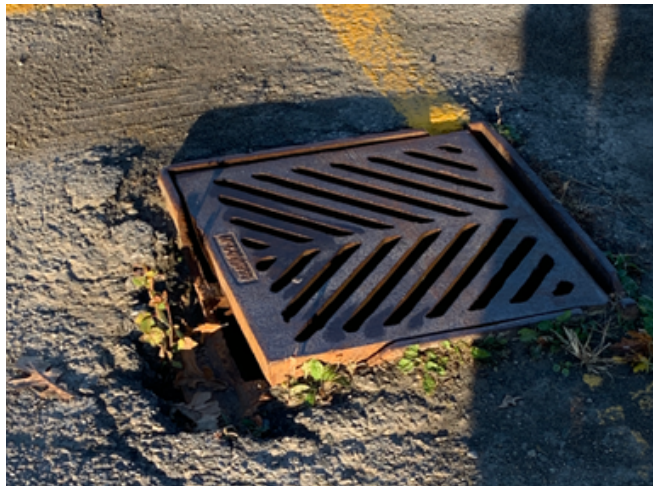
Parking lot lighting is in good condition, but the asphalt surface is only in fair condition, with numerous cracks and visible wear. Several catch basins are in poor condition, with approximately four requiring immediate repair to prevent further deterioration. Each catch basin repair is estimated to cost between \$4,000 and \$4,500. Overall, the parking lot's condition is rated as fair to good, pending these necessary repairs.

The soccer fields are well-maintained with healthy natural grass and minimal weed presence, creating an excellent playing surface. The goal frames are structurally sound but exhibit some rust; the report recommends sanding and repainting to preserve their condition. Player benches are in average condition, showing signs of wood decay and rust on the steel support posts. Monitoring the benches for further wood decay and repainting the posts is advised to maintain their usability.
