BUILDING CONDITION ASSESSMENT

MUNICIPALITY OF STRATHROY-CARADOC

Strathroy and Area Senior Centre

WalterFedy Project No.: 2018-0485-10

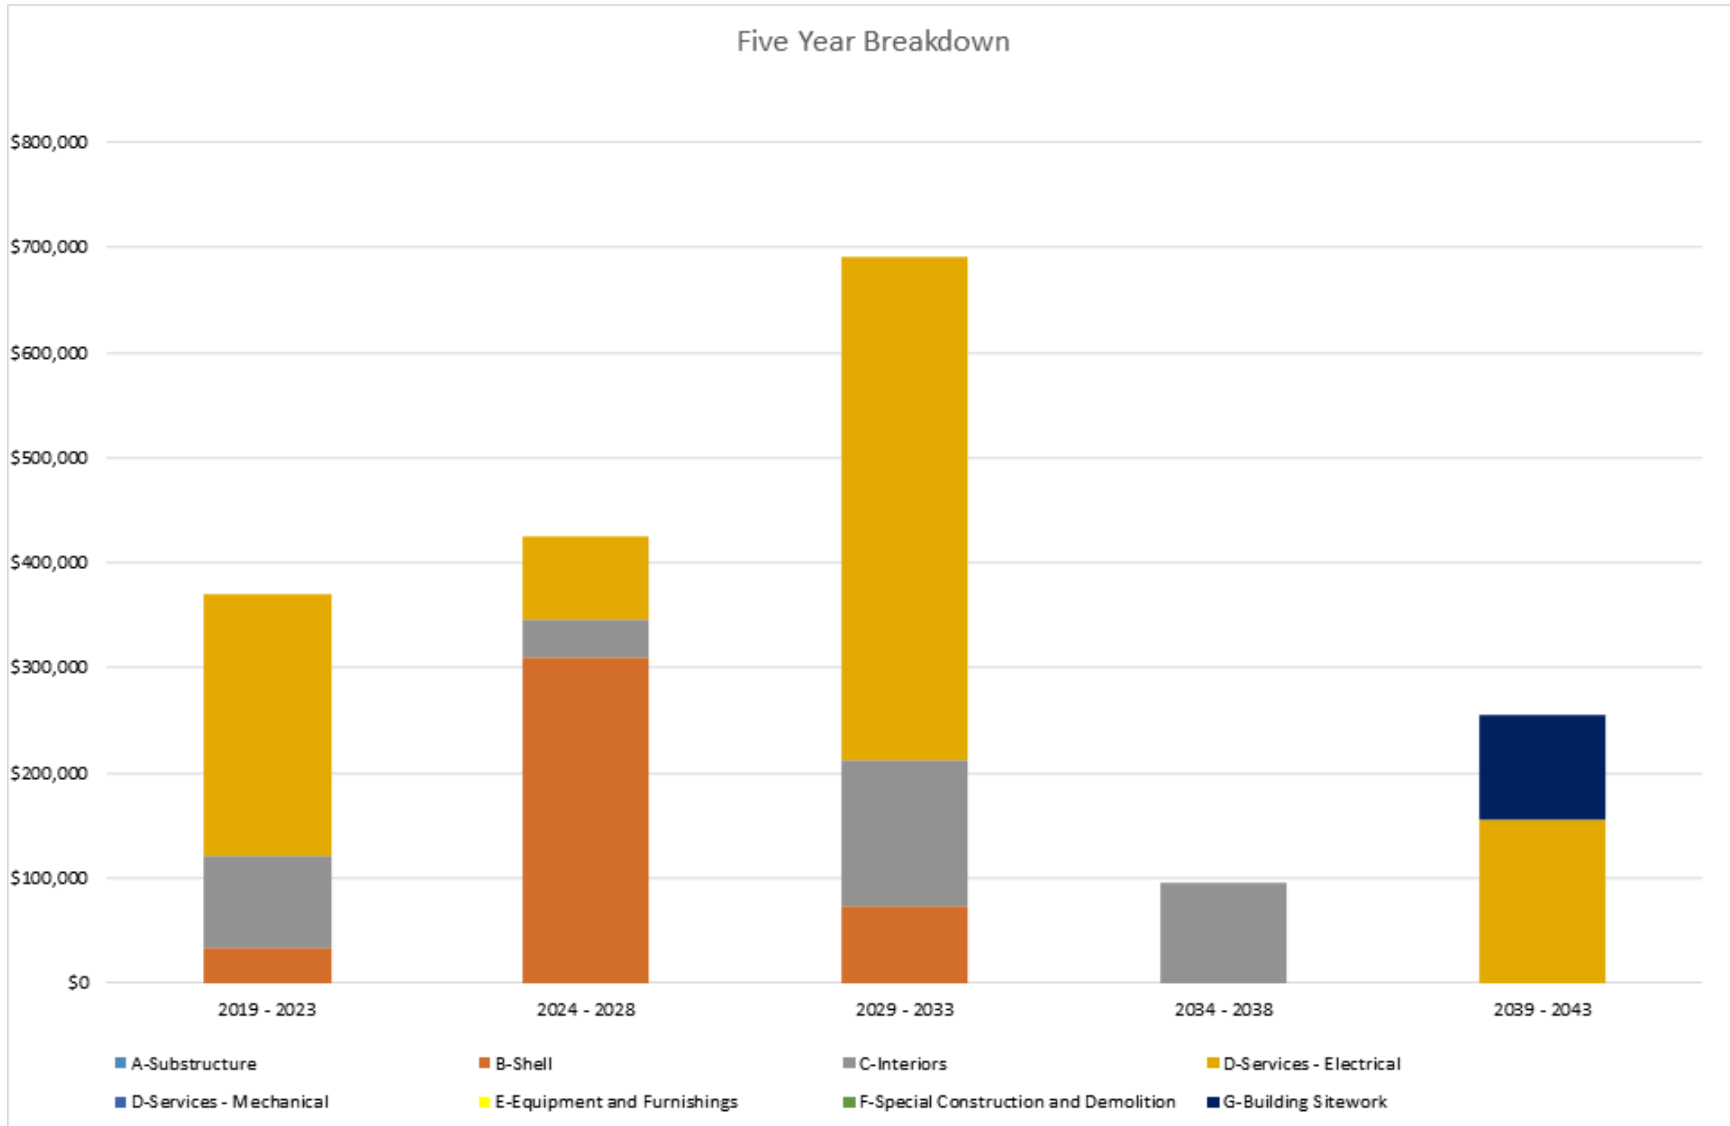
Figure 1: Five-Year Expenditure Breakdown Chart

Figure 1 displays recommended expenditures over the next twenty-five (25) years, separated into five-year increments. Details of the expenditure allocation and reserve fund study are provided in the attached reserve fund study spreadsheet.

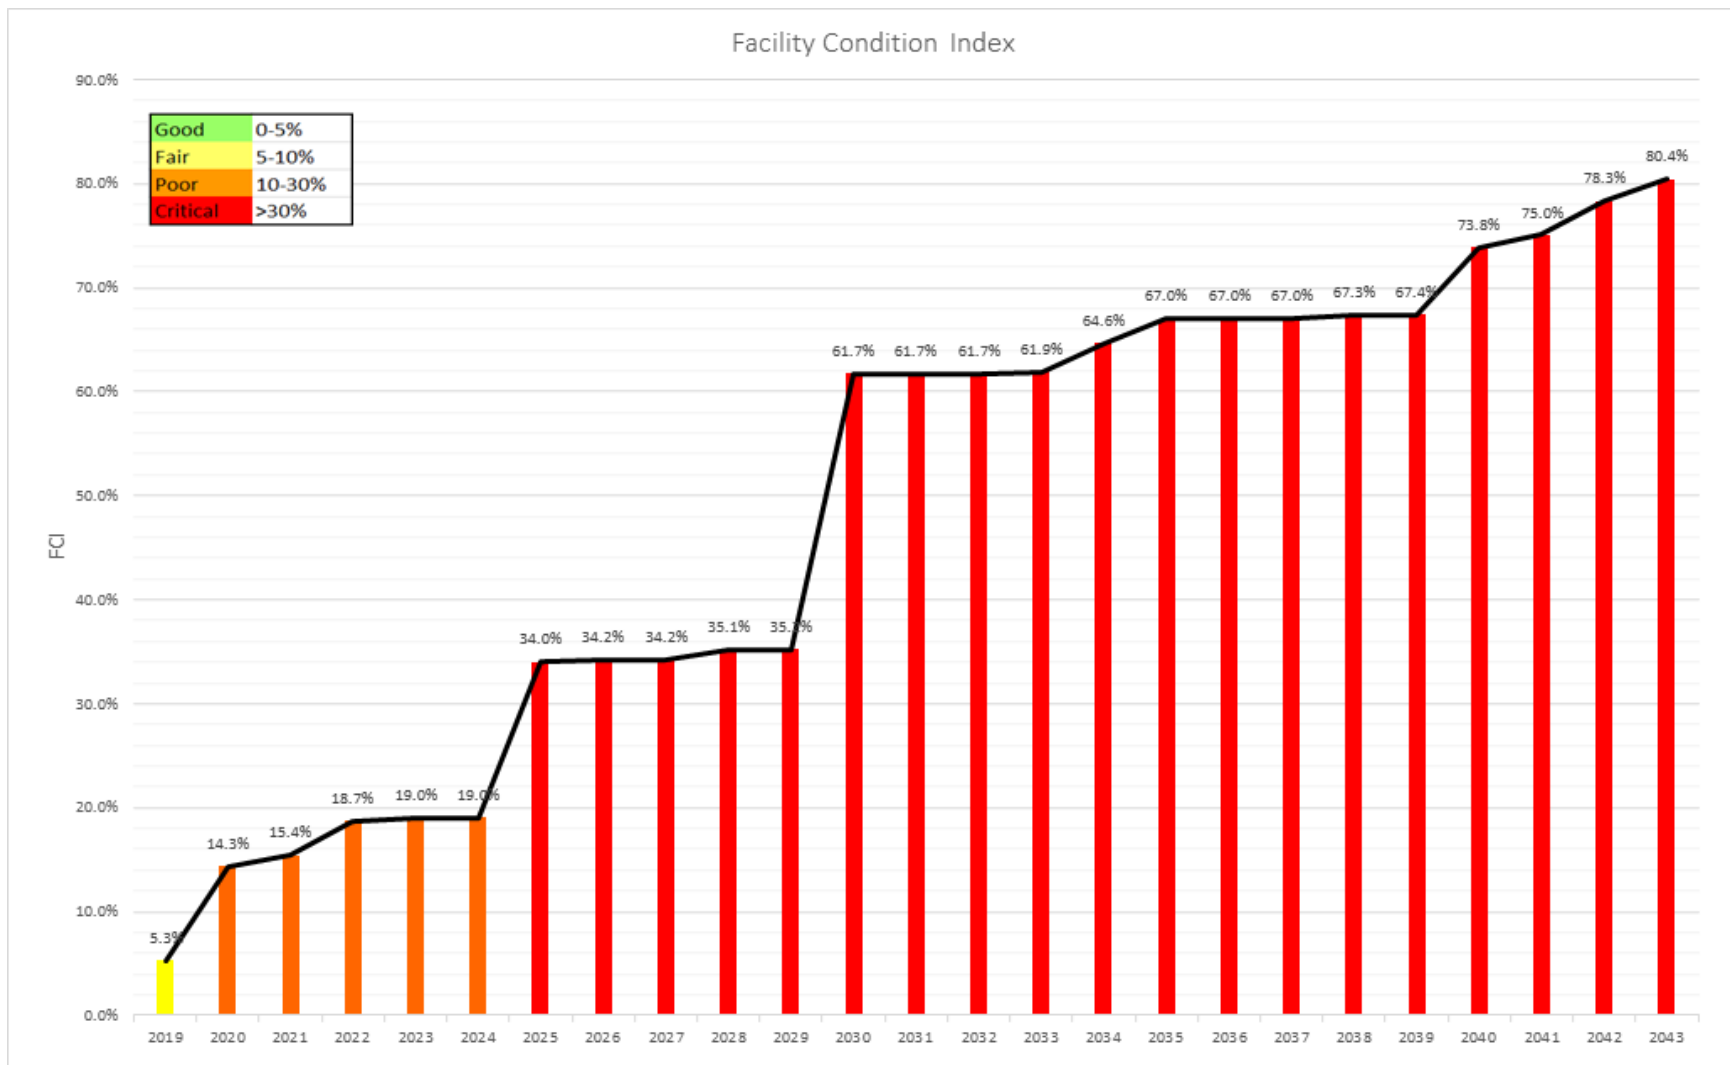
Figure 2: Facility Condition Index (FCI) Chart

At present the FCI is calculated to be 5.3%, or good. However, by 2020, if none of the recommended actions in this report are completed, the FCI will be 14.3% or in the Poor condition range. Over the next 10 years, the average FCI is calculated to be 22.9% implying that the facility will be in the Poor condition overall. If the FCI is calculated in longer term such as 25 years, some of the lifecycle replacement actions may be repeated. Therefore, the calculation results will not be accurately reflecting the actual condition. Figure 2 displays the FCI graph over twenty-five (25) years.

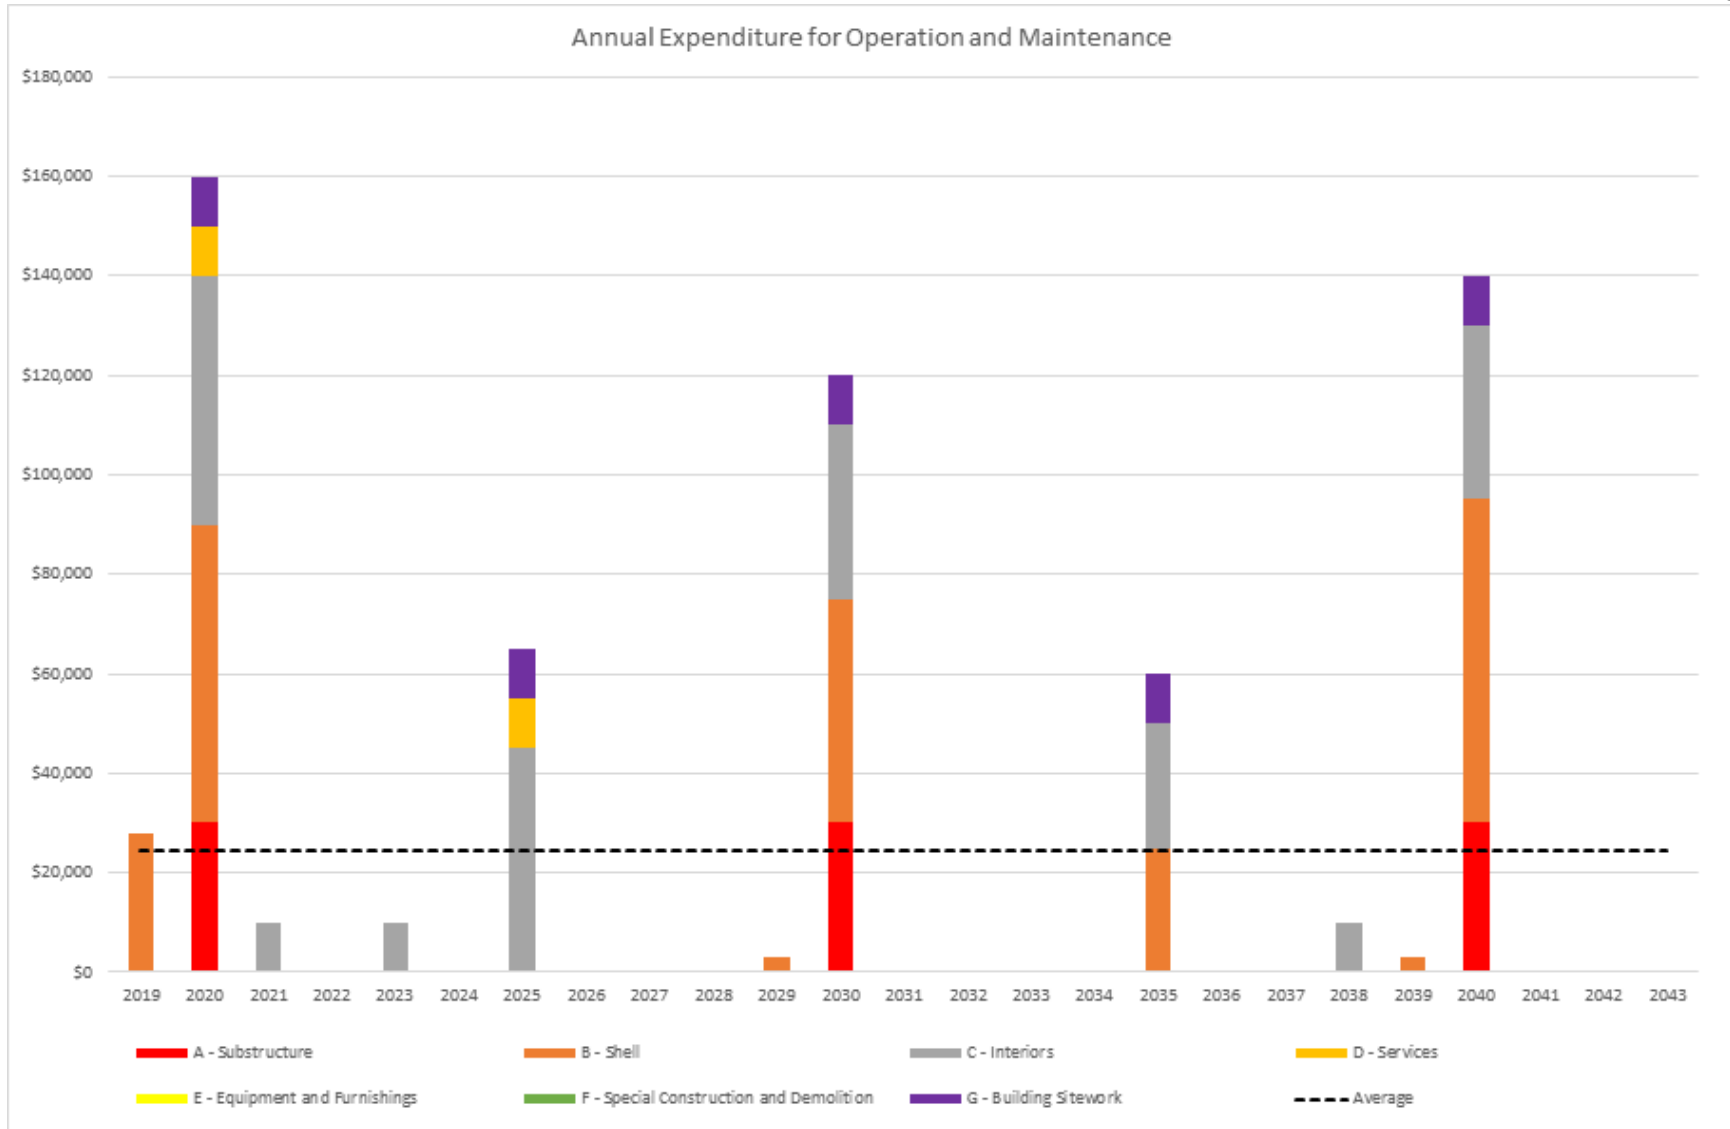
Figure 4: Annual Expenditures Chart for Operation and Maintenance

Table 6: Summary of Annual Expenditure for Operation and Maintenance

Average Annual Expenditure [\$]	24360
Maximum Annual Expenditure [\$]	160000
Total 25-Year Expenditure [\$]	609000
