<u>Re: Cedar Trees and Tennis Courts – Fairgrounds Recreation Complex</u>

JUSTFOURTENNIS has been involved in the maintenance and improvements for the four tennis courts at the Fairgrounds Recreation Complex on at least 3 separate occasions. As requested, we submit our report regarding the cedar trees along the north-west side of the courts.

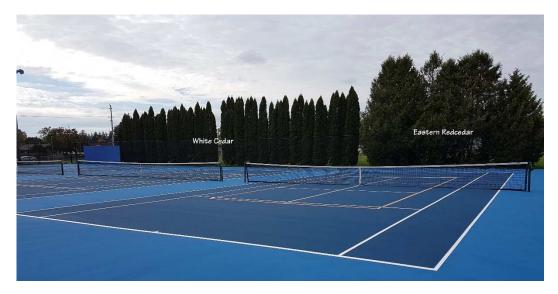
Cedar trees are used frequently for wind and shade protection. They are dense in growth and very resistant to adverse weather conditions. There are two types of cedars adjacent to the courts – these are detailed below.

1. Court Safety: Shedding from the cedars occurs seasonally with residuals having a significant impact on the court surface. Along with staining, when the residuals break

down, they can fill the course texture of the court surfacing resulting in a smooth surface which is extremely slippery when damp. This can be hazardous for players on the court.

- 2. Drainage: The cedar shedding residual also accumulates at the base of the exterior fence line. This forms restrictions for court runoff and results in ponding along the court side of the fence line. While the surfacing is very durable to wet conditions, it will quickly degrade if submerged on a continuous basis.
- 3. Court Surface Structural Base: Cedar trees general have a shallow root structure which can radiate out with the potential to damage adjacent structures. While the lateral root system tends to be the fibrous feeder type, there is evidence of minor surface irregularities associated with tree root damage.
- 4. As mentioned, drainage flows off the courts towards the cedar trees. To provide the ideal drainage conditions, the crossfall on the adjacent ground should be at least 3%. Currently the grade is 0% (level) with the courts further restricting runoff.

- 1. Remove all cedar trees along the northwest side of the tennis courts. This should include root removal taking care not to upset the tennis court asphalt pavement and perimeter fence foundations.
- 2. Grade areas after tree removal to create a grade of at least 3% away from the tennis courts.
- 3. If required, install fence windscreens to provide wind protection for players on the courts.
